A Better,  
Safer  
Railway

# Level crossing digest

Issue 4, January 2022 edition

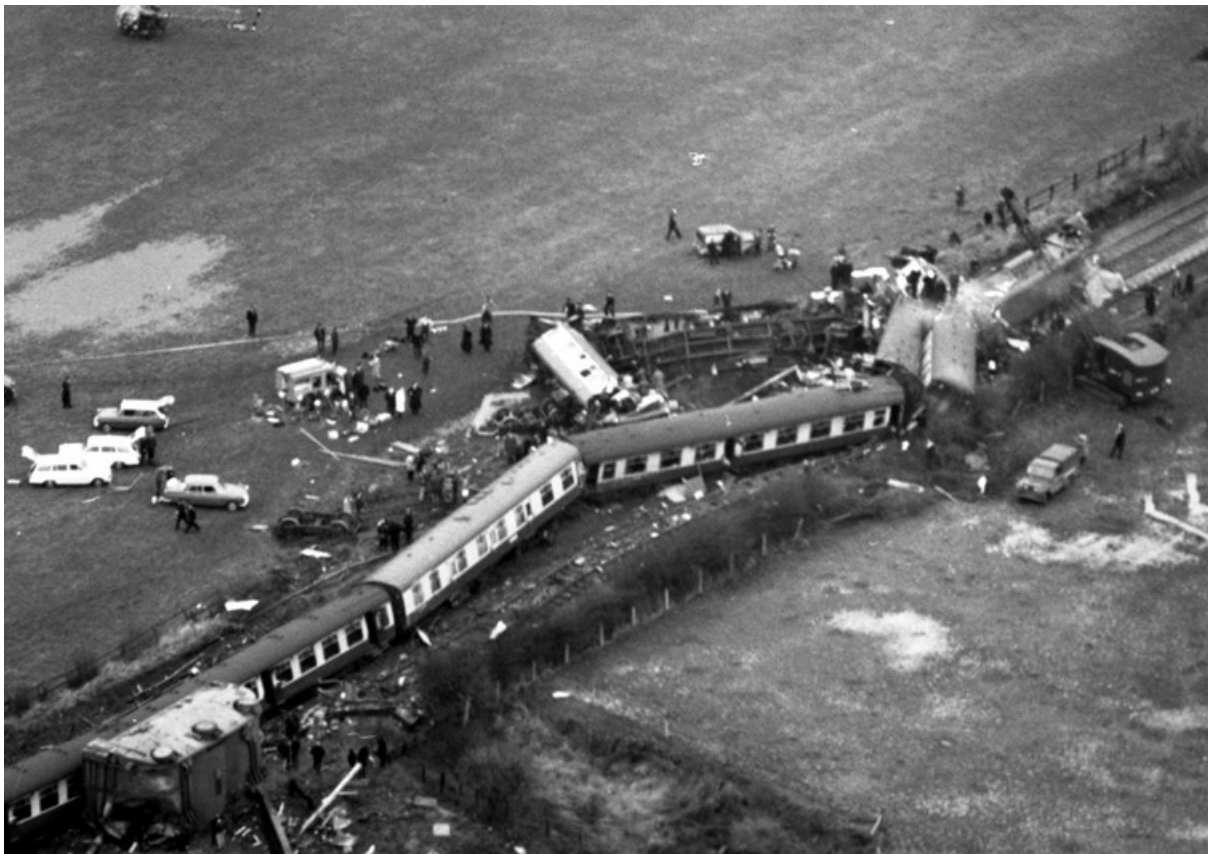
6 January 1968 and, its police escort already across, a colossal road transporter carrying a 120-ton transformer was crawling carefully over [Hixon](#) AHB in Staffordshire. At around 12:30 pm, the red lights started to flash, and the barriers began to lower. The vehicle driver had failed to phone the signalman; the vehicle failed to get clear. It was struck by an express train at around 75 mph. Eleven

people were killed, 120 yards of track were damaged, and the overhead power lines were brought down.

Realising that the RI's involvement in the AHB's development compromised its independence, the government chose to hold a Court of Inquiry under the [Regulation of Railways Act 1871](#), appointing Mr E B Gibbens QC as chair. In the first such inquiry since Tay Bridge<sup>9</sup>, the Court found that the haulage company had failed to inform BR that it intended to take the transporter over the crossing, which in turn prevented BR from taking appropriate precautions.

The report highlighted poor communications between railway and police, and railway and haulier, about telephoning the signaller when large, slow-moving vehicles were being routed. It also cited inadequate signs and poor police training as part of the causal chain. However, the report found the 'origin of the accident' to be 'the failure of officers of both the Ministry and British Railways in collaboration to appreciate the measures necessary to deal with a hazard of which they were aware'.

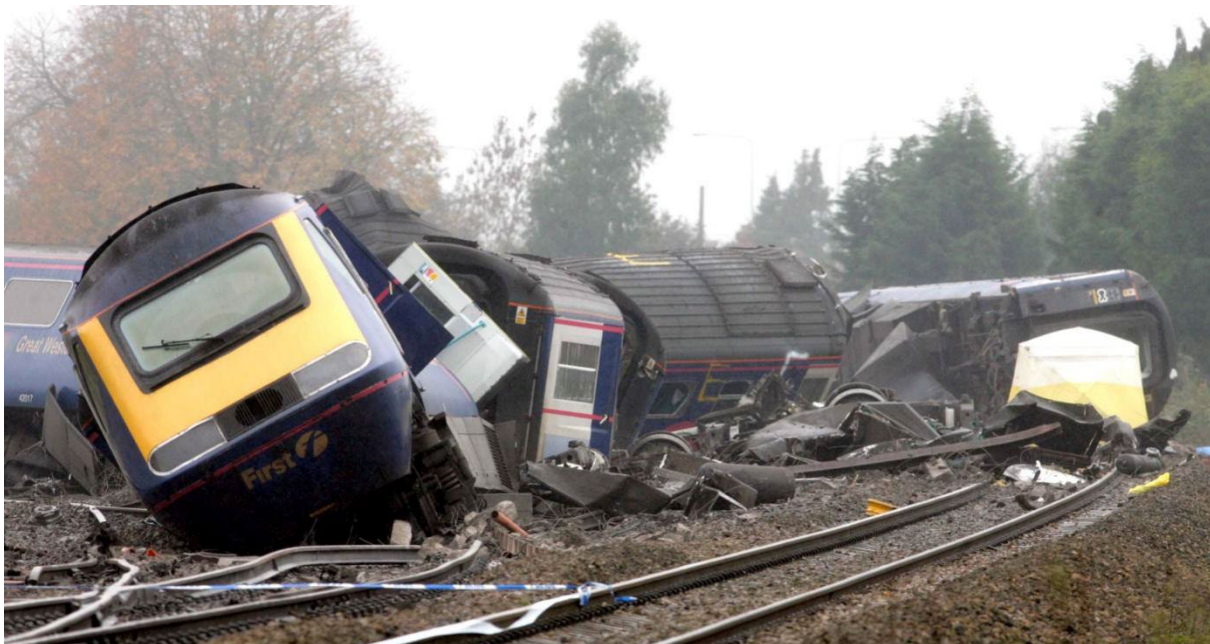
#### Ufton, Berkshire, 2004

No level crossing can be absolutely safe, but all are intended to be safe if used correctly. Sometimes, however, the way new designs are introduced can lead to problems. This was evident at Hixon. In the years following Lockington, the most serious level crossing collision occurred at Ufton AHB on 6 November 2004.

That afternoon, a car had been deliberately driven onto the crossing by a suicidal motorist. It was struck by a High Speed Train (HST), which resulted in the leading wheelset of the train derailing. Normally, it would have braked to a stand, but less than 100 metres ahead was a set of points leading to a loop. The derailed wheelset started to turn towards this loop, causing the train's leading vehicles to overturn. Seven people—including the car driver and train driver—were killed.

As a result of Ufton, RSSB also launched research into obstacle detection, which recommended the adoption of technologies that would enable their use.<sup>16</sup> In 2012, an MCB in Filey, North Yorkshire,

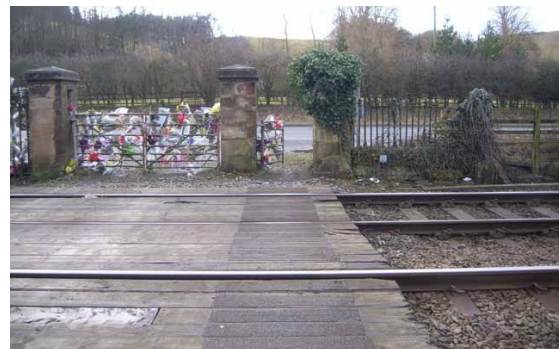
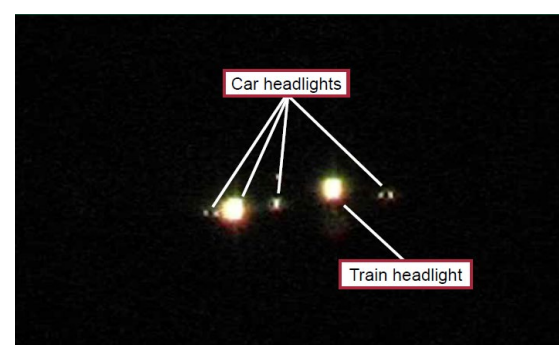
On 22 January 2008, a freight train struck and killed a person using [West Lodge UWC](#) to deliver coal on foot.

Shortly after 17:00, a delivery driver parked his vehicle across the approach to West Lodge. The two coalmen then carried a sack of coal each over the crossing. The driver made out the delivery paperwork at his vehicle while his colleague delivered a third sack and walked back towards the lorry. At this time, the train was on the approach.

At 17:13, the train driver confirmed seeing a person appear from trackside vegetation to his left. Despite the driver having sounded the warning horn immediately and continuously, the person continued to walk the few steps from the crossing onto the line.

The Rail Accident Investigation Branch (RAIB) said the user had been unaware of the approaching train, possibly because the sighting distance and warning time were less than required at the West Lodge side of the crossing.

The fact the user was not required to contact the signaller also had an effect. Furthermore, he would be unlikely to recognise a train’s headlights among those of road vehicles until it was within a second or two of the crossing (see photo, right). Traffic noise

For RAIB, the underlying factor was that Network Rail’s management systems did not acknowledge the findings of local inspections and assessments. As a result, it did not act to reduce the identified risks. Furthermore, Network Rail’s methods of level crossing inspection and assessment did not consider foreseeable environmental conditions that resulted in users being unable to recognise a train’s headlights among those of road vehicles, and its sounds masked by traffic noise and wind.

Key point: the crossing type should be appropriate to the local environment and patterns of use in all conditions.

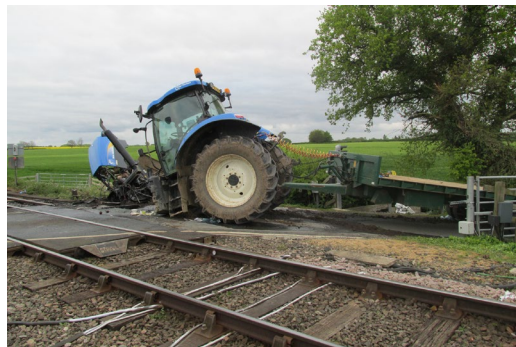
## Oakwood Farm, Knaresborough, 2015

On 14 May 2015, a passenger train collided with a tractor at [Oakwood Farm UWC](#), near Knaresborough. The train, which was travelling at 65 mph, did not derail, but the impact caused the front of the tractor to become detached from its cab. The tractor driver suffered minor injuries; the train driver was treated for shock. In different circumstances, the consequences could have been much worse.

The tractor driver began crossing the railway after the illuminated warning at the crossing started to display a red light. This was probably because he was unfamiliar with the crossing’s operation, it being one of a small number in the country fitted with power-operated gate opening (POGO), which is designed to reduce the number of traverses a UWC vehicle user has to take and increase the desired behaviour of closing the gates behind them.

RAIB reported that the tractor driver probably did not recheck the warning lights after first stopping on the approach to press a button to open the gates. This button had not originally been intended to open the gates (it should only have been capable of being used to close them). It was situated at such a distance from the crossing that the time it took for the tractor driver to stop, open the gates and drive on to the crossing was greater than the time between the warning light turning red and the arrival of the train.

The tractor driver pleaded guilty to endangering safety on the railway. After the accident, Network Rail and the authorised user further discussed legal responsibilities for invited crossing users and how risks could be better managed. A briefing pack now helps the authorised user to brief visitors. In addition, other options for this closure were considered, the crossing signs were reviewed, and the POGO equipment replaced.

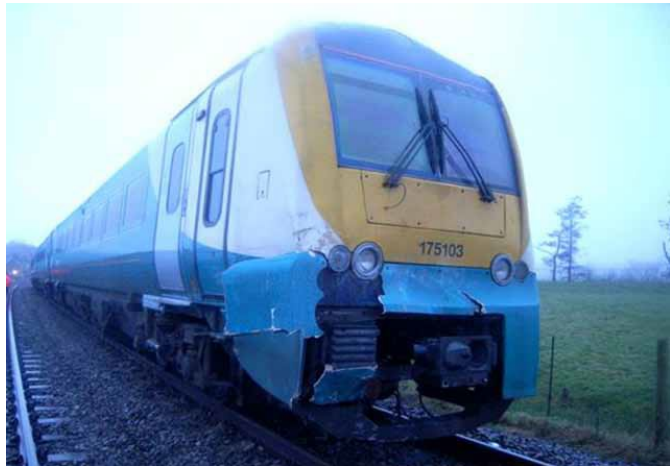
Such was the case on 16 January 2010, when a collision occurred between a passenger train and two cars on the level crossing at [Moreton-on-Lugg](#), near Hereford. A passenger in one of the cars was killed.

The signaller raised the barriers in error when the train was too close to be able to stop before reaching the crossing. He'd just been involved in a telephone call from another crossing (about the movement of sheep to a field in an area where this did not normally happen), which interrupted his normal task of monitoring the passage of the train. As a result, he believed that the train had already gone.

There was no safeguard in the signalling system to prevent this from happening. There was no plan to fit such a safeguard, and no industry requirement to consider the safety benefits of one.

RAIB noted that, as well as being put off by the telephone call, the signaller probably also lost his normal cues, because he was not standing in the optimal position in the box to monitor the situation, and also felt a degree of pressure to re-open the barriers at Moreton-on-Lugg.

RAIB noted that a 'possible underlying factor was the lack of regular liaison between Network Rail's operational risk team and signalling engineers'. This 'made it less likely that the risk associated with signaller error, and the potential mitigation, would be considered'.

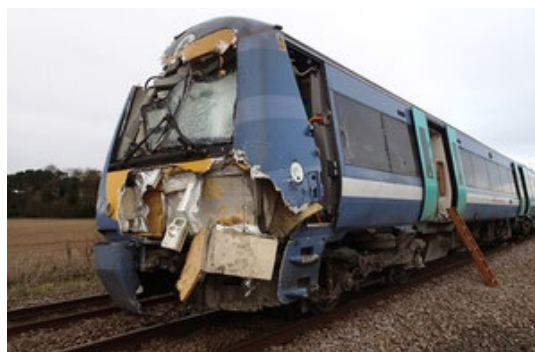
## Hockham Road, Norfolk, 2016

At 12:30 on Sunday 10 April 2016 a Norwich–Cambridge service collided with a tractor and trailer at [Hockham Road level crossing](#). The tractor driver was seriously injured; the train driver and several passengers received minor injuries. The tractor was destroyed, and the train was badly damaged.

Hockham Road crossing, which is on a private road near Thetford, also carries a public footpath. Vehicle users must open and close the gates themselves and, at the time of the accident, had to use the telephone to obtain permission from a signaller at Cambridge before crossing.

The tractor driver was given permission to traverse, and had got half-way across when his vehicle was struck by the train, which was travelling at 84 mph.

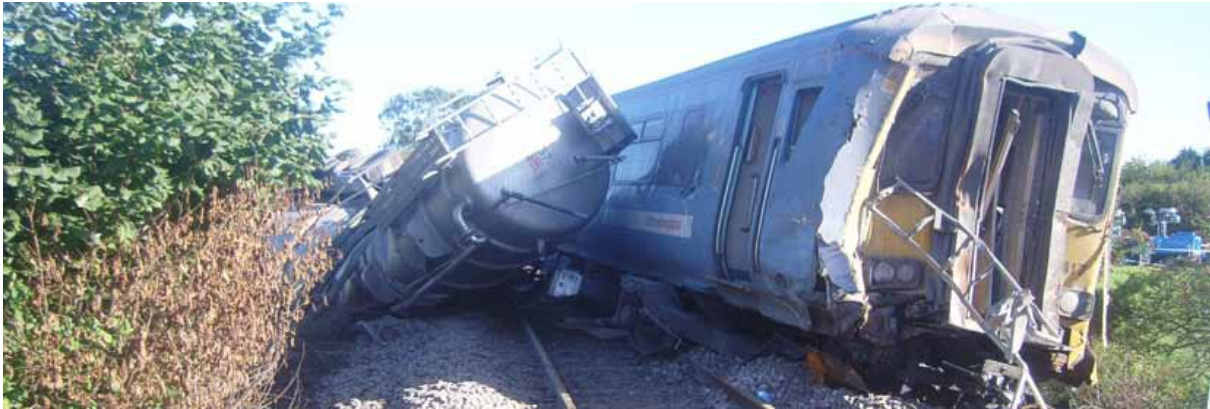
## Sewage Works Lane, Suffolk, 2010

At around 17:35 on 17 August 2010, a passenger train collided with a loaded 44-tonne articulated road tanker on [Sewage Works Lane UWC](#) (a private railway crossing), near Sudbury in Suffolk. The collision caused the train to derail. Several passengers and the conductor were injured; four passengers and the train driver were seriously injured.

RAIB found that the driver of the road tanker did not use the telephone provided before driving onto the crossing, although it was a requirement to do so.
