**IN RESPECT OF THE APPEAL AGAINST THE DECISION OF HERTFORDSHIRE  
COUNTY COUNCIL FOR THE DEVELOPMENT OF  
LAND AT HATFIELD AERODROME, OFF HATFIELD ROAD, HATFIELD,  
HERTFORDSHIRE**

**PLANNING INSPECTORATE REF: APP/M1900/W/24/3346607**

**Ellenbrook Country Park Footpath Assessments**

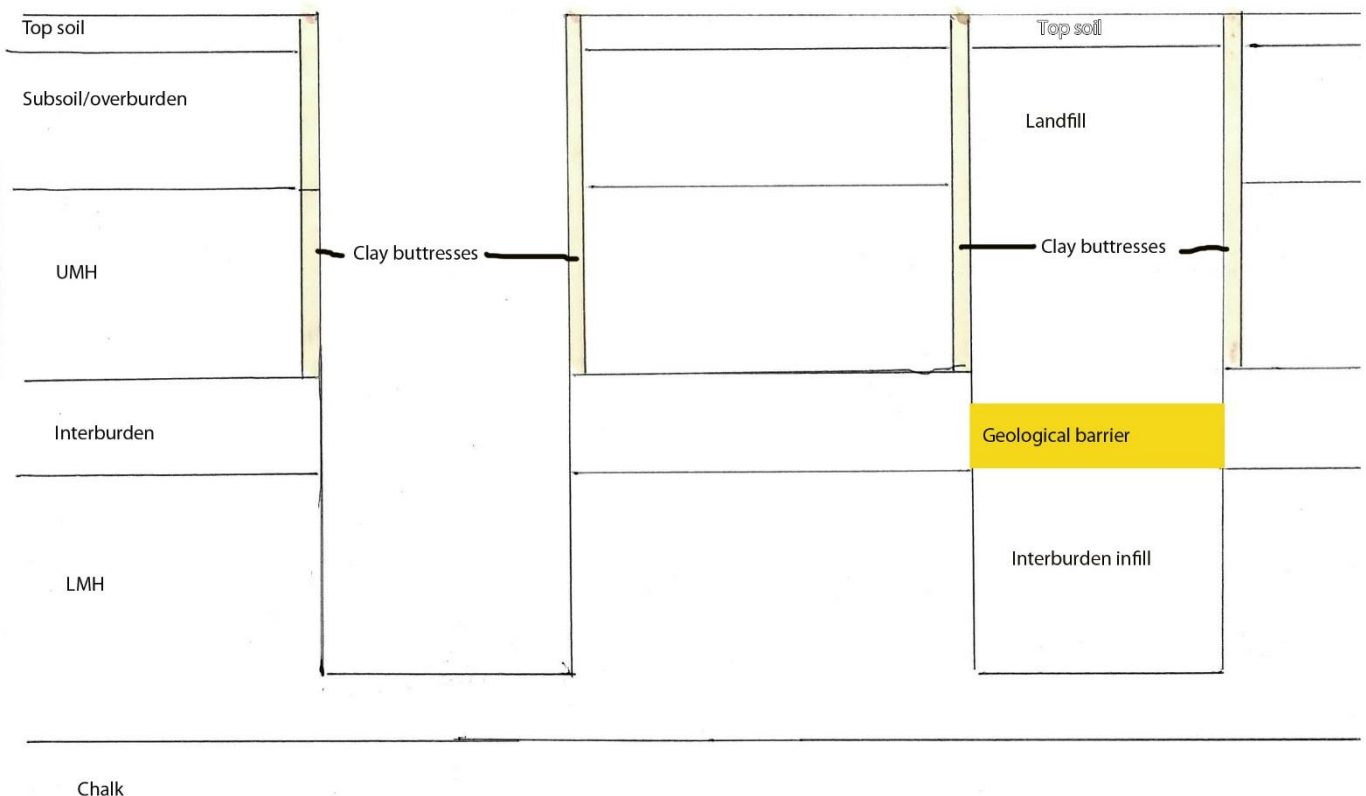
CHPC illustrative cross sections based on the appellants data.

4.28 Each phase the UMH has clay buttresses around all sides and once LMH has been worked the LMH is filled in inter-burden which the applicant states is boulder clay (Water Environment 6, table 6-4) which has a very low porosity, so effectively sealing each phase. Then backfilling into the UMH which is effectively a waterproof soil filled tank. Given the low porosity of soils found on site the small layer of topsoil over clay buttresses (3.4.1) will provide inadequate to allow horizontal drainage from within the sealed areas or tanks.

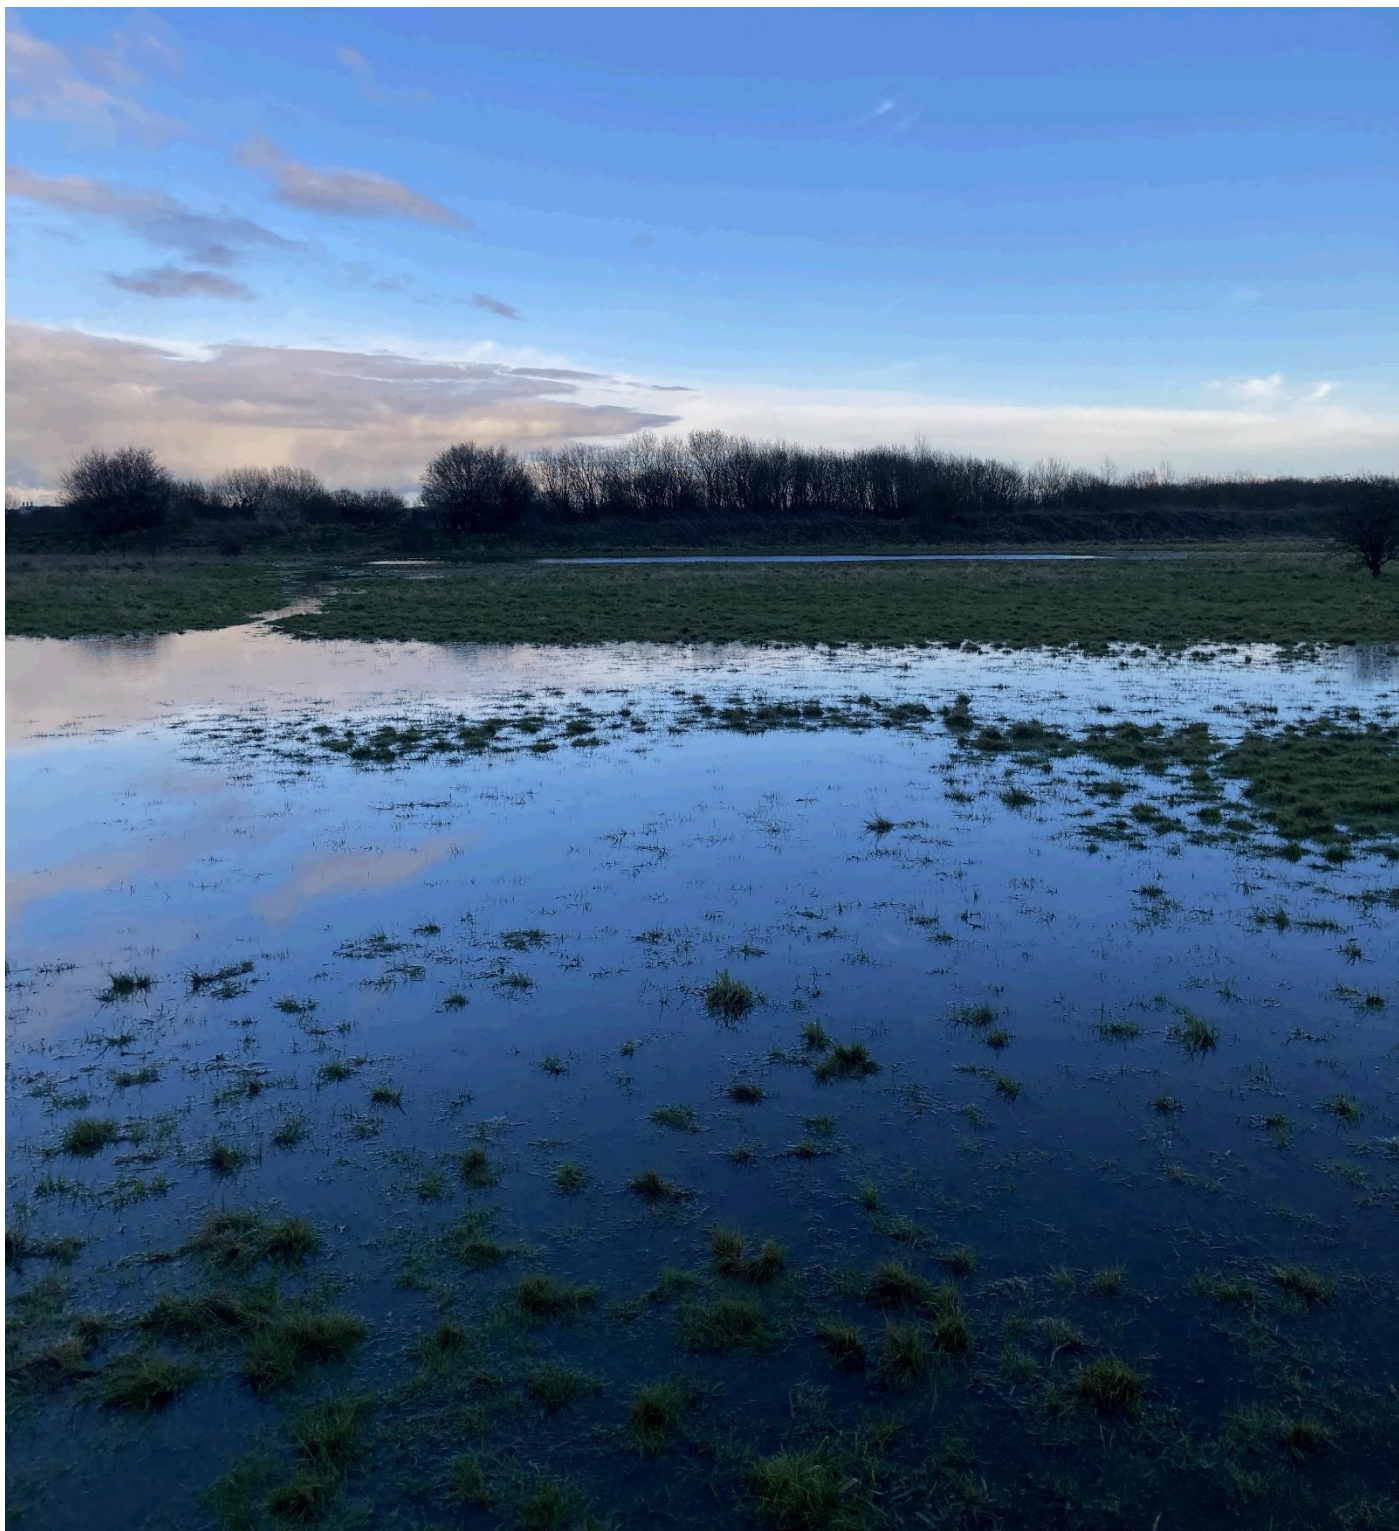
**4.35 The annual rainfall in the area is above the water holding capacity of the soil as each phase is surrounded by an impermeable layer of clay, they will become saturated in the winter months this is likely to last into the spring.**

Central open area looking northwest towards Smallford taken 2<sup>nd</sup> March 2024

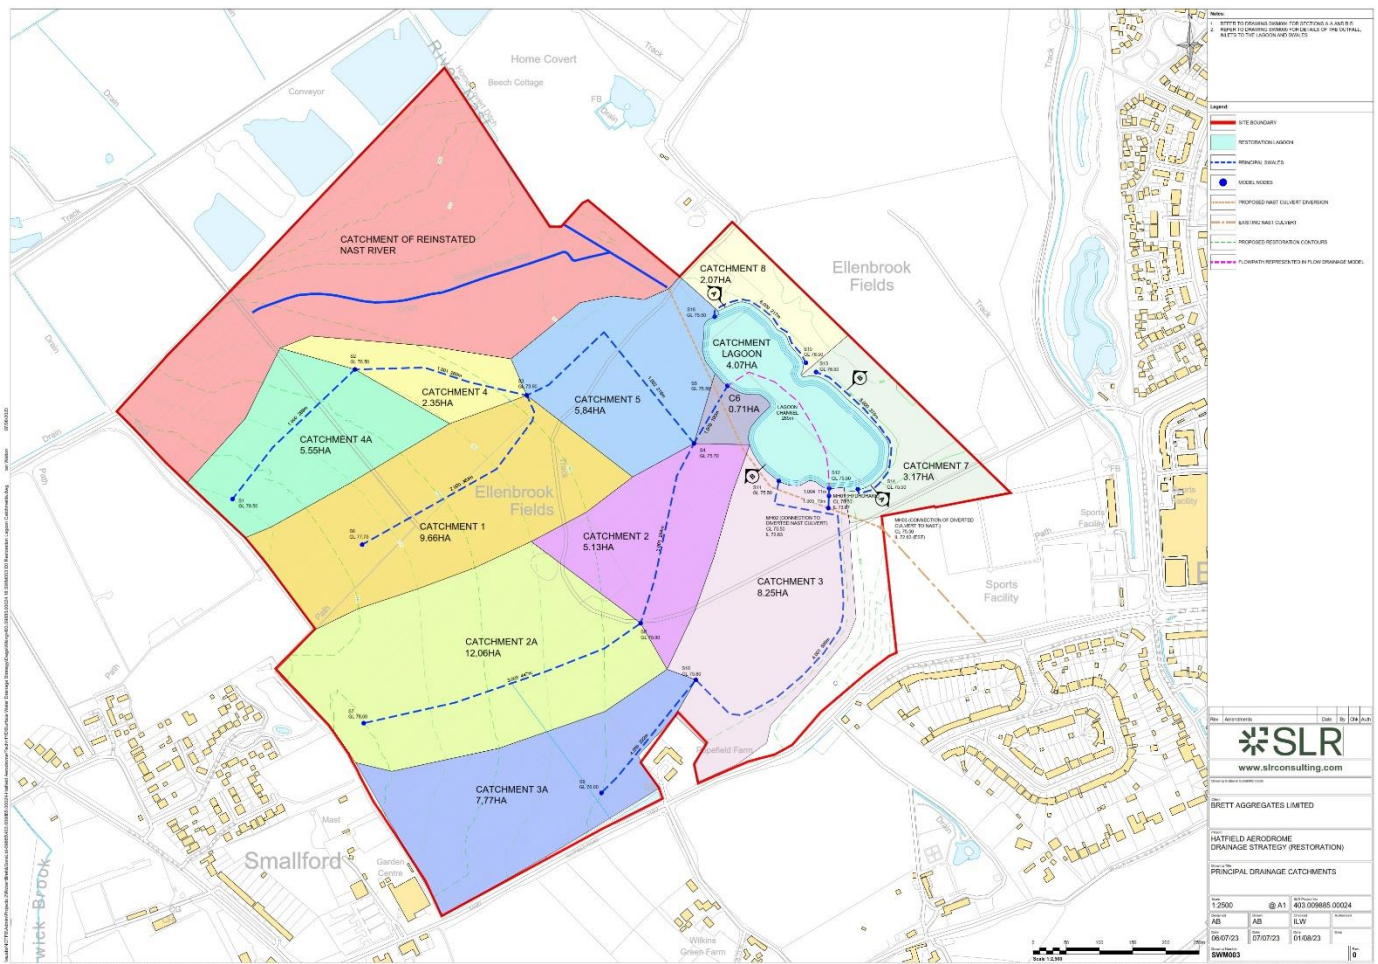
- 4.38 An experienced landscape surveyor should have noted that some areas of the park currently suffer from winter waterlogging. This results in clearly evident with the premature death, loss of limbs and stunted growth of trees and shrubs. Therefore, an experienced landscape surveyor should have recommended undertaking additional investigations.

- 4.39 The Brett identifies the need for surface drainage, but this only undertaken in the final restoration stage as illustrated in this plan.
- 4.40 It is difficult to understand how Bretts LVIA comes to the conclusion the that in landscape effect is the same in all phases. If the landscape effect of phase A is moderate, then phases C-E would be significantly greater as it divides the Country Park into small segments. Eastern end Hatfield Village, lagoons and related infrastructure, phases A and B restored or semi restored, operational phases C-E, unworked phases F and G, the access road and processing area. One must also note that these phases last longer due the combined impact of multi phases compare the staring single phase A thus changing the overall balance to considerably greater harm.

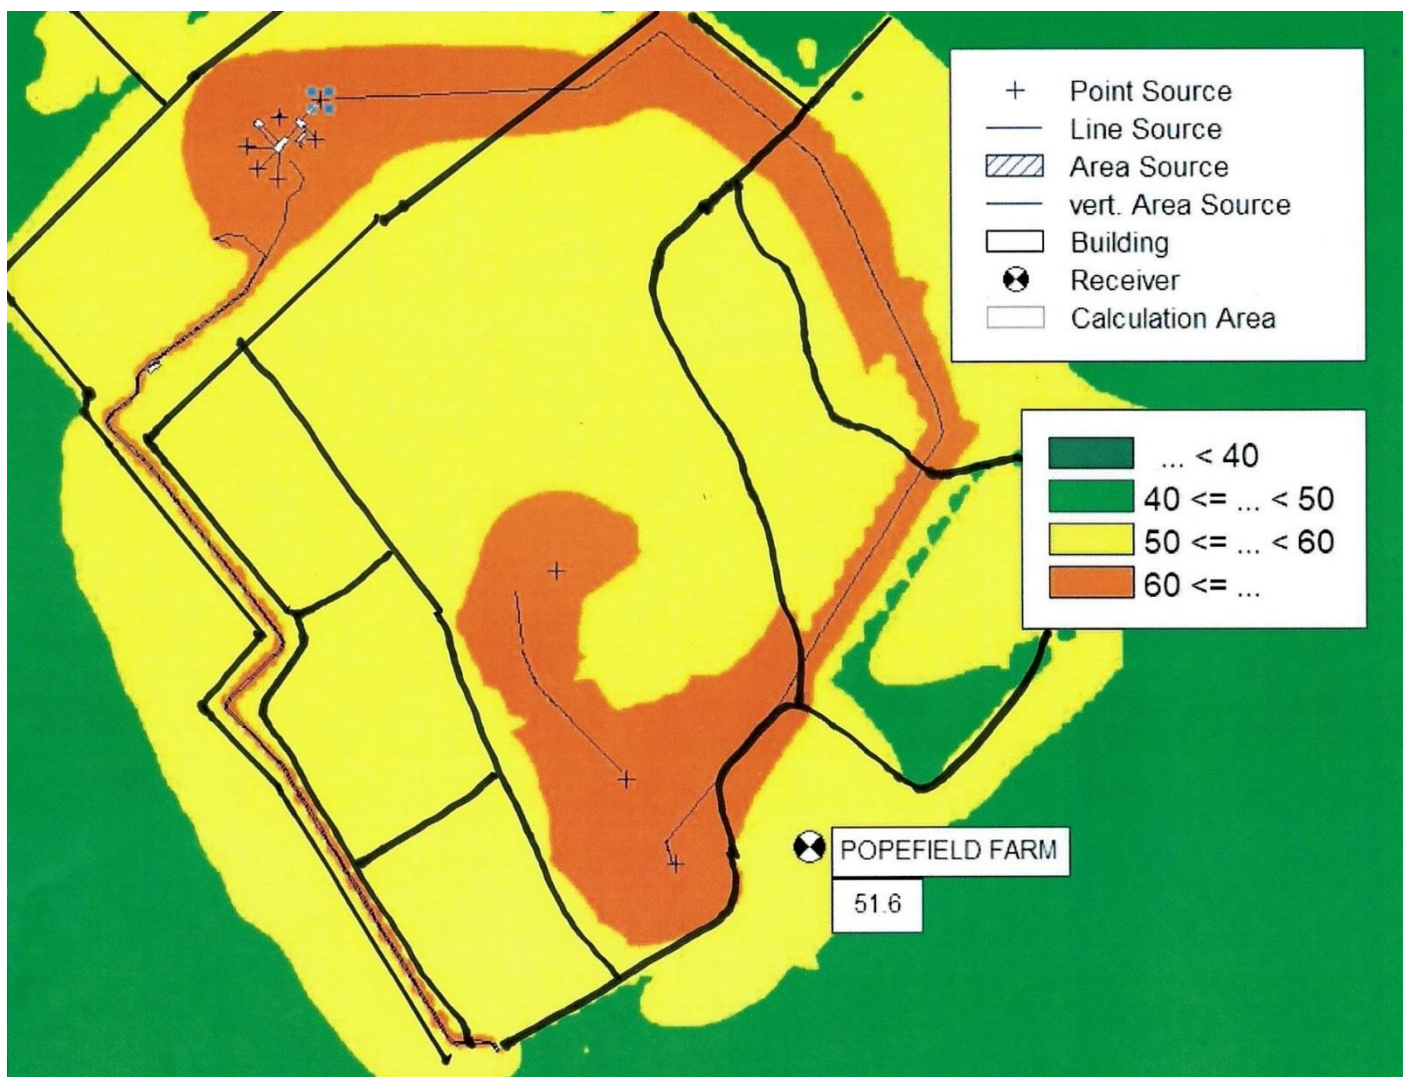
Appellants Noise map overlaid with footpaths at phase 'D' (in black)

- 4.43 CHPC notes that Bretts data only relates to impact on nearby homes and does not supply any data on the impact on users of the Country Park. We are also unable to find any detailed assessment of the combined impacts of the Cemex site and the application site on the Country Park.
- 4.44 The new noise assessment on the impact at Popefield Farm indicating noise levels above the desirable limits is a significant concern. CHPC also notes the concerns raised by Welwyn Hatfield BC in relation to the noise assessments the concerns raised by WHBC on their reliability.
- 4.45 The Bretts noise map of the entire site also raises concern over impact on users of the Country Park with levels between 10-20db above the ambient levels.

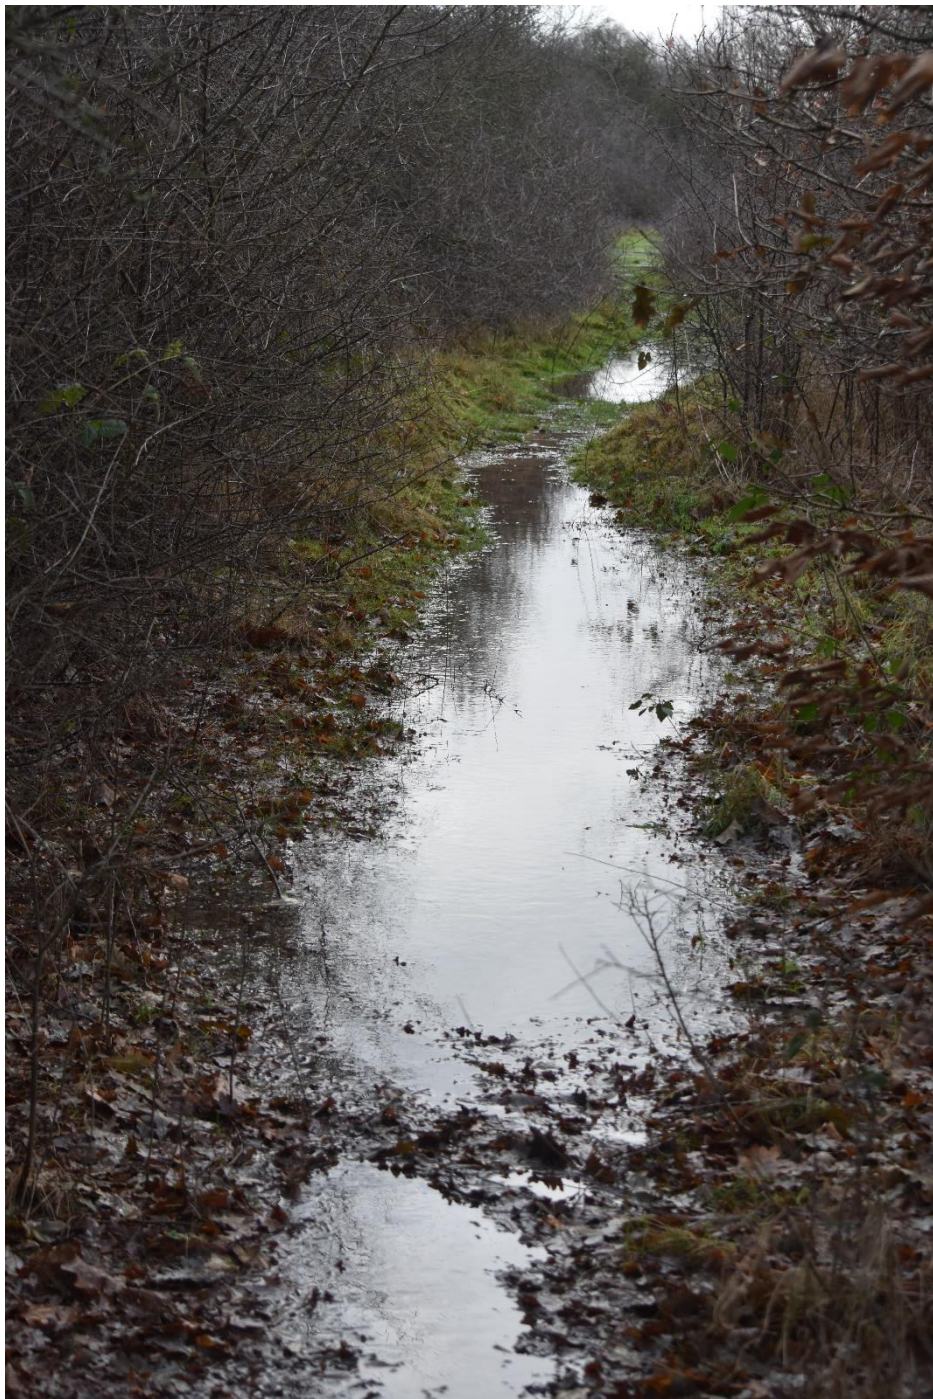
Photo taken 1/1/2023

- 5.36 The proposed new route from the entrance of the site from Beech to the corner of Home Wood is very wet during periods of heavy rain. From midwinter onwards it only passable in wellington boots. The deepest area of water recorded on the path was 270mm deep.
- 5.37 Due the lack of any path construction details a concern must be that this route will be impassable during the winter so not offering a viable alternative route.

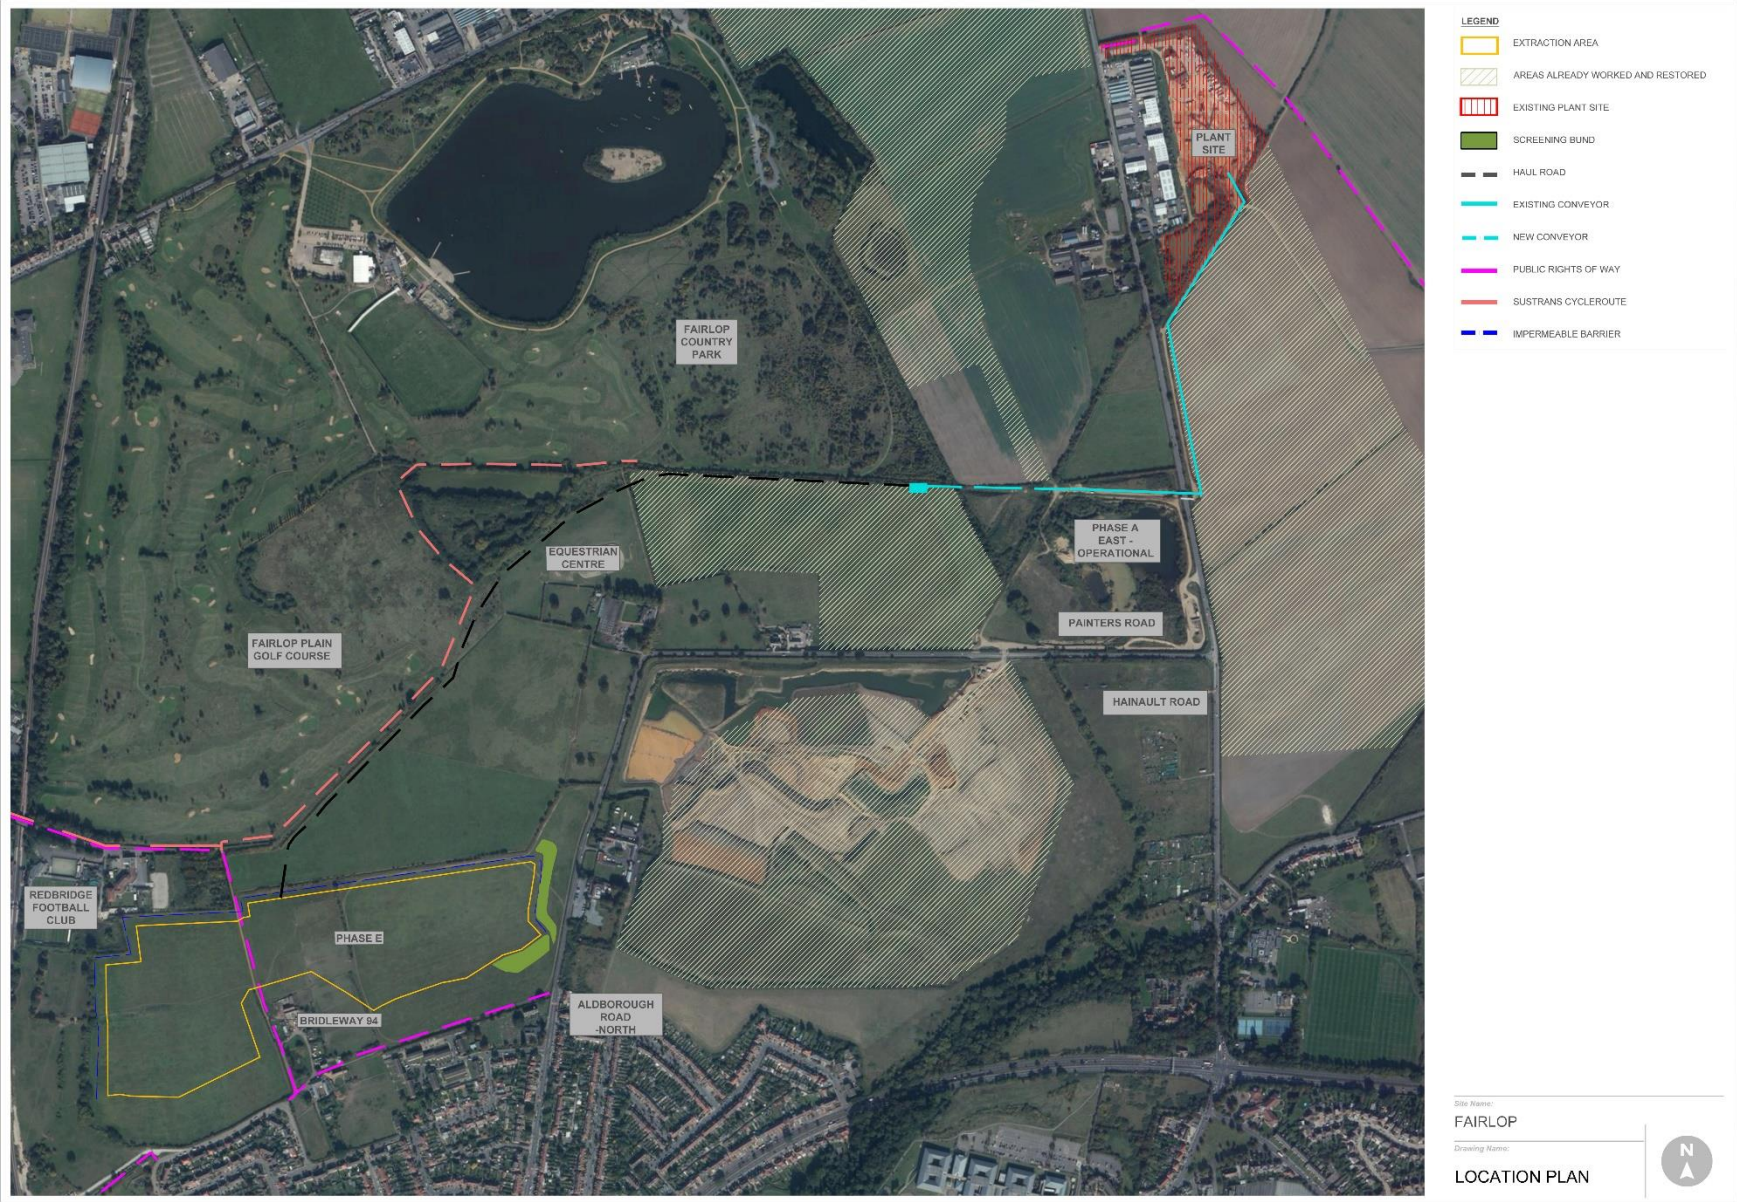
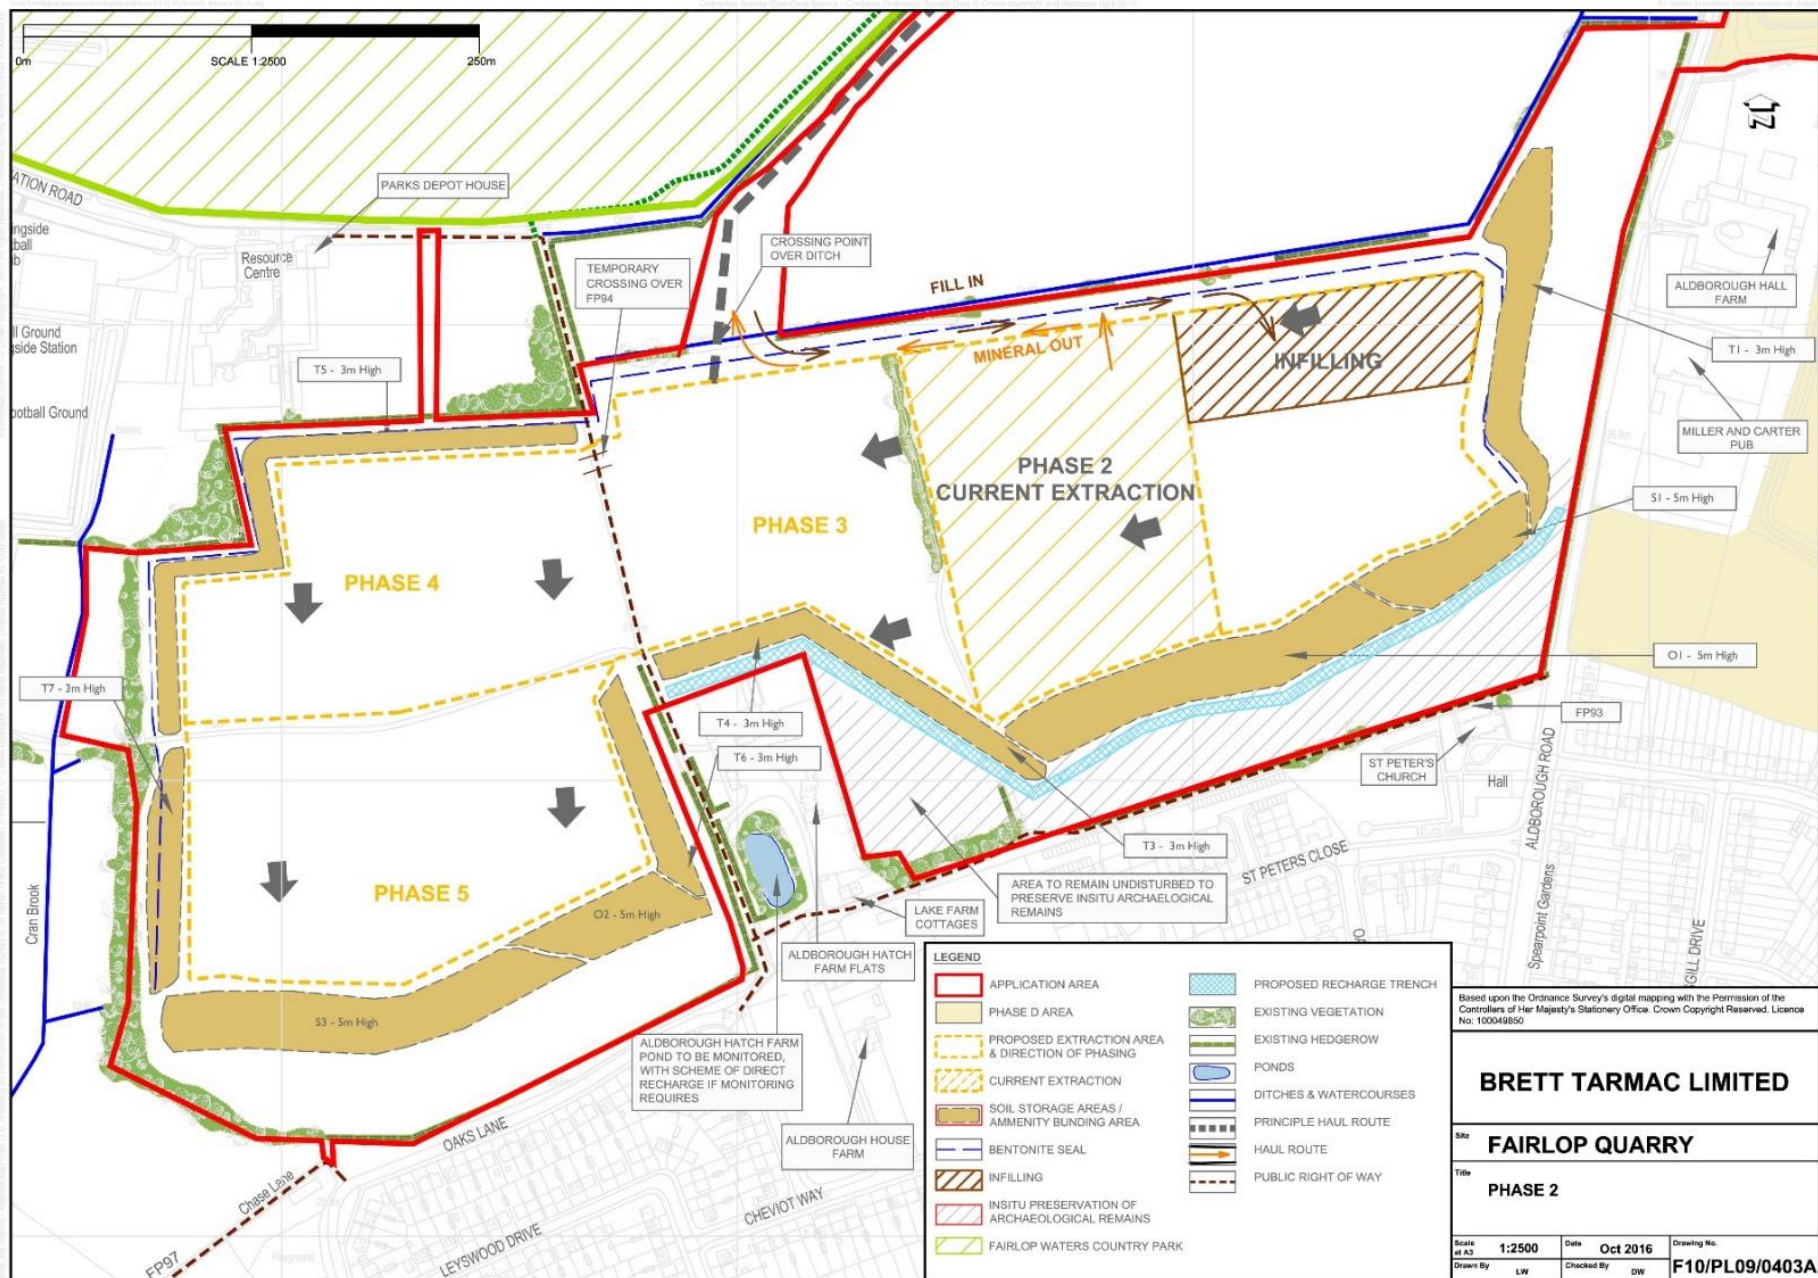
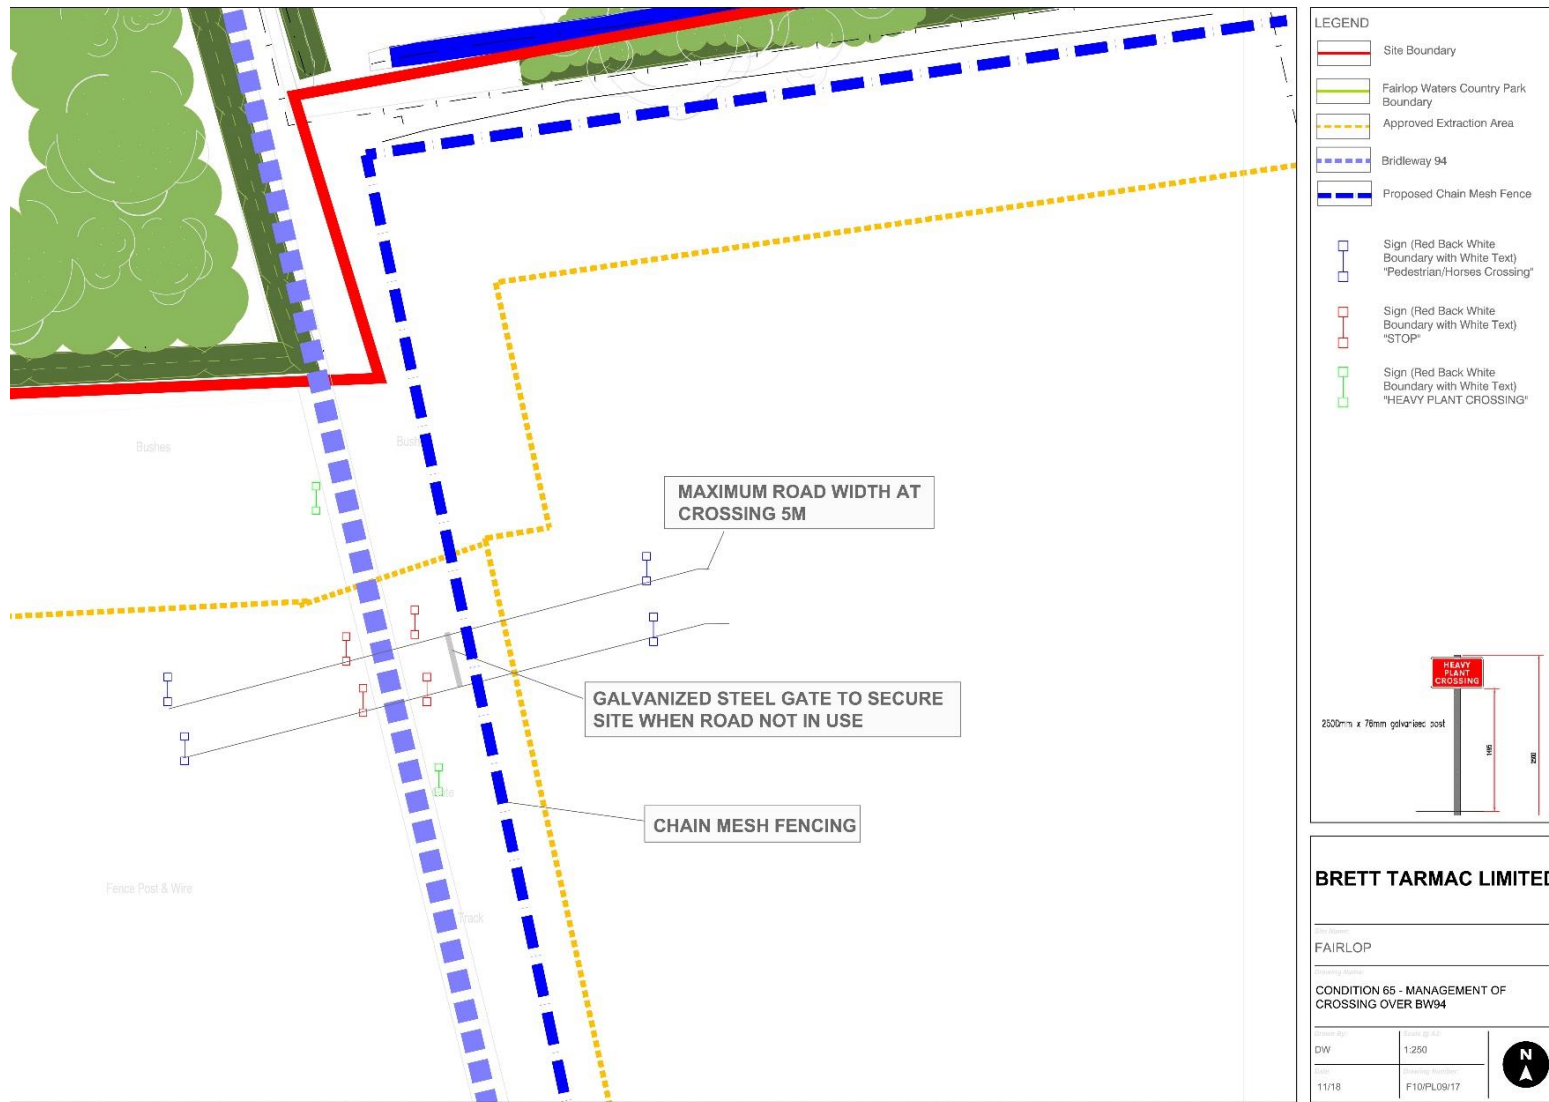
Path Crossings at Fairlop Quarry Hainault Road Romford

Bridleway crossing layout all the signs were in place on 25<sup>th</sup> August 2024 however I would have significant concerns over the safety of this layout including cyclist and for those with disabilities, the layout at Painters Road was slightly safer see photos below.

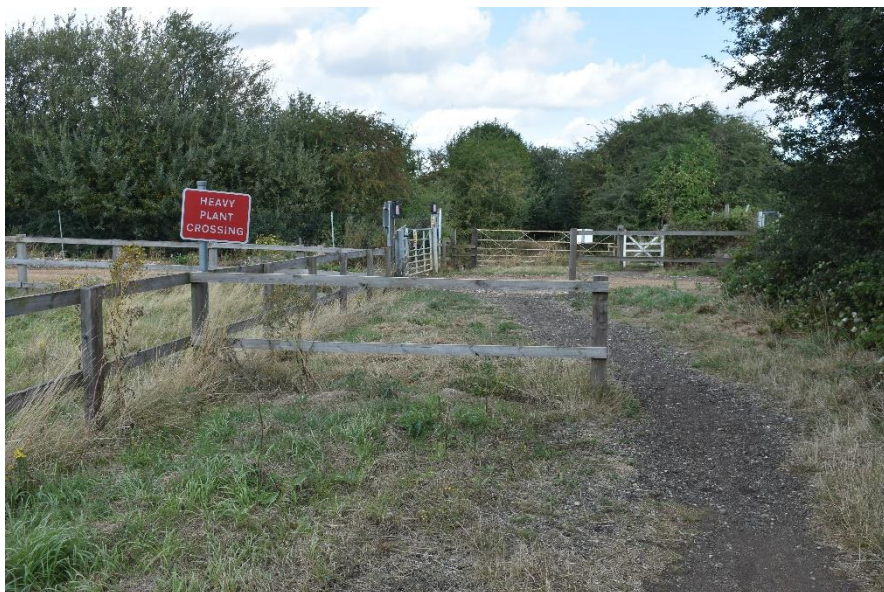
Painter Road access crossing showing part restriction of the  
bridleway this clearly several years old. This layout would safer than  
the proposed design at the other crossing.

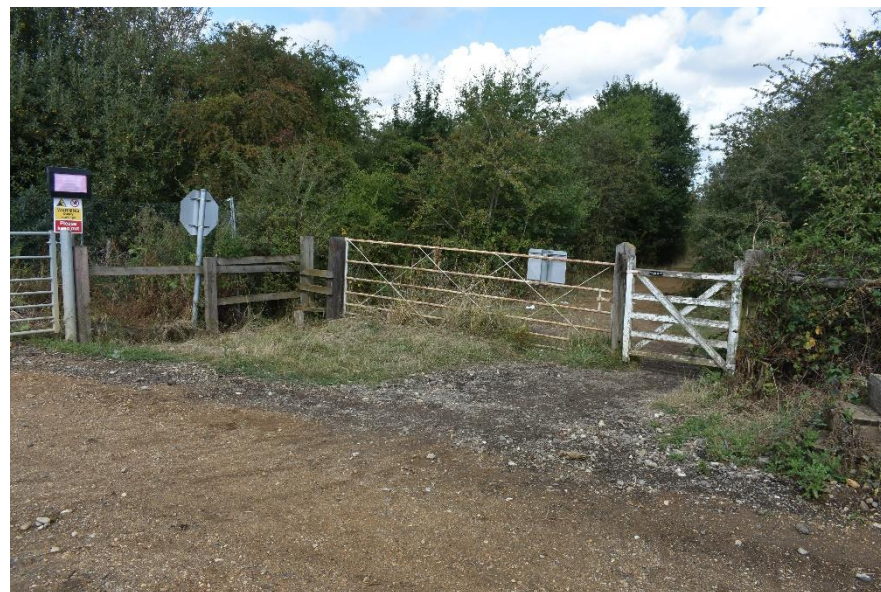
Painter Road access crossing the County Park side of the Crossing  
with gate and stile, the stile is clearly substandard see image below.

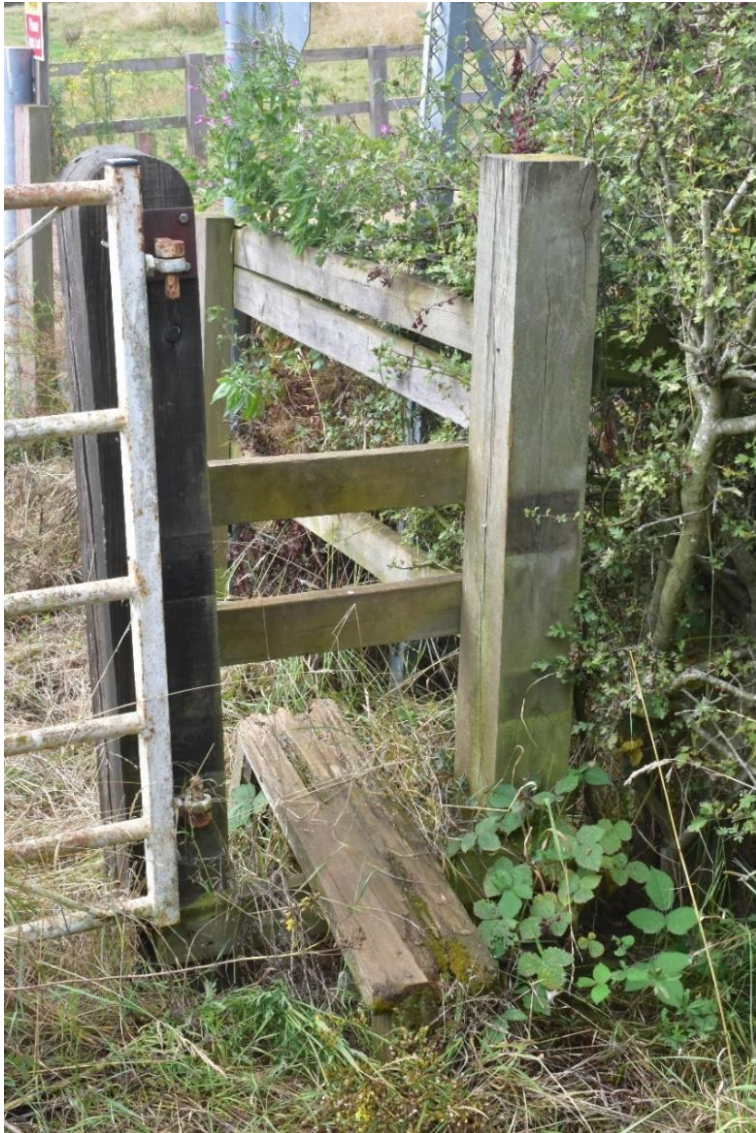
Stile at Painter Road access crossing, which is considered to poor standard and unsuitable for people with mobility difficulties.
