Appendix 10A  
**Phase 1 Land Quality Assessment to Inform  
Proposed Development for 12 mppa Planning  
Application**

## Bristol Airport Limited

Phase 1 Land Quality  
Assessment to Inform Proposed  
Development for 12 mppa  
Planning Application

Doc Ref. 40506RR004i2

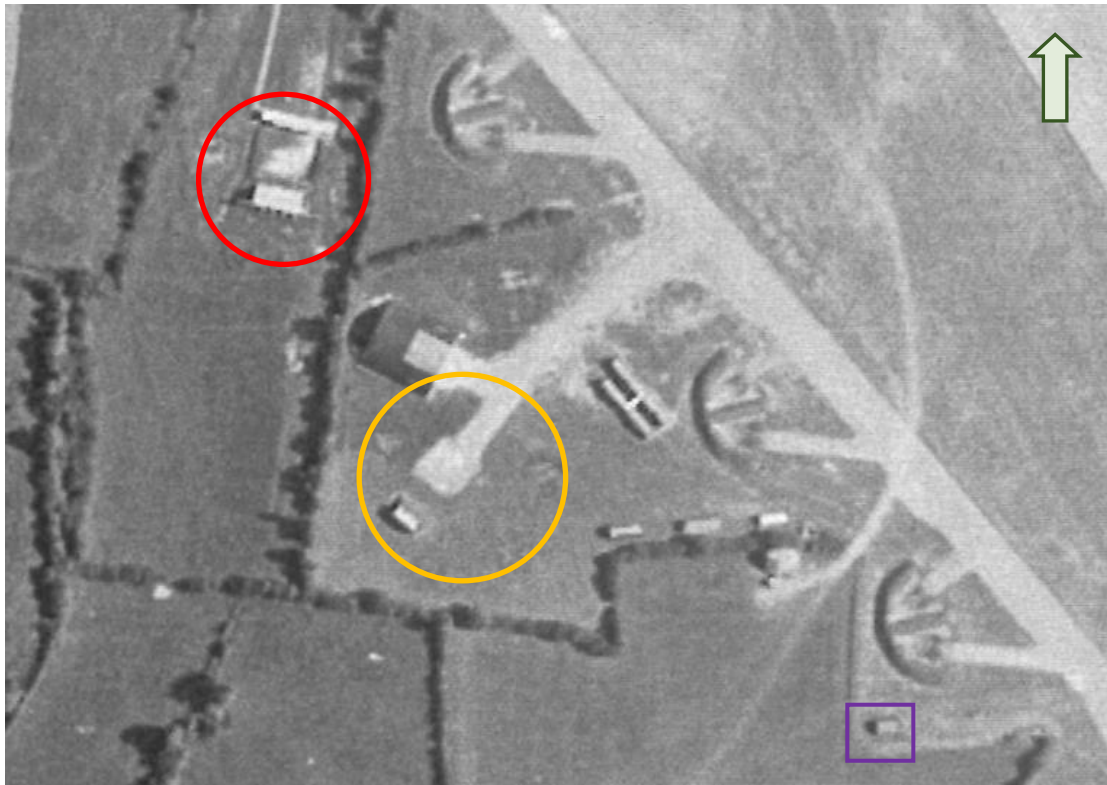
**Plate 8** Aerial photograph showing firing ranges at RAF Lulsgate Bottom, 12<sup>th</sup> July 1946

A machine gun and cannon range was also situated close by. These are both shown on Plate 8, an aerial photograph dated the 12<sup>th</sup> July 1946.

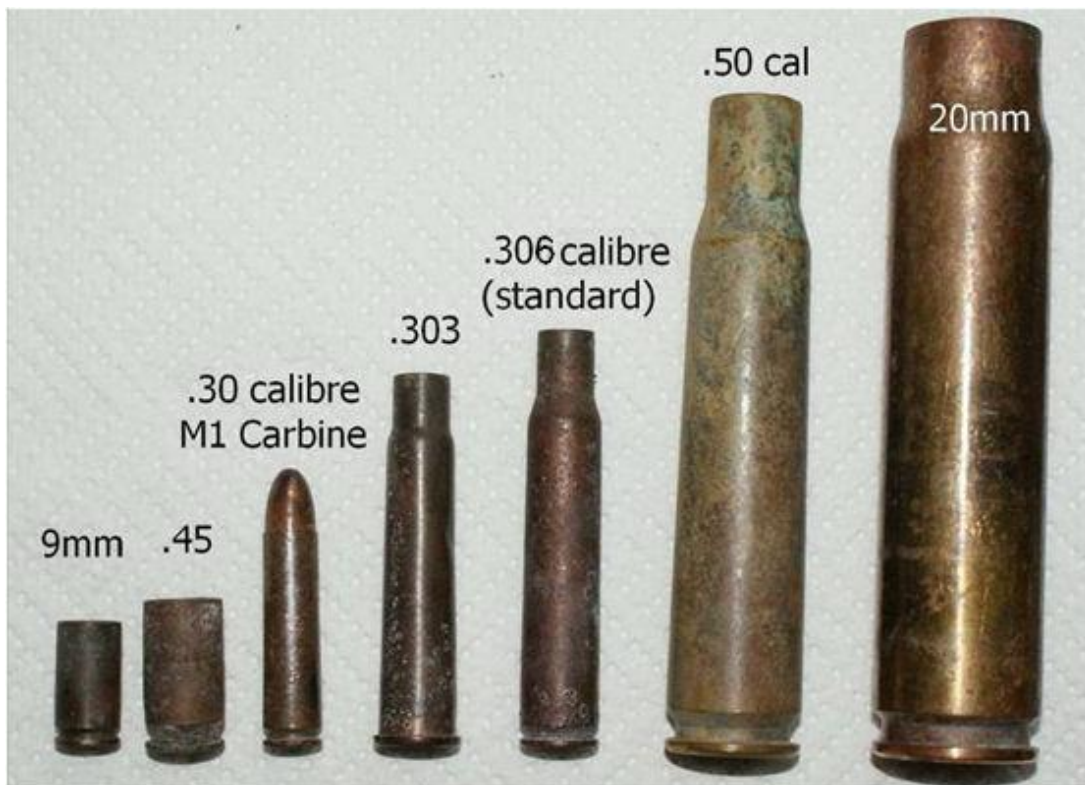
**Plate** Photograph of typical WWII small arms ammunition

Generally small arms ordnance has a relatively low risk as UXO, although the larger calibre categories may have the same detonation risk as larger high explosive ordnance. SAA is often associated with discarded ammunition boxes around firing practice ranges. The Plate below illustrates some common SAA.

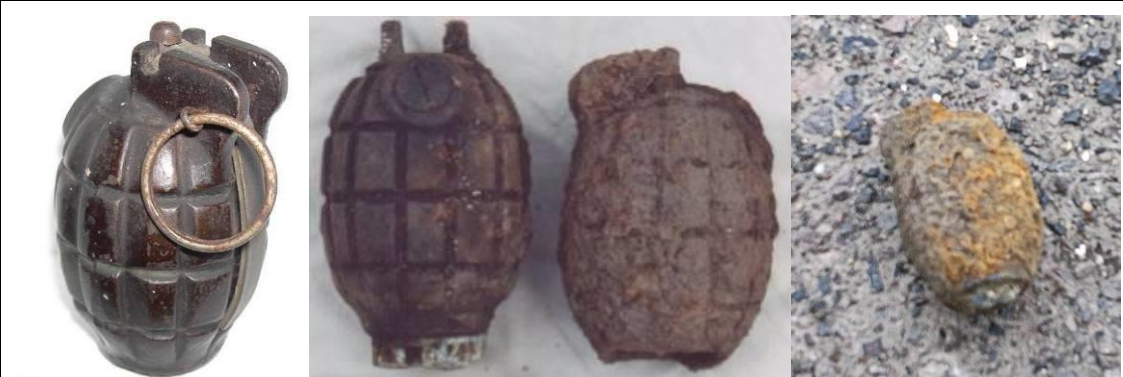
**Plate** Photographs of a typical and an excavated WWII No. 36 hand grenades

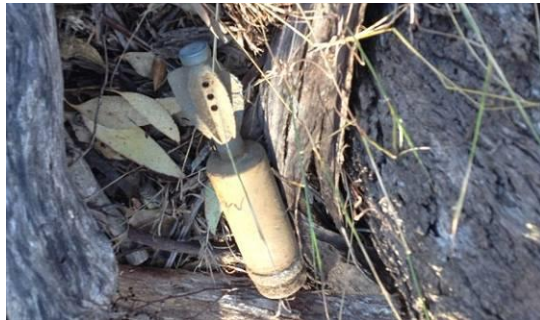
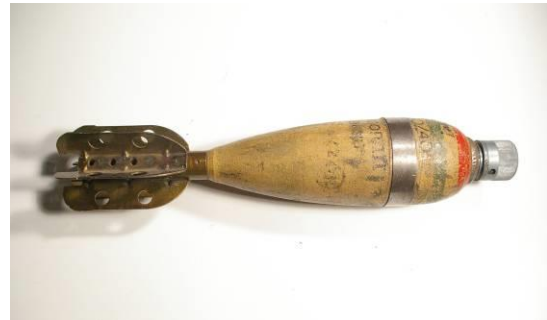
<b>Plate</b>	Photographs of WWII 2-inch and 3-inch mortars
--------------	---

The Plate below shows a typical 2-inch mortar bomb found (left) and a demonstration 3-inch mortar bomb (right).

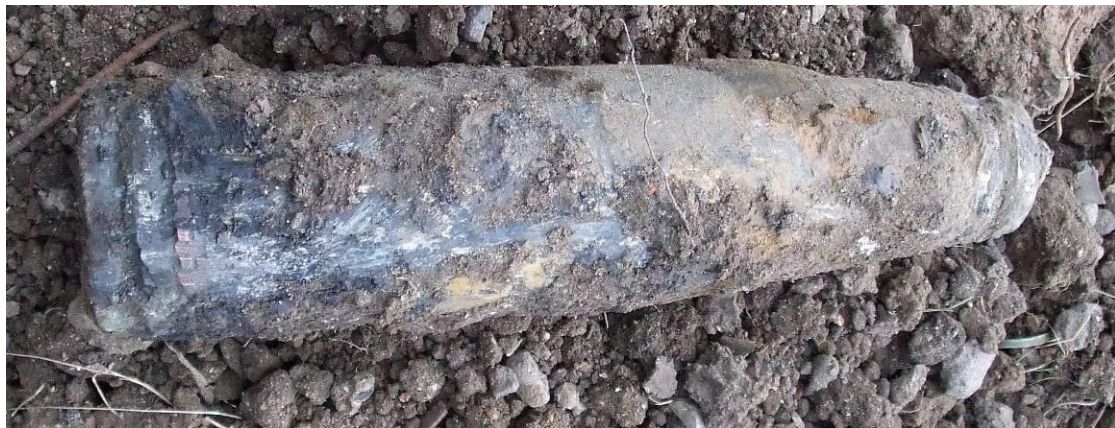
<b>Plate</b>	Photograph of a recently excavated 3.7" AA shell
--------------	--

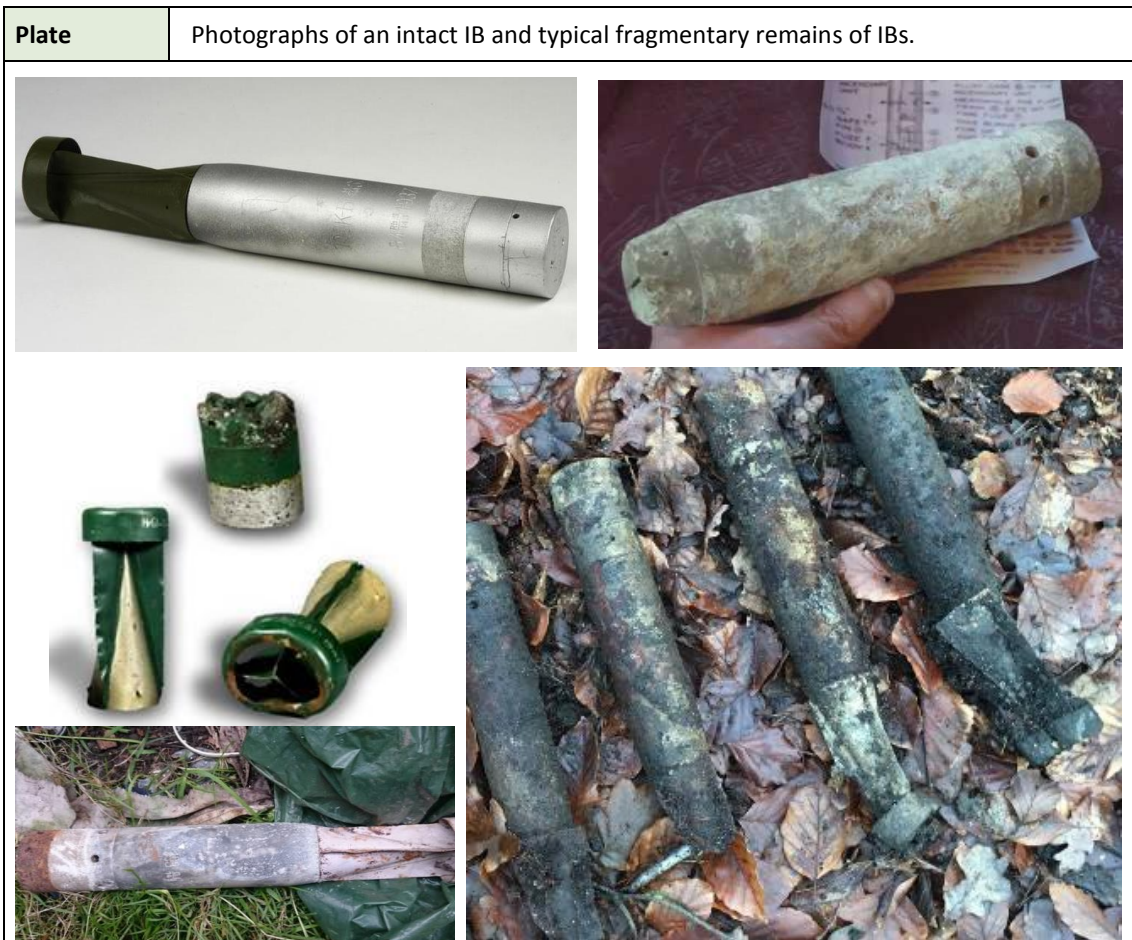
The Plate below shows a typical variety of fragmentary remains of IBs and IBs recovered by the Civil Defence during WWII, along with a photograph of 4No. spent IBs found in Hertfordshire in January 2017 (lower right).

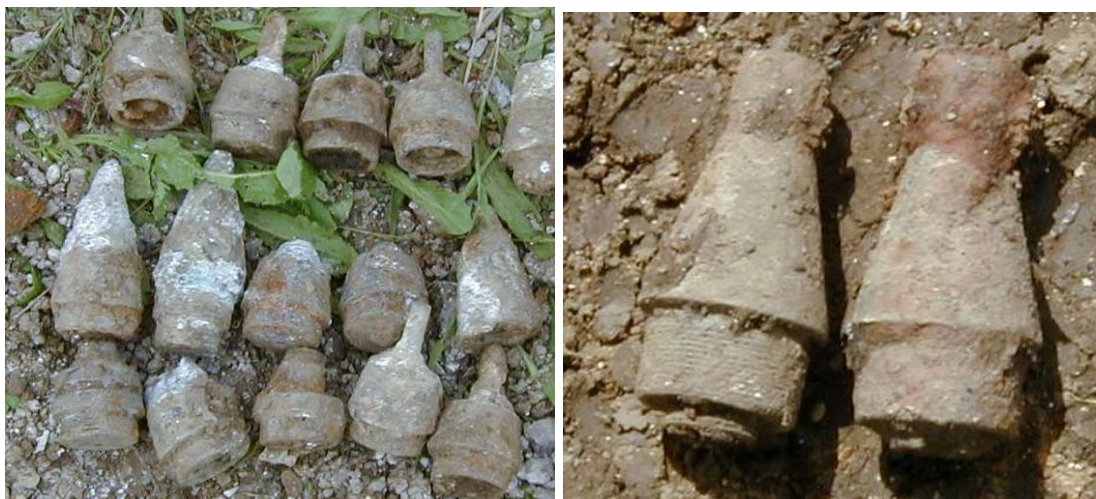
**Plate** Photographs showing examples of WWII fuzes

Bomb components such as detonators, gains and fuzes were stored at operational airfields during WWII and typically contained some type of explosive charge to initiate the detonation of a munition. A wide variety of these components were used and examples of some common fuzes are shown in the Plate below.

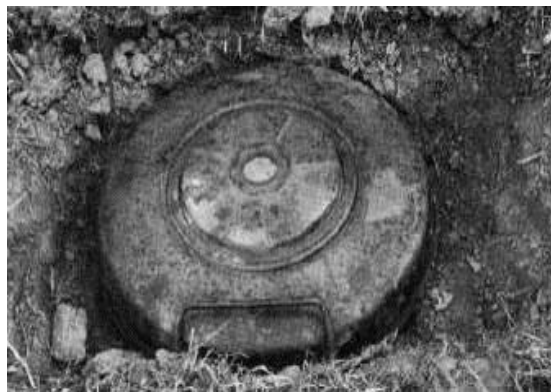
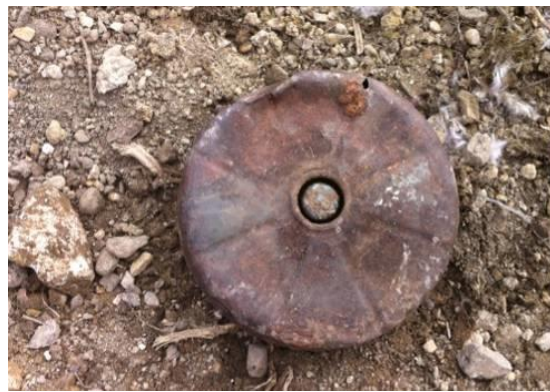
**Plate** Photographs of original and recently excavated WWII land mines

The Plate below is a photograph of a typical WWII land mine used on the land area, beaches and cliffs around Britain. This example was found at Gatwick Airport formerly RAF Gatwick.

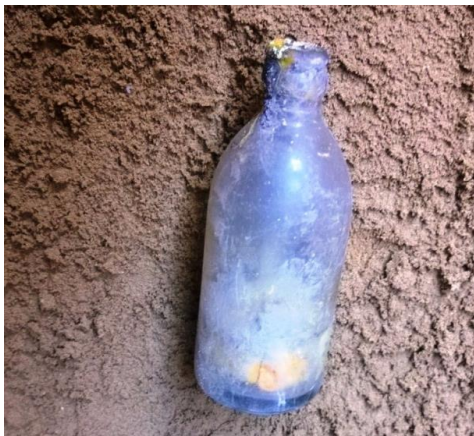
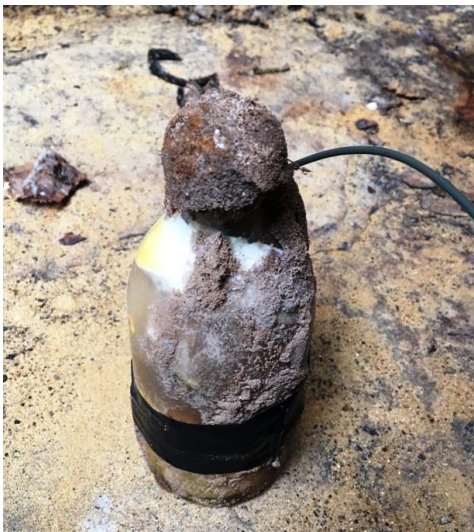
**Plate** | Photographs of No. 76 SIP grenades

The Plate below is a photograph of a No. 76 SIP grenade (LHS) with an explanatory leaflet produced by ZeticaUXO for site staff (RHS).

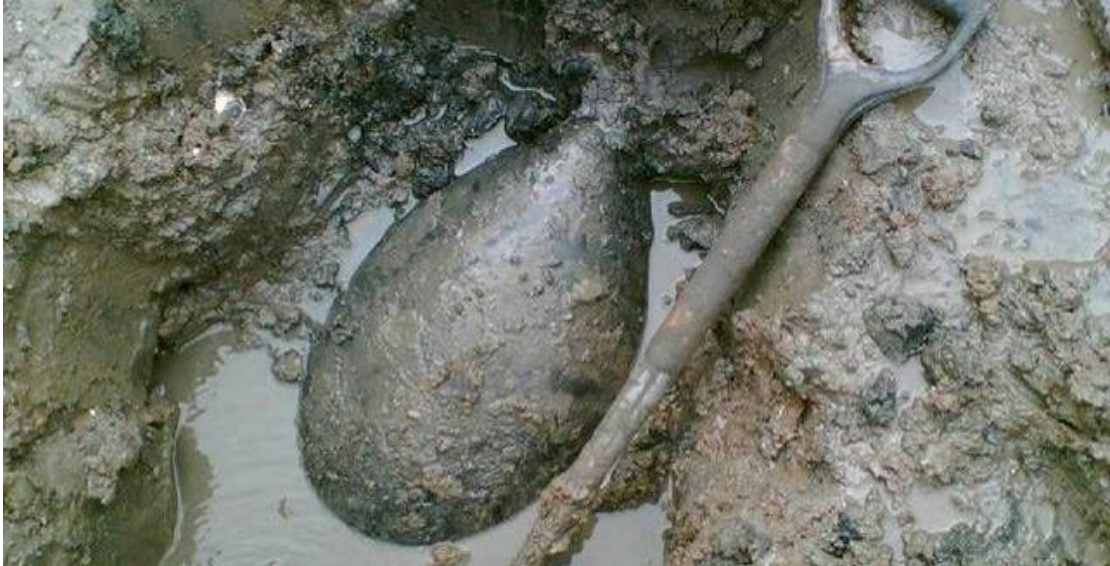
<b>Plate</b>	Photograph of the 500kg WWII UXB at Bowers Marsh, 8 <sup>th</sup> March 2010

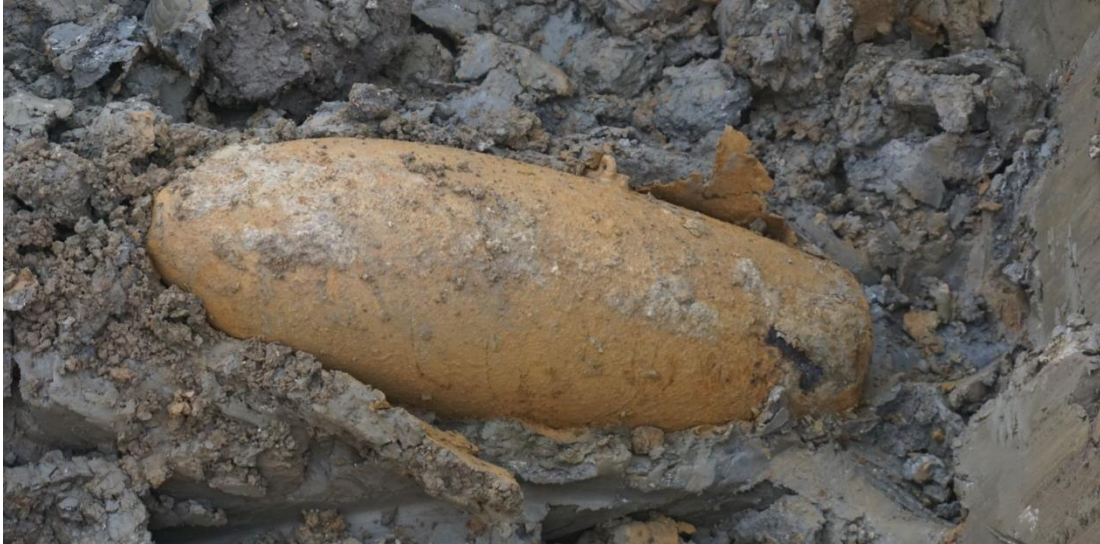
Plate	Photograph of a recently excavated WWII British 500lb GP bomb

Source: Zetica Ltd	
<p>On the 23<sup>rd</sup> February 2011, 1No. WWII UXB was found on a building site in Notte Street in Plymouth City centre. The bomb was removed by EOD personnel and demolished at sea.</p> <p>On the 22<sup>nd</sup> July 2012, a landslip in the cliffs at Mappleton in the East Riding of Yorkshire exposed over 1,000No. UXO items, including practice bombs, mortars, rockets, shells and grenades. The cliff was part of a former bombing and artillery range, used during WWII and until the 1970s.</p> <p>UXO items were removed by Explosive Ordnance Disposal (EOD) officers from Catterick and MoD staff from Leconfield. 15No. controlled explosions were undertaken by the Royal Engineers (RE) to detonate the more volatile items in situ, while other less hazardous UXO devices were left in place to be dealt with at a later date.</p> <p>1No. WWI bomb was found on the Isle of Sheppey on the 2<sup>nd</sup> August 2012 during a geophysical survey following desk study research by Zetica Ltd which had established that a previously unknown WWI bombing range existed on the site. A further WWI bomb was found in the same location in August 2015.</p> <p>On the 23<sup>rd</sup> March 2015, 1No. WWII 500kg UXB was found on a building site in The Grange, Bermondsey. The bomb was made safe by EOD personnel and removed for demolition.</p> <p>On the 21<sup>st</sup> May 2015, 1No. 50kg UXB was found on a building site near Wembley Stadium, London Borough of Brent. The bomb was made safe by EOD personnel and removed for demolition.</p> <p>On the 10<sup>th</sup> August 2015, 1No. 250kg UXB was found under the basement of a building site at Bethnal Green, London Borough of Tower Hamlets. It was made safe and removed by an EOD team from the RLC.</p> <p>On the 21<sup>st</sup> September 2015, 1No. UXB was uncovered on a construction site in Cheylesmore, Coventry, by the operator of a mechanical digger. It was destroyed in situ by an EOD team from the RLC.</p> <p>In January 2016, Zetica discovered 3No. 500lb British UXB at a former airfield in Cambridgeshire. These were destroyed in controlled explosions. The Plate below is a photograph of one of the bombs.</p>

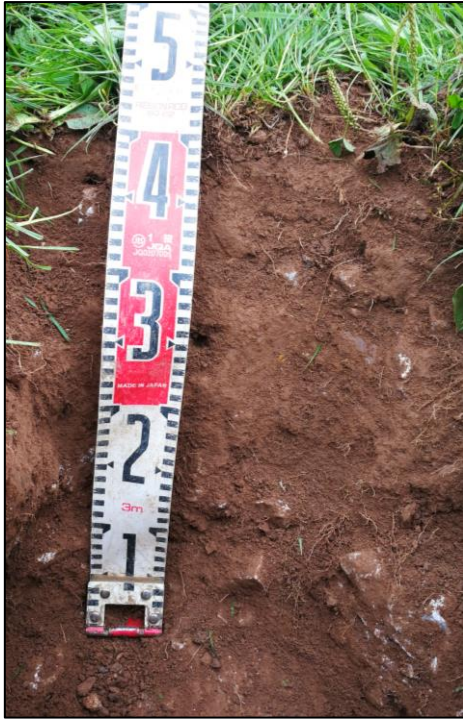
**Photo 1. Trial Pit 1 – Soil Type 1**

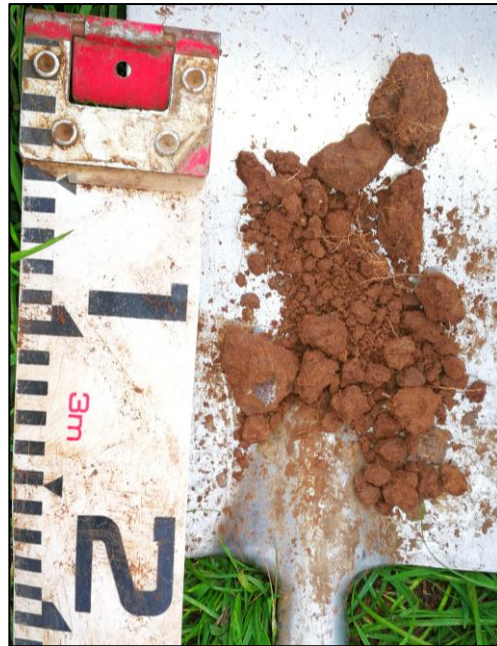
**Photo 2. Structure of Topsoil – Trial Pit 1**

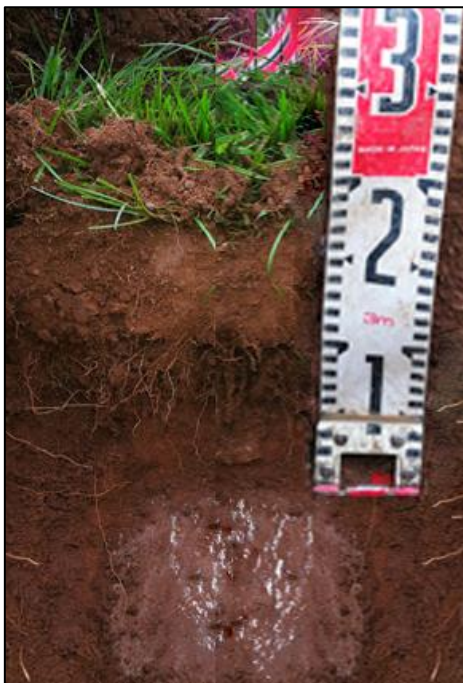
**Photo 3. Trial Pit 2 – Soil Type 1**

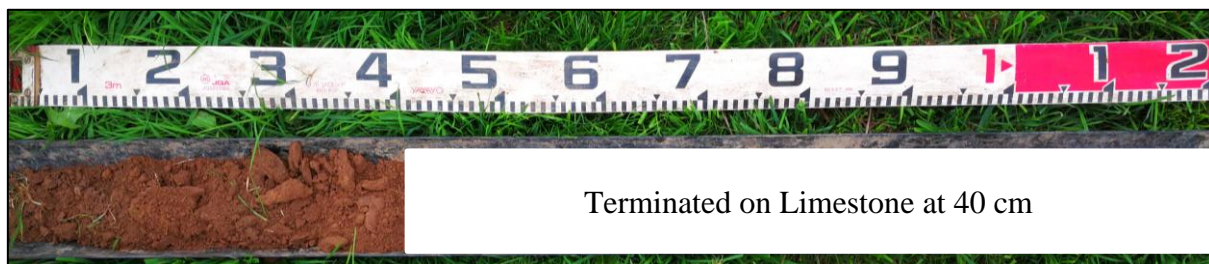
**Photo 4. Borehole 3 – Soil Type 2\***

\*NB Borehole photographs are included for an illustration of horizons, to verify profile depth and provide an indication of colour but are not intended to verify any structure.

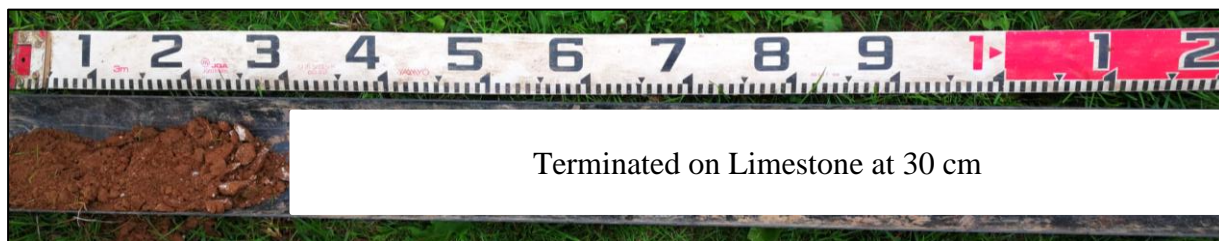
**Photo 6. Borehole 5 – Soil Type 1\***

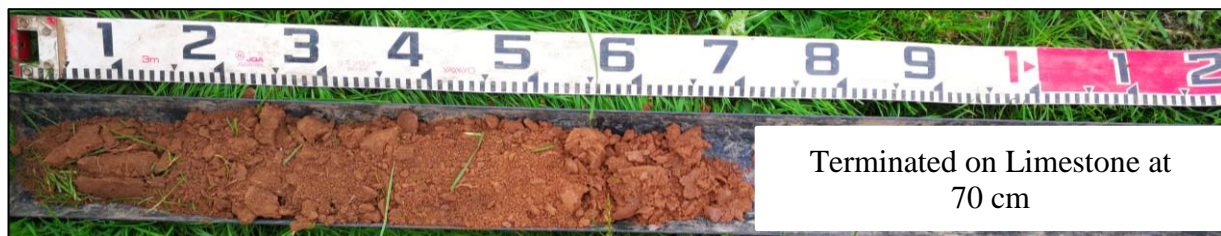
**Photo 7. Borehole 6 – Soil Type 3\***

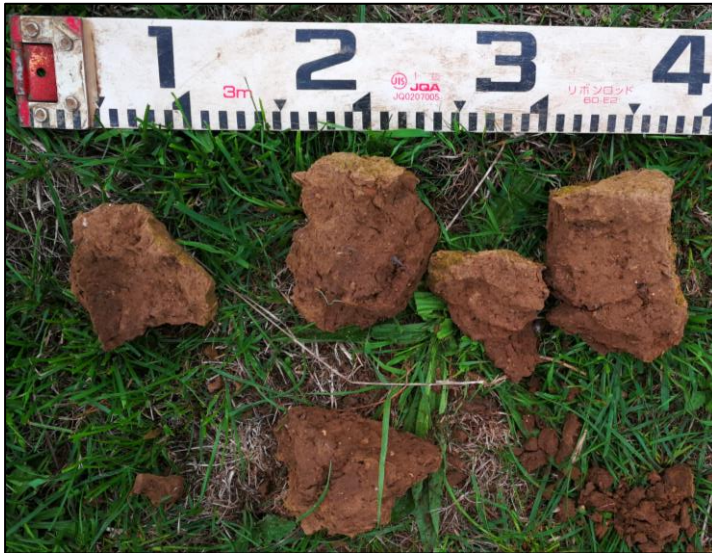
**Photo 8. Borehole 6 – Subsoil 2, Soil Type 3**
