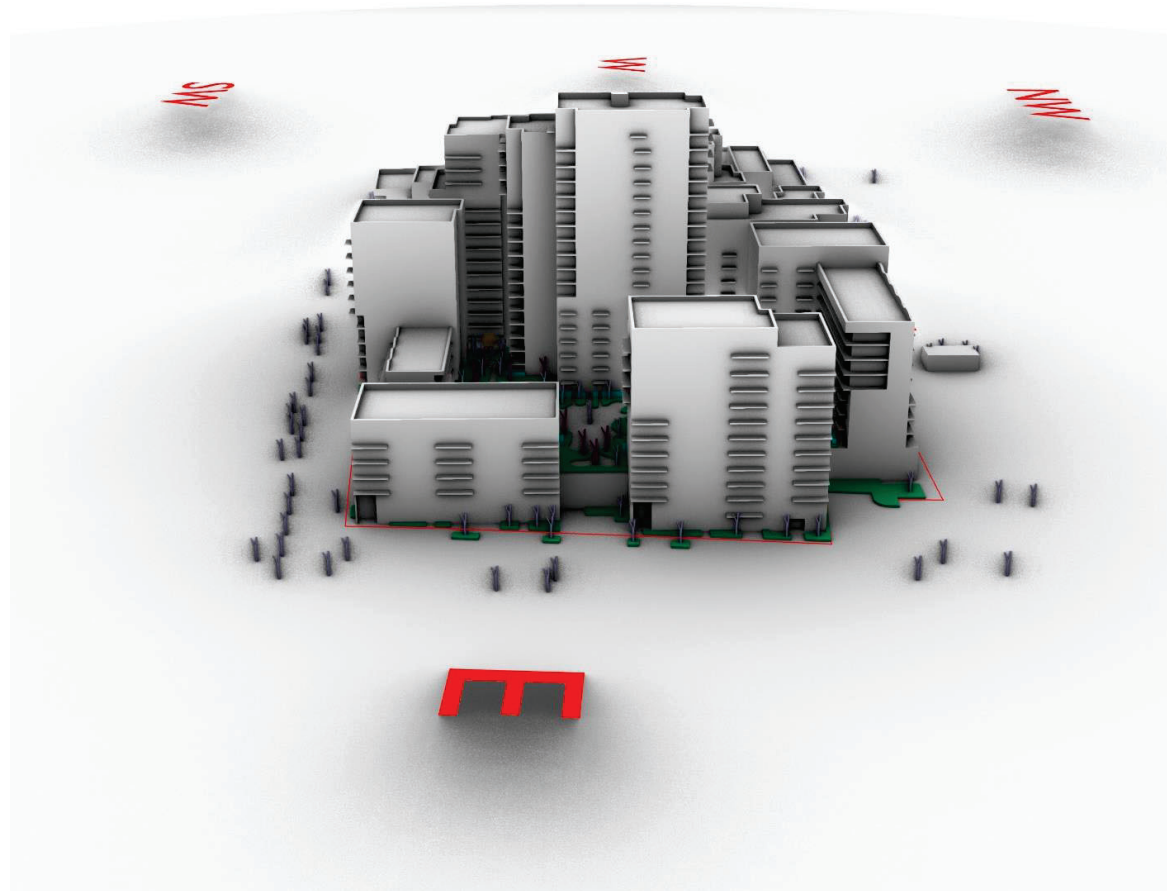
Figure 5h: Mitigation Measures Tested – (CONFIGURATION 4) Completed Proposed Development with Existing Surrounds and Proposed Landscaping – 3D West Aspect

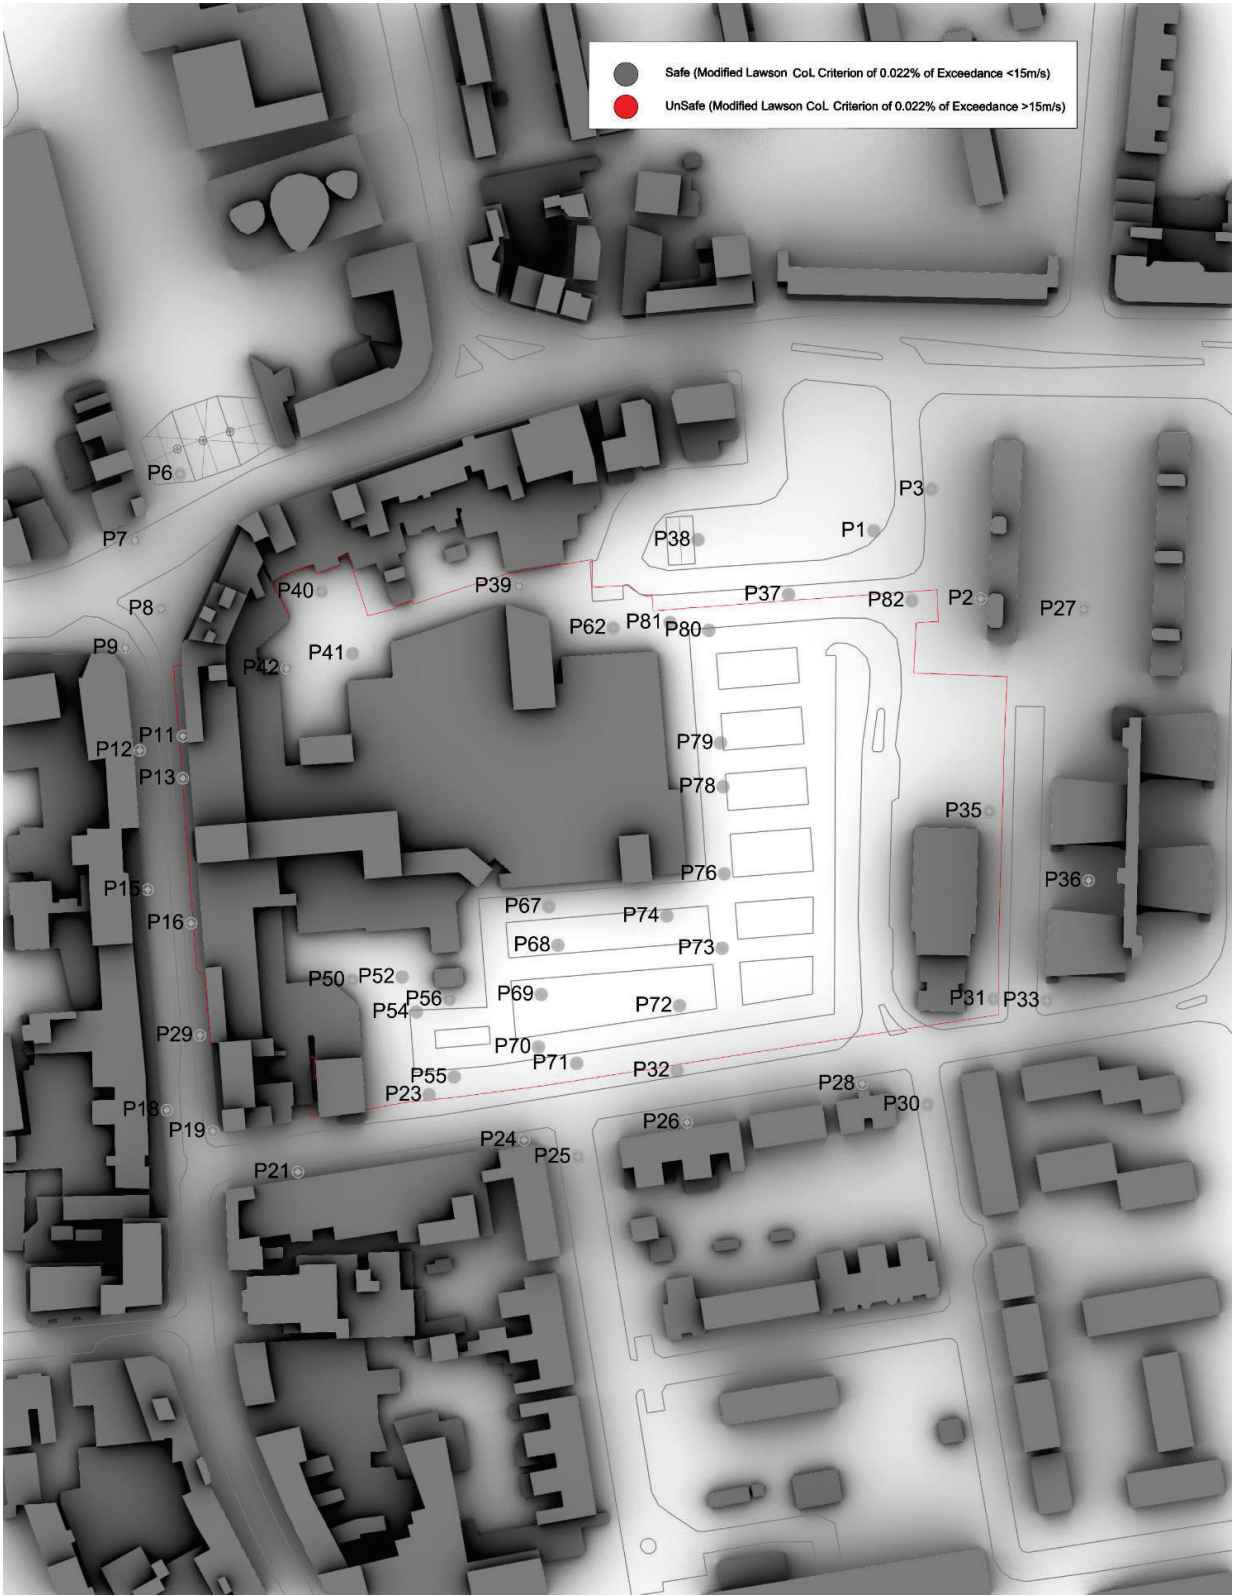
Figure 6a: Wind Tunnel Results – The Existing Site with Existing Surrounds, Safety Results, Annual, Ground

The results for the existing surrounds indicate that the wind conditions at ground level do not exceed the safety criterion within the site and surrounds. The wind conditions are rated as safe for pedestrians and cyclist use throughout the year.

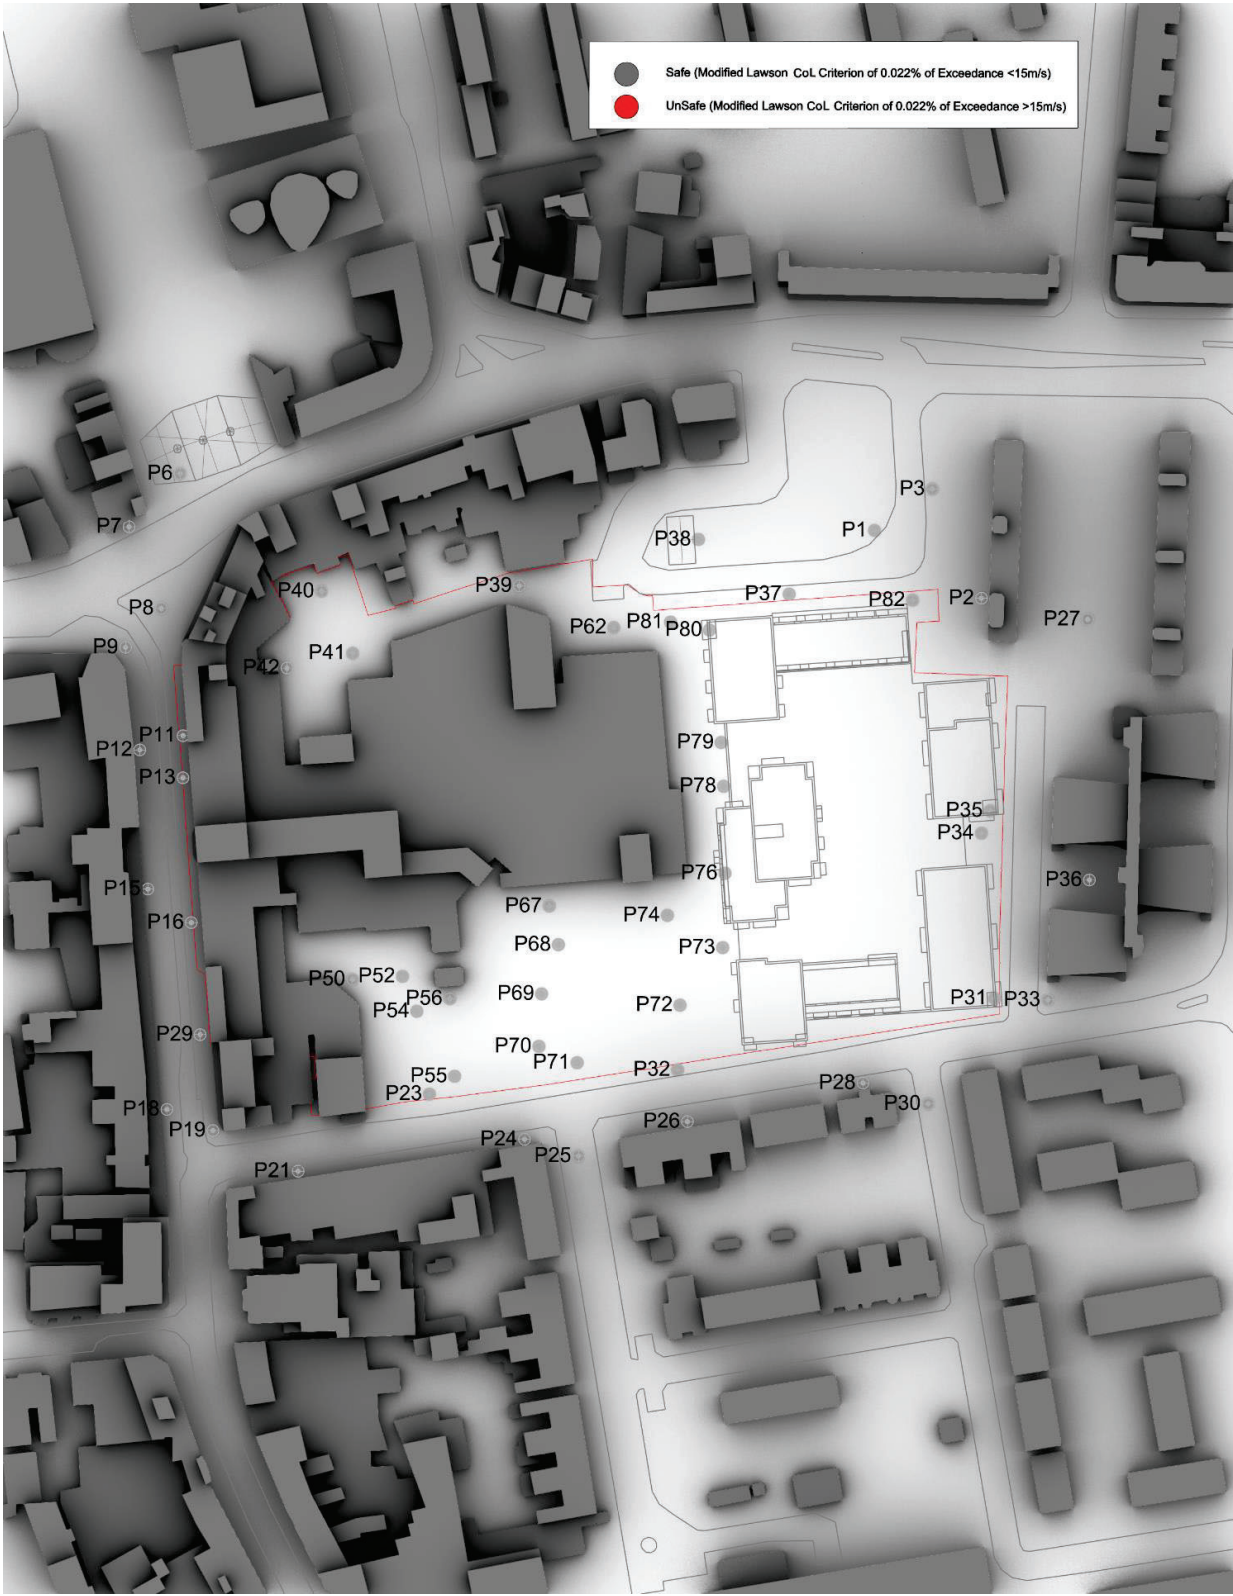
Figure 6b: Wind Tunnel Results – Interim Phase of the Proposed Development with Existing Surrounds, Safety Results, Annual, Ground

The results for the interim phase of the proposed development with the existing surrounds indicate that the wind conditions at two elevated levels do exceed the safety criterion (**Points P91 and 147**). The wind conditions in all other areas on and off-site are rated as safe for pedestrians and cyclist use throughout the year.

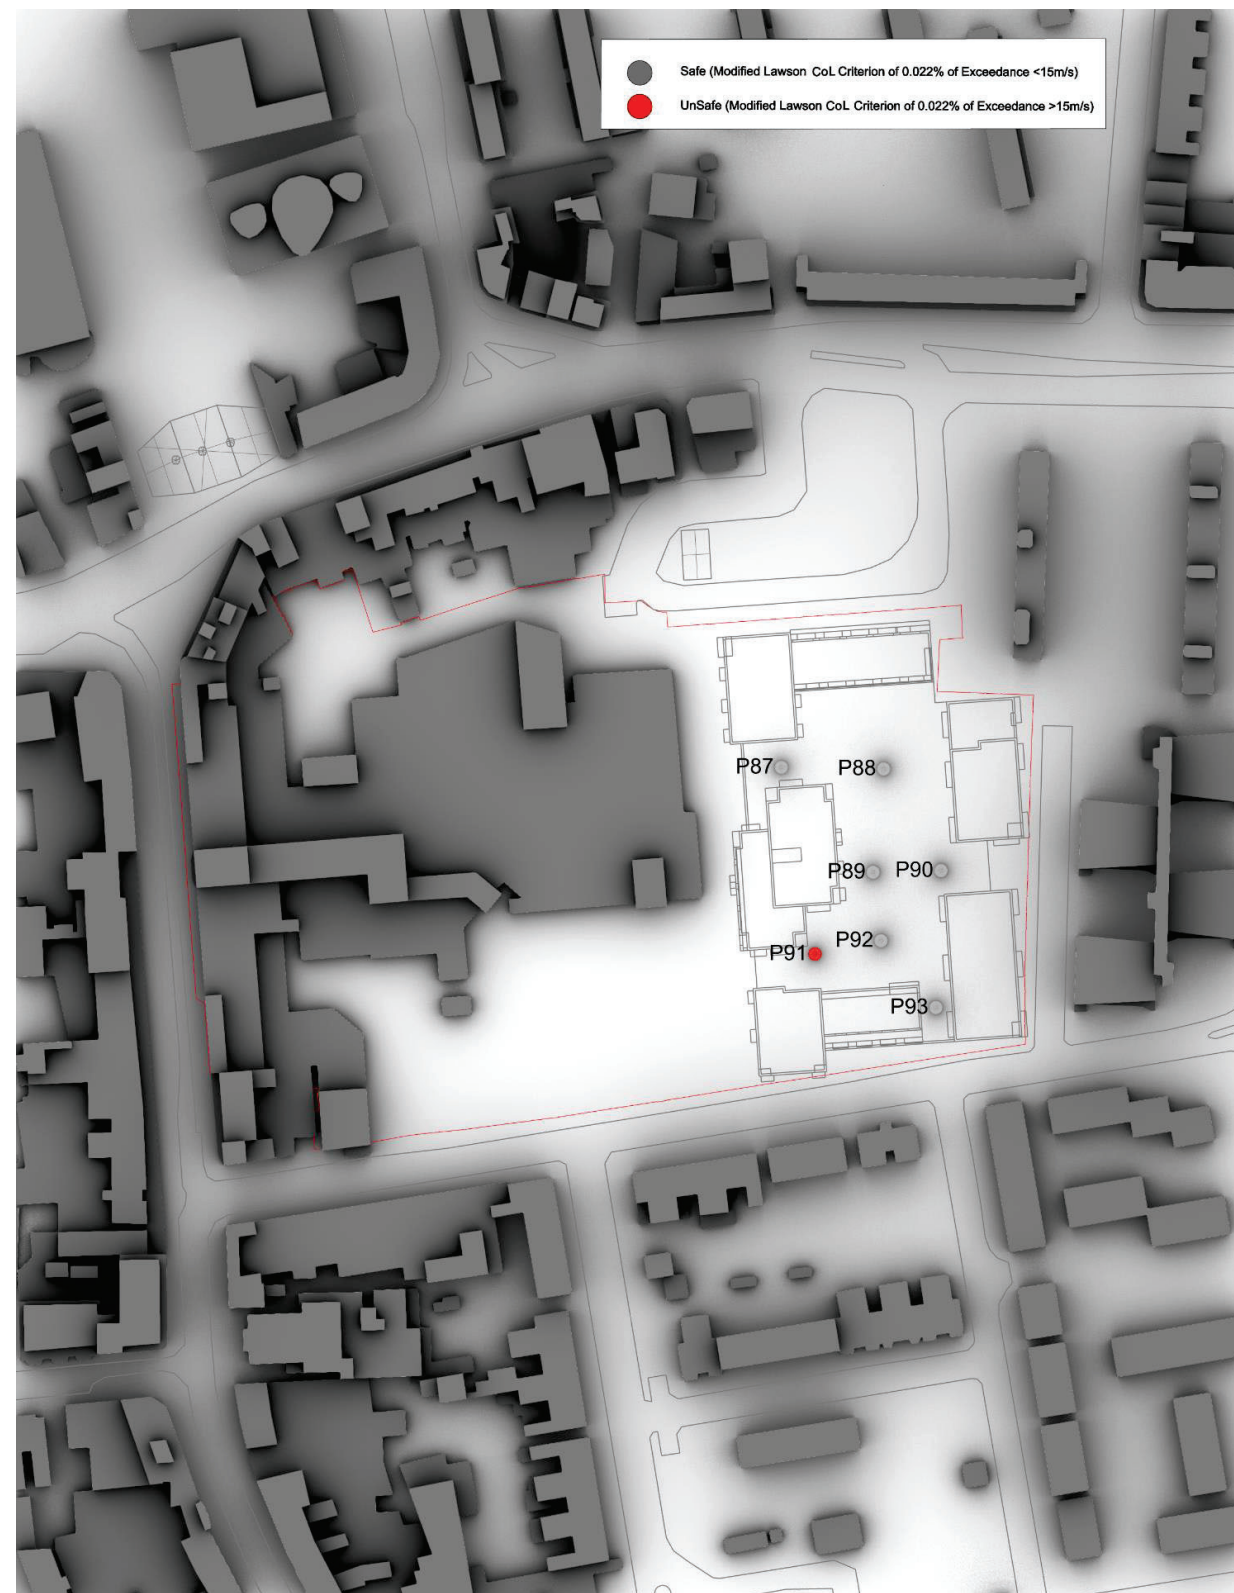
Figure 6c: Wind Tunnel Results – Interim Phase of the Proposed Development with Existing Surrounds, Safety Results, Annual, Elevated Amenity

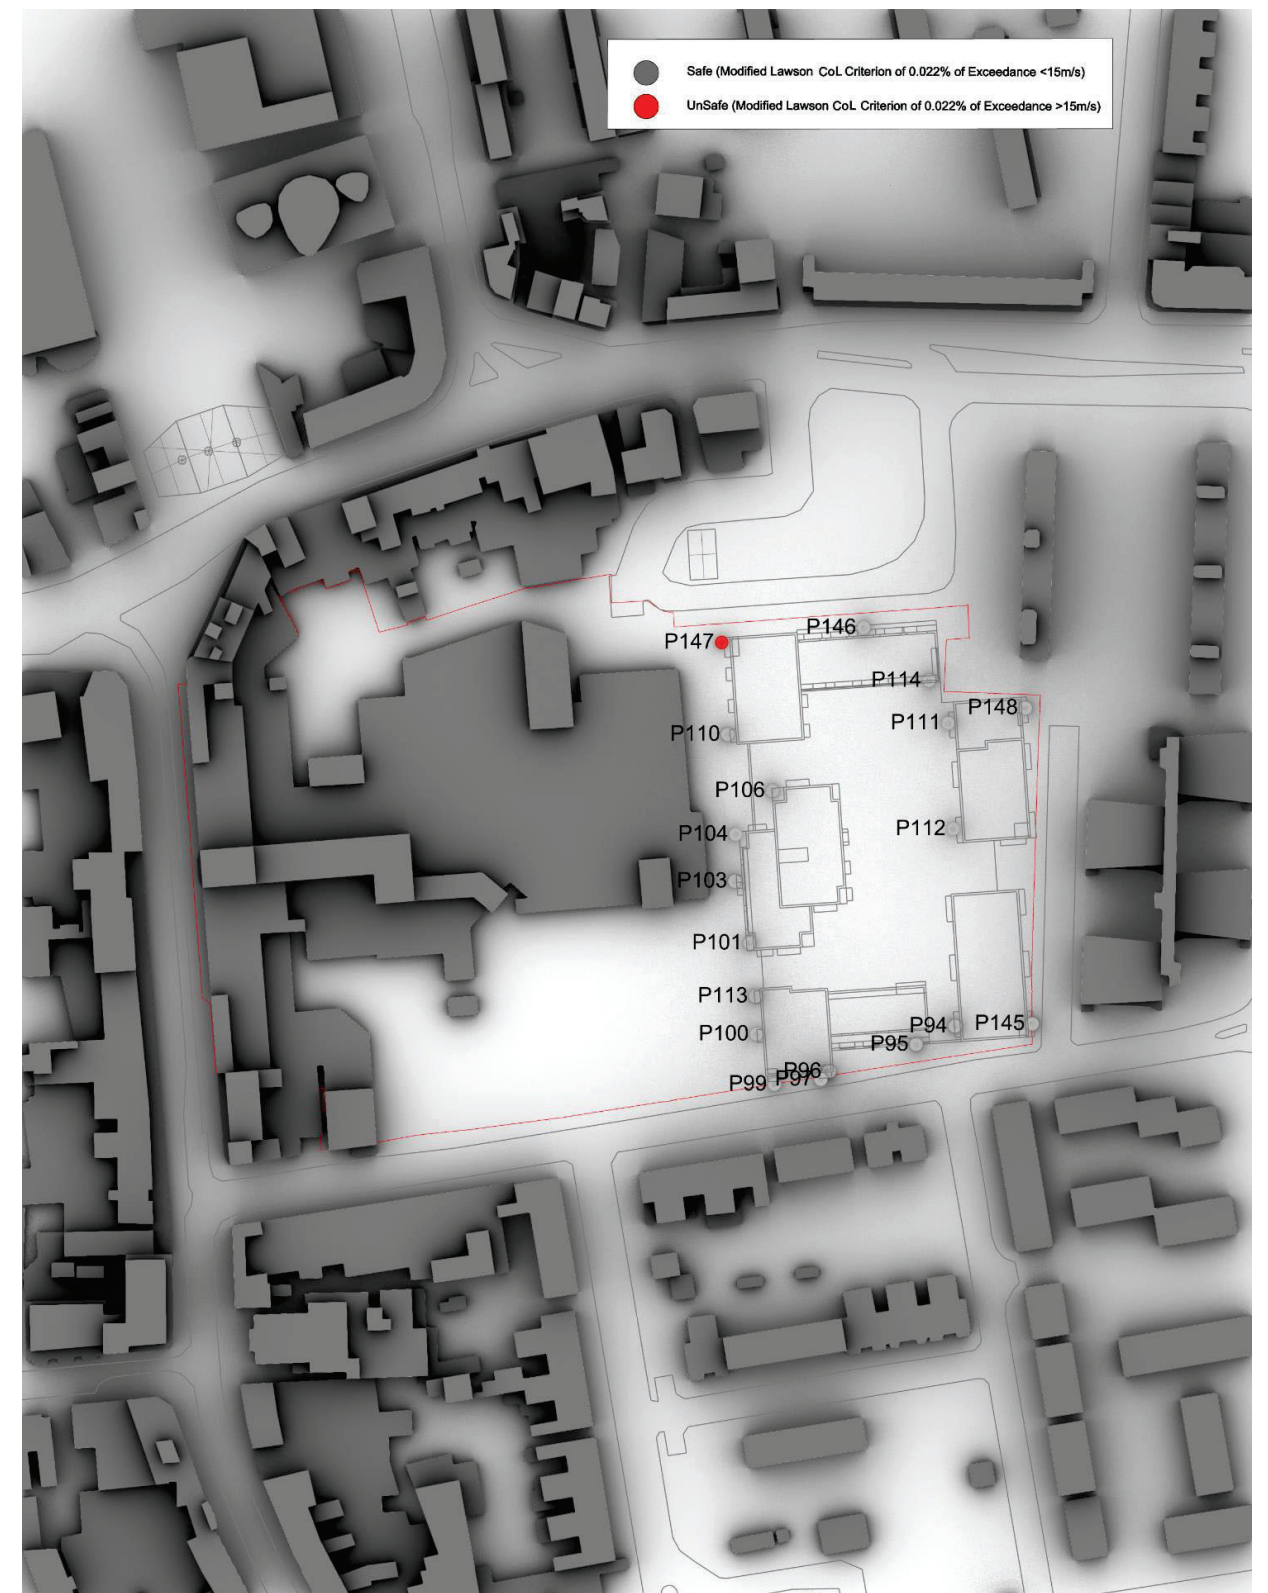
Figure 6d: Wind Tunnel Results – Interim Phase of the Proposed Development with Existing Surrounds, Safety Results, Annual, Elevated Balcony Low

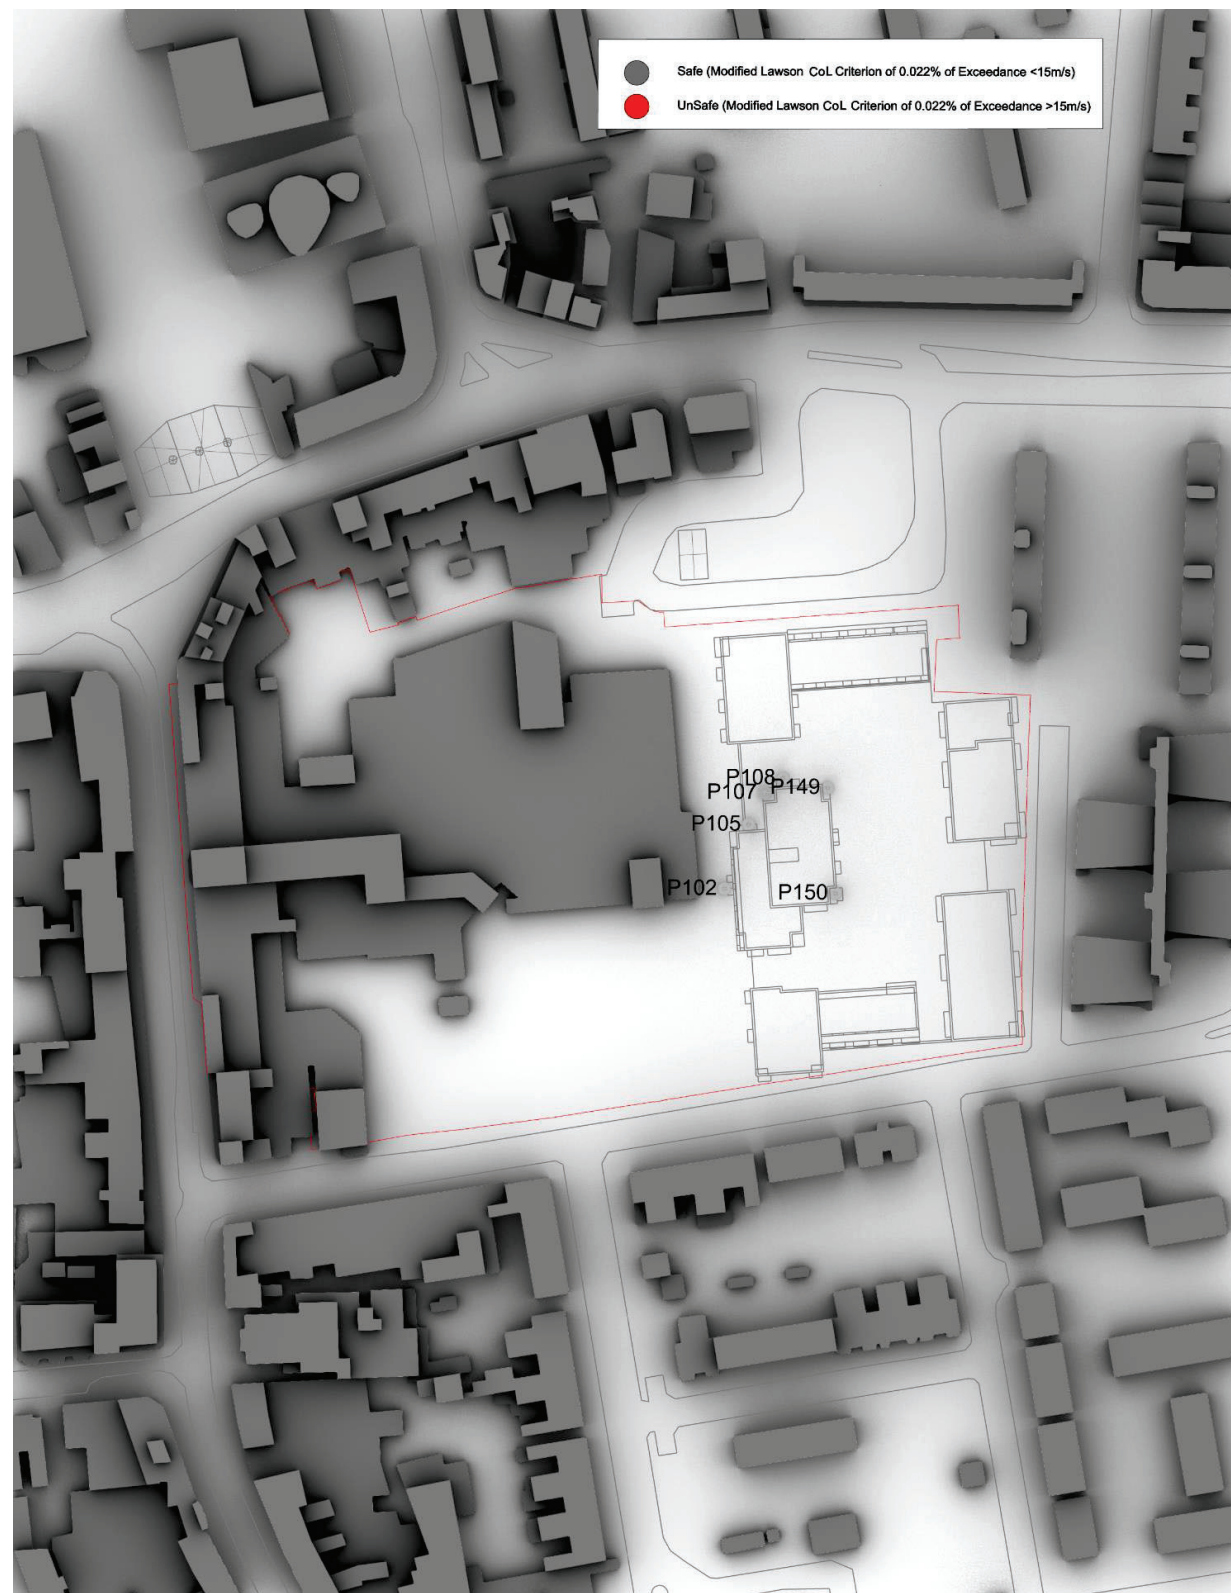
Figure 6e: Wind Tunnel Results – Interim Phase of the Proposed Development with Existing Surrounds, Safety Results, Annual, Elevated Balcony Top

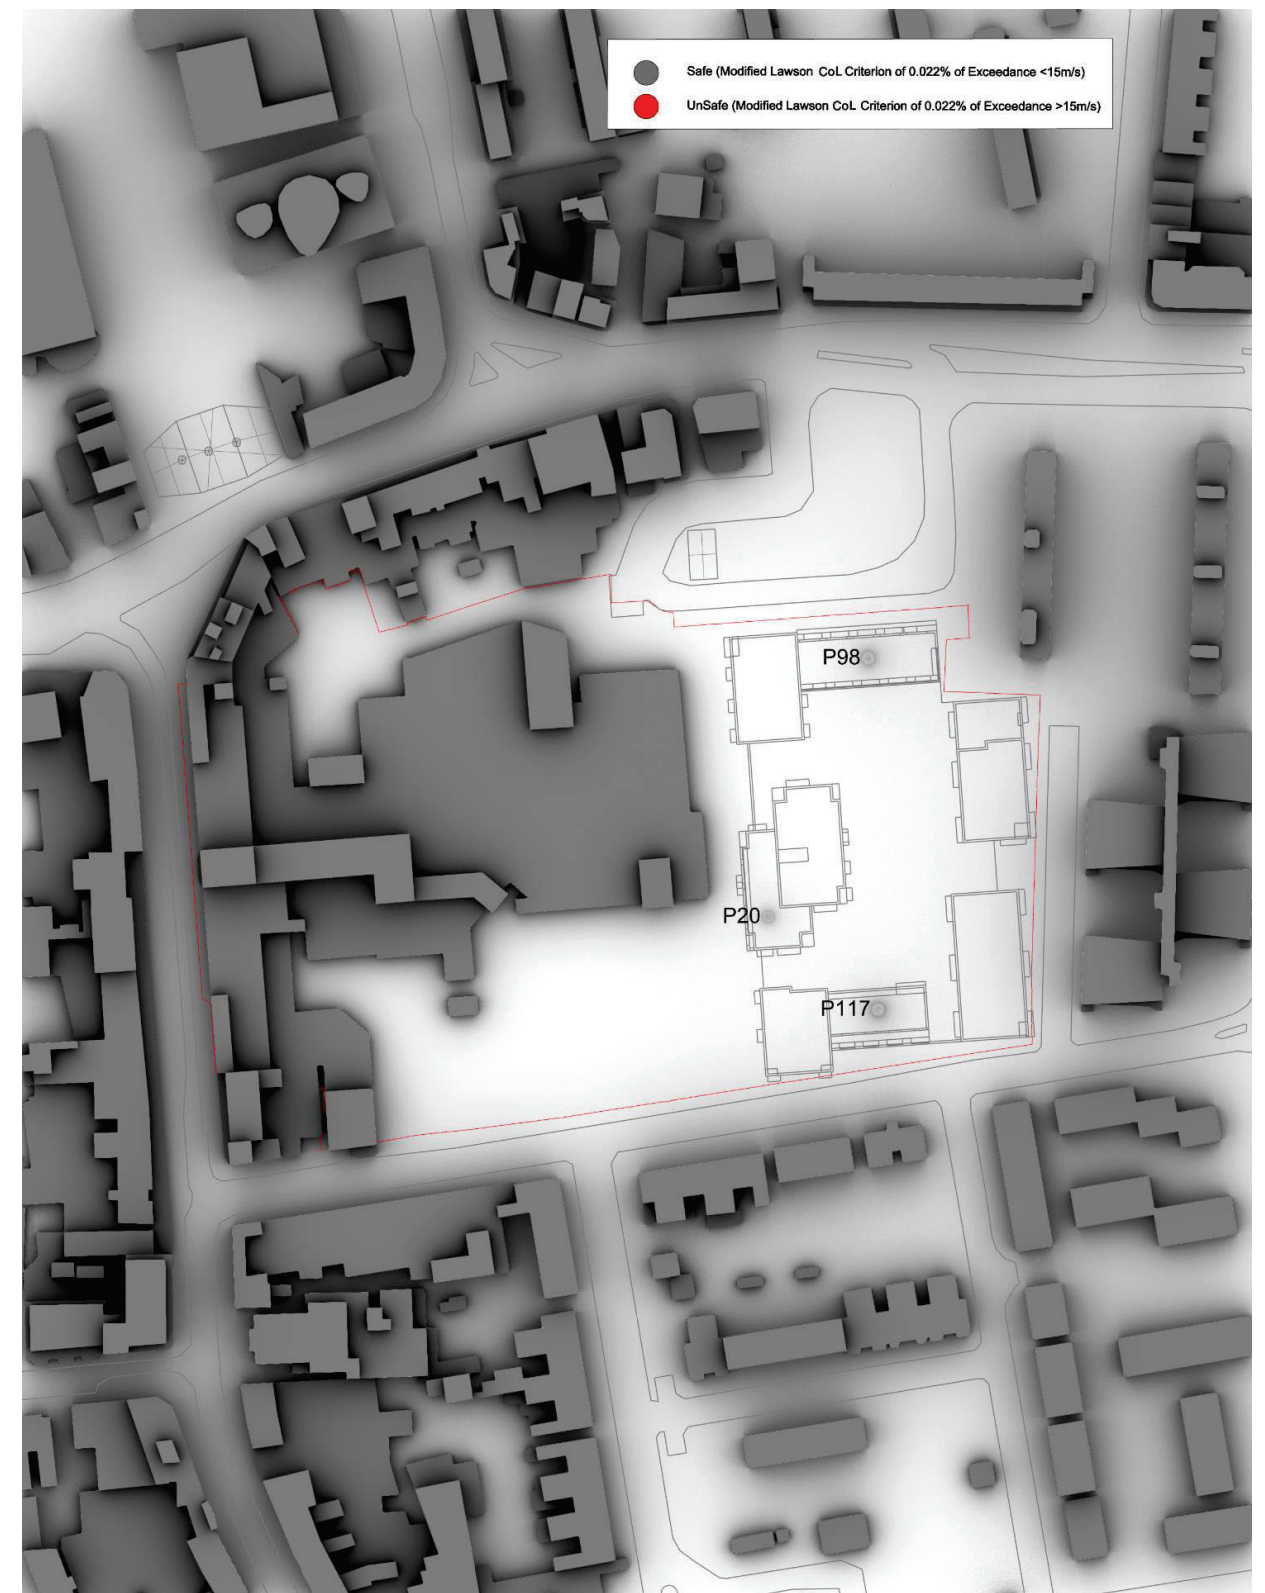
Figure 6f: Wind Tunnel Results – Interim Phase of the Proposed Development with Existing Surrounds, Safety Results, Annual, Elevated Terraces Top

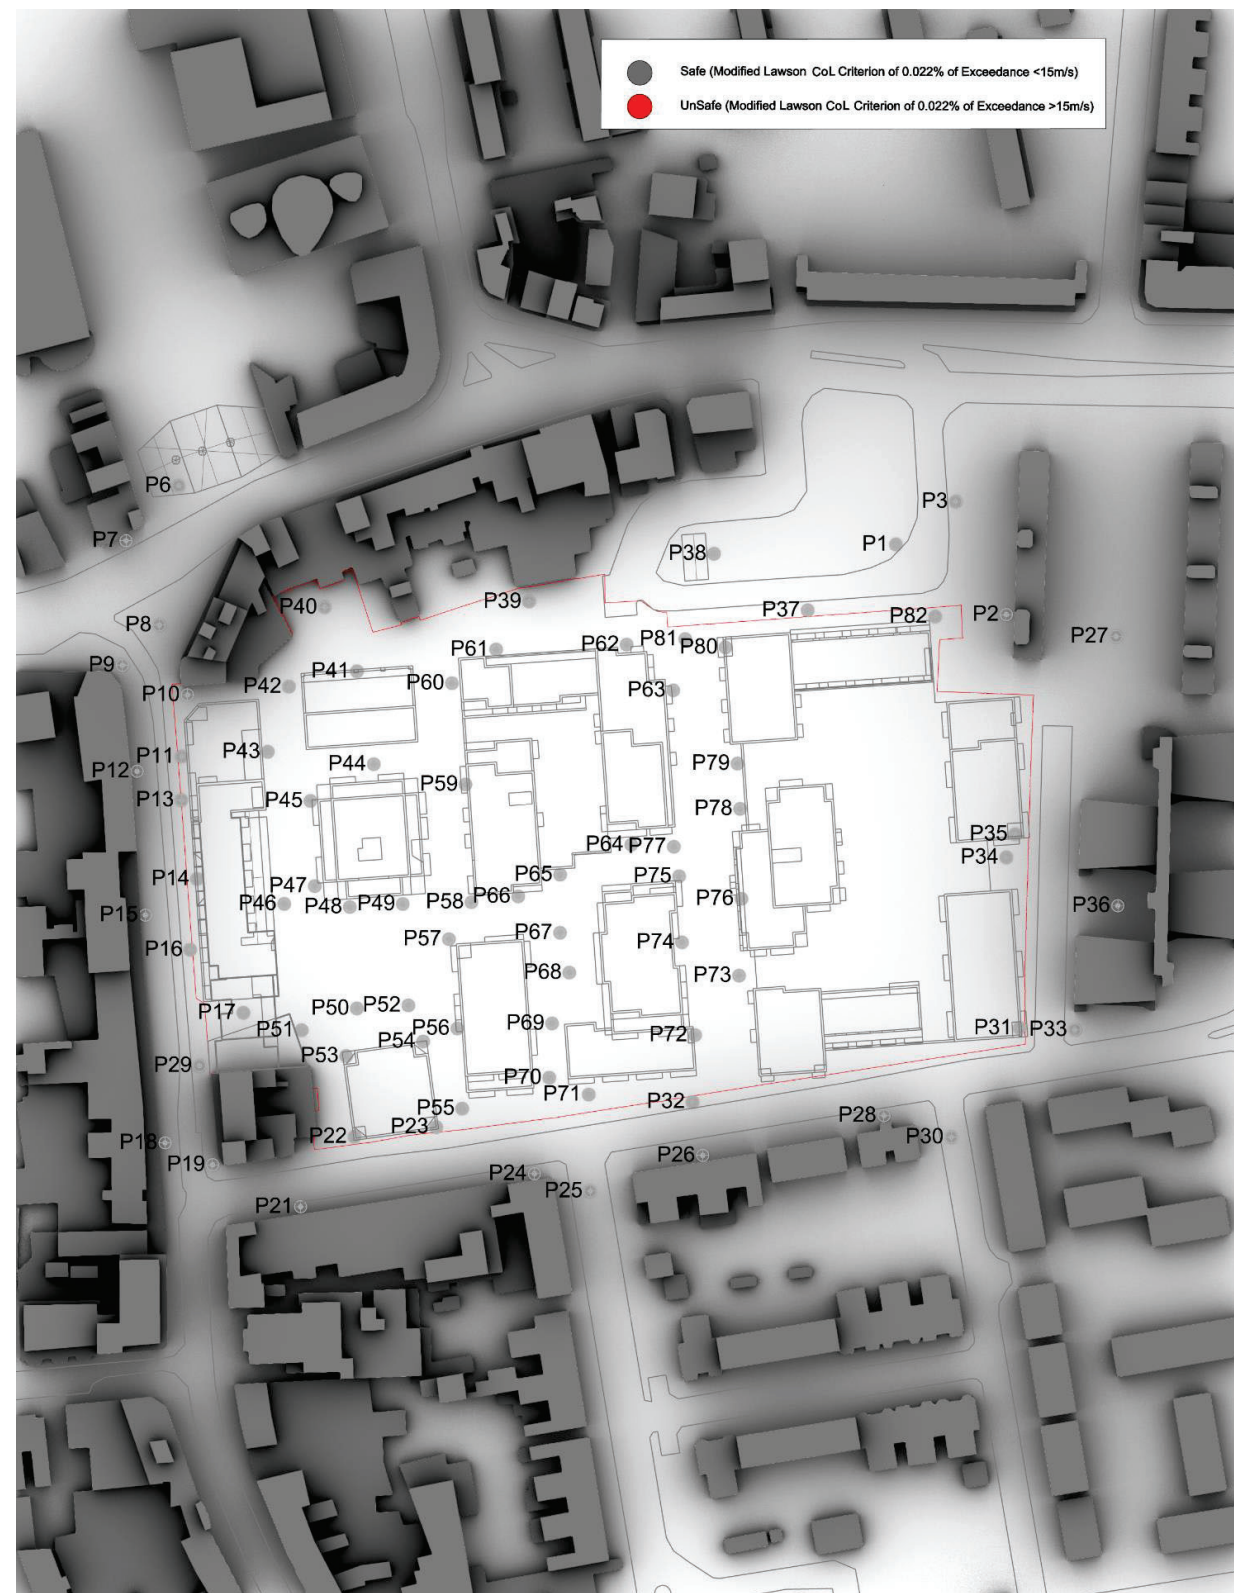
Figure 6g: Wind Tunnel Results - Completed Proposed Development with Existing Surrounds, Safety Results, Annual, Ground

The results for the completed proposed development with the existing surrounds indicate that the wind conditions at three elevated levels do exceed the safety criterion (**Points P20, 102 and P143**). The wind conditions in all other areas on and off-site are rated as safe for pedestrians and cyclist use throughout the year.

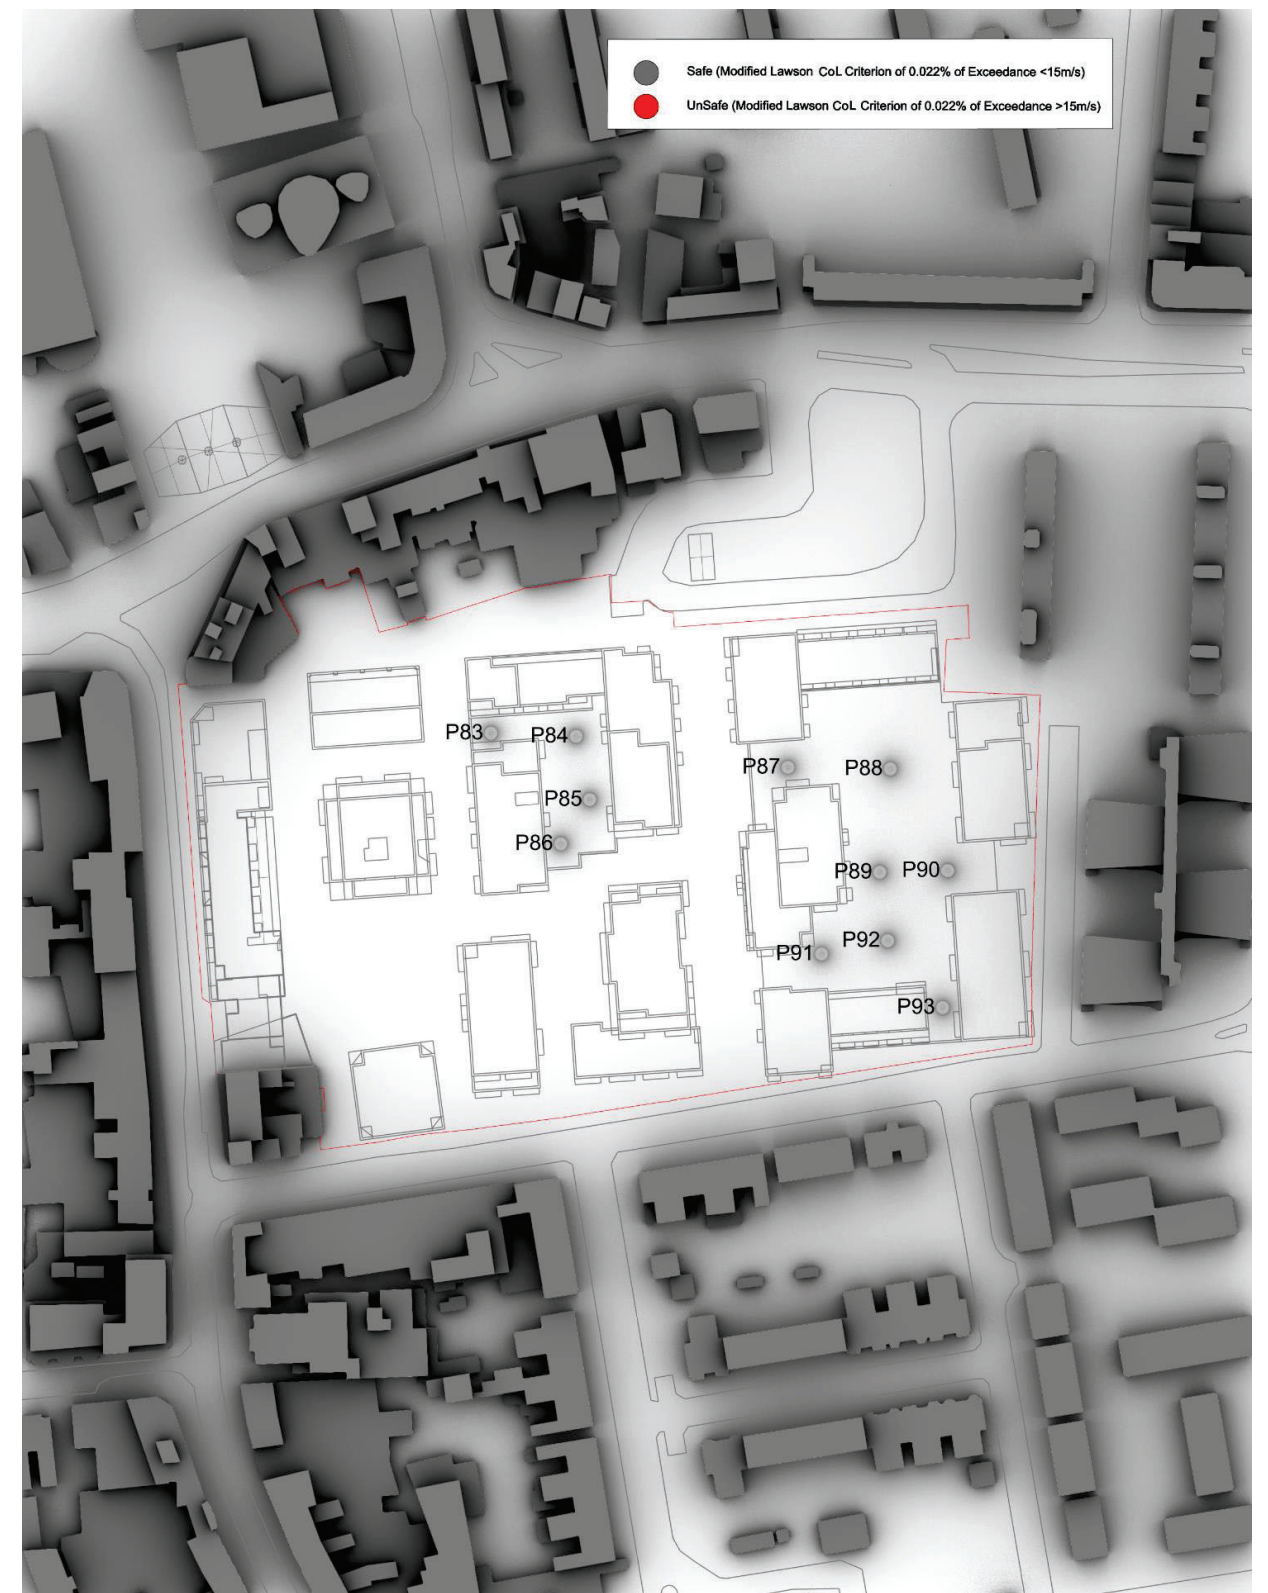
Figure 6h: Wind Tunnel Results – Completed Proposed Development with Existing Surrounds, Safety Results, Annual, Elevated Amenity

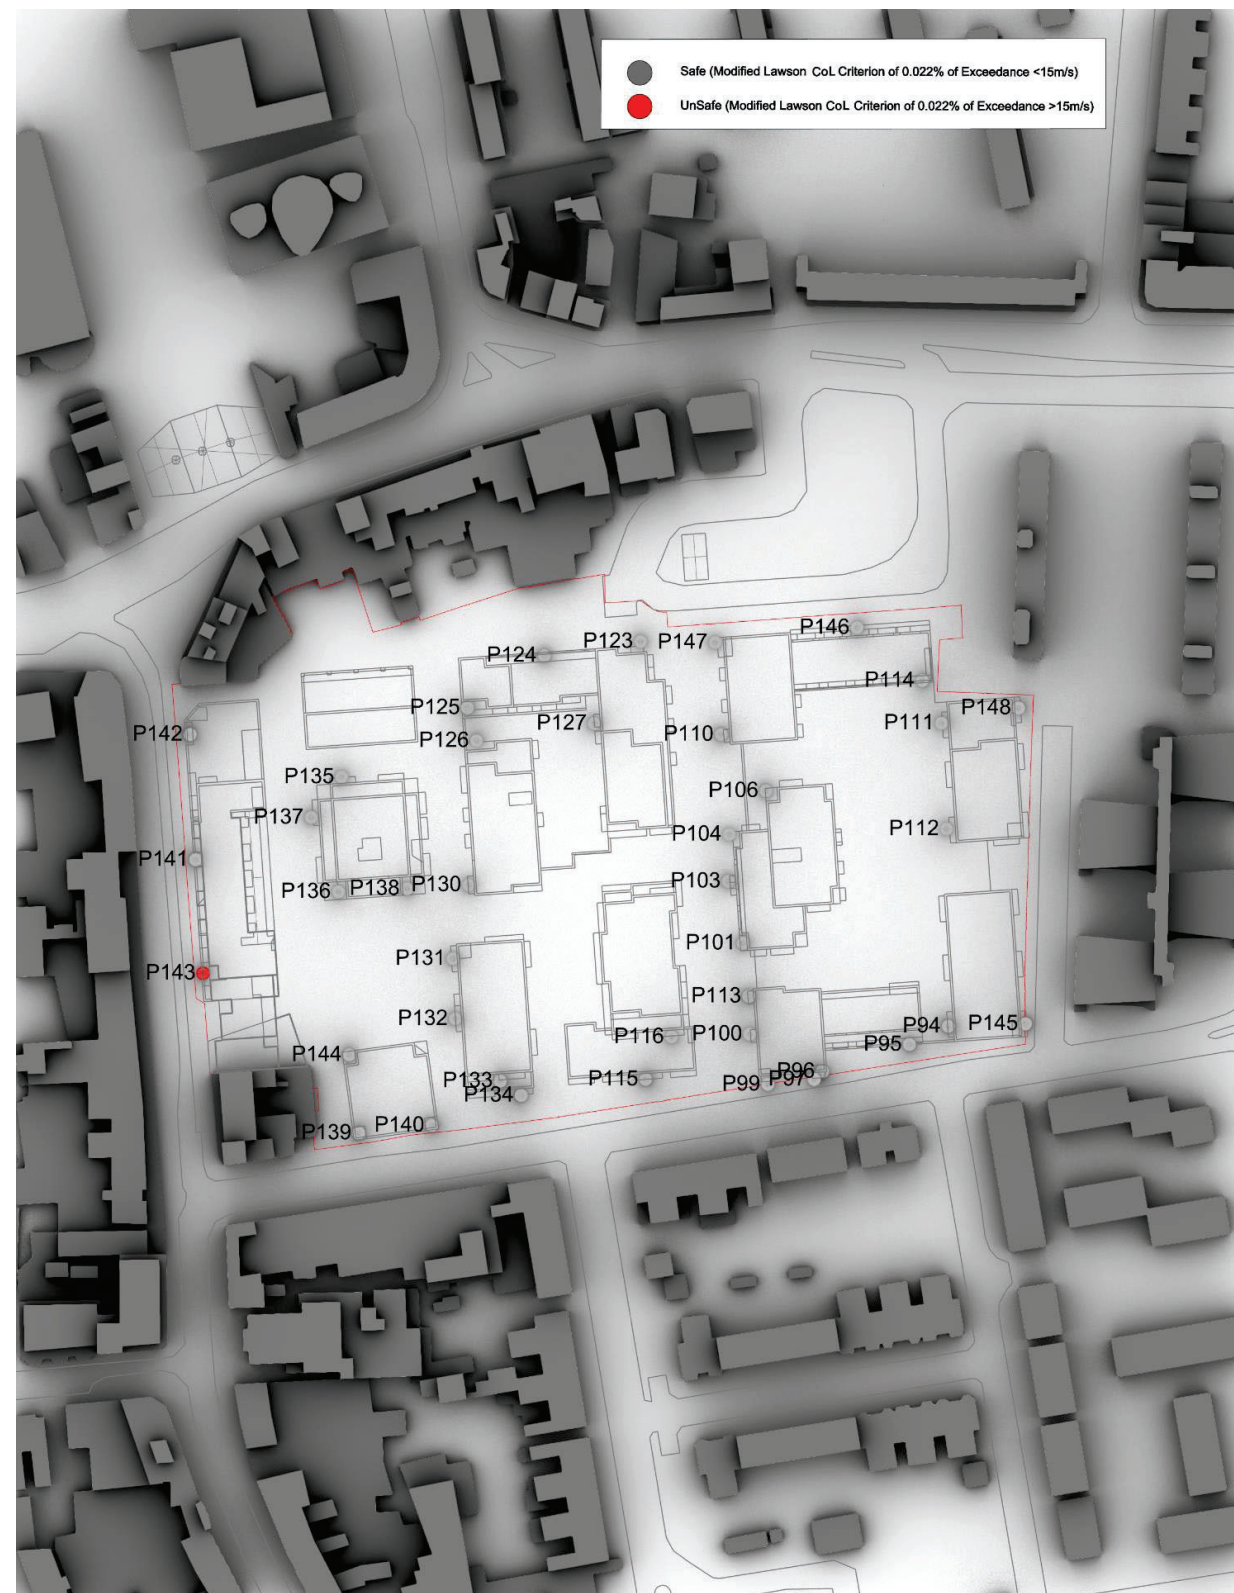
Figure 6i: Wind Tunnel Results – Completed Proposed Development with Existing Surrounds, Safety Results, Annual, Elevated Balcony Low

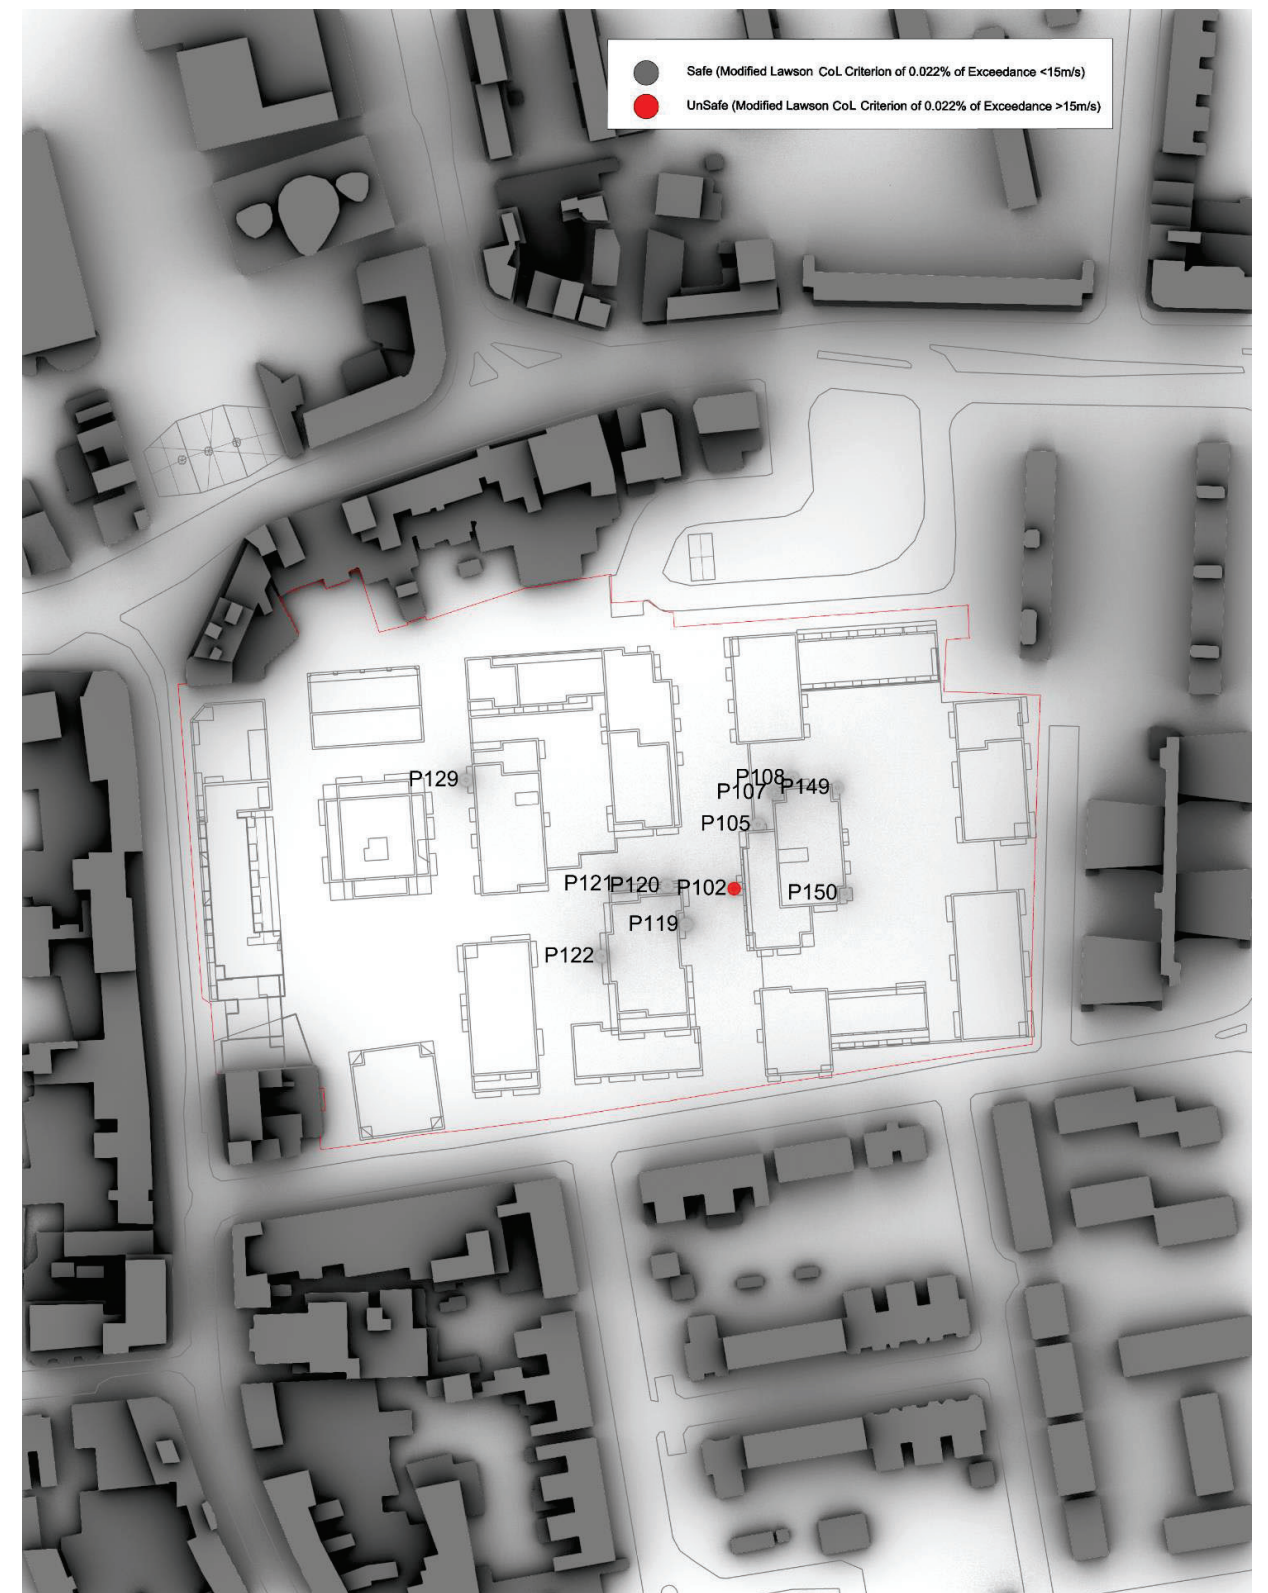
Figure 6j: Wind Tunnel Results – Completed Proposed Development with Existing Surrounds, Safety Results, Annual, Elevated Balcony Top
