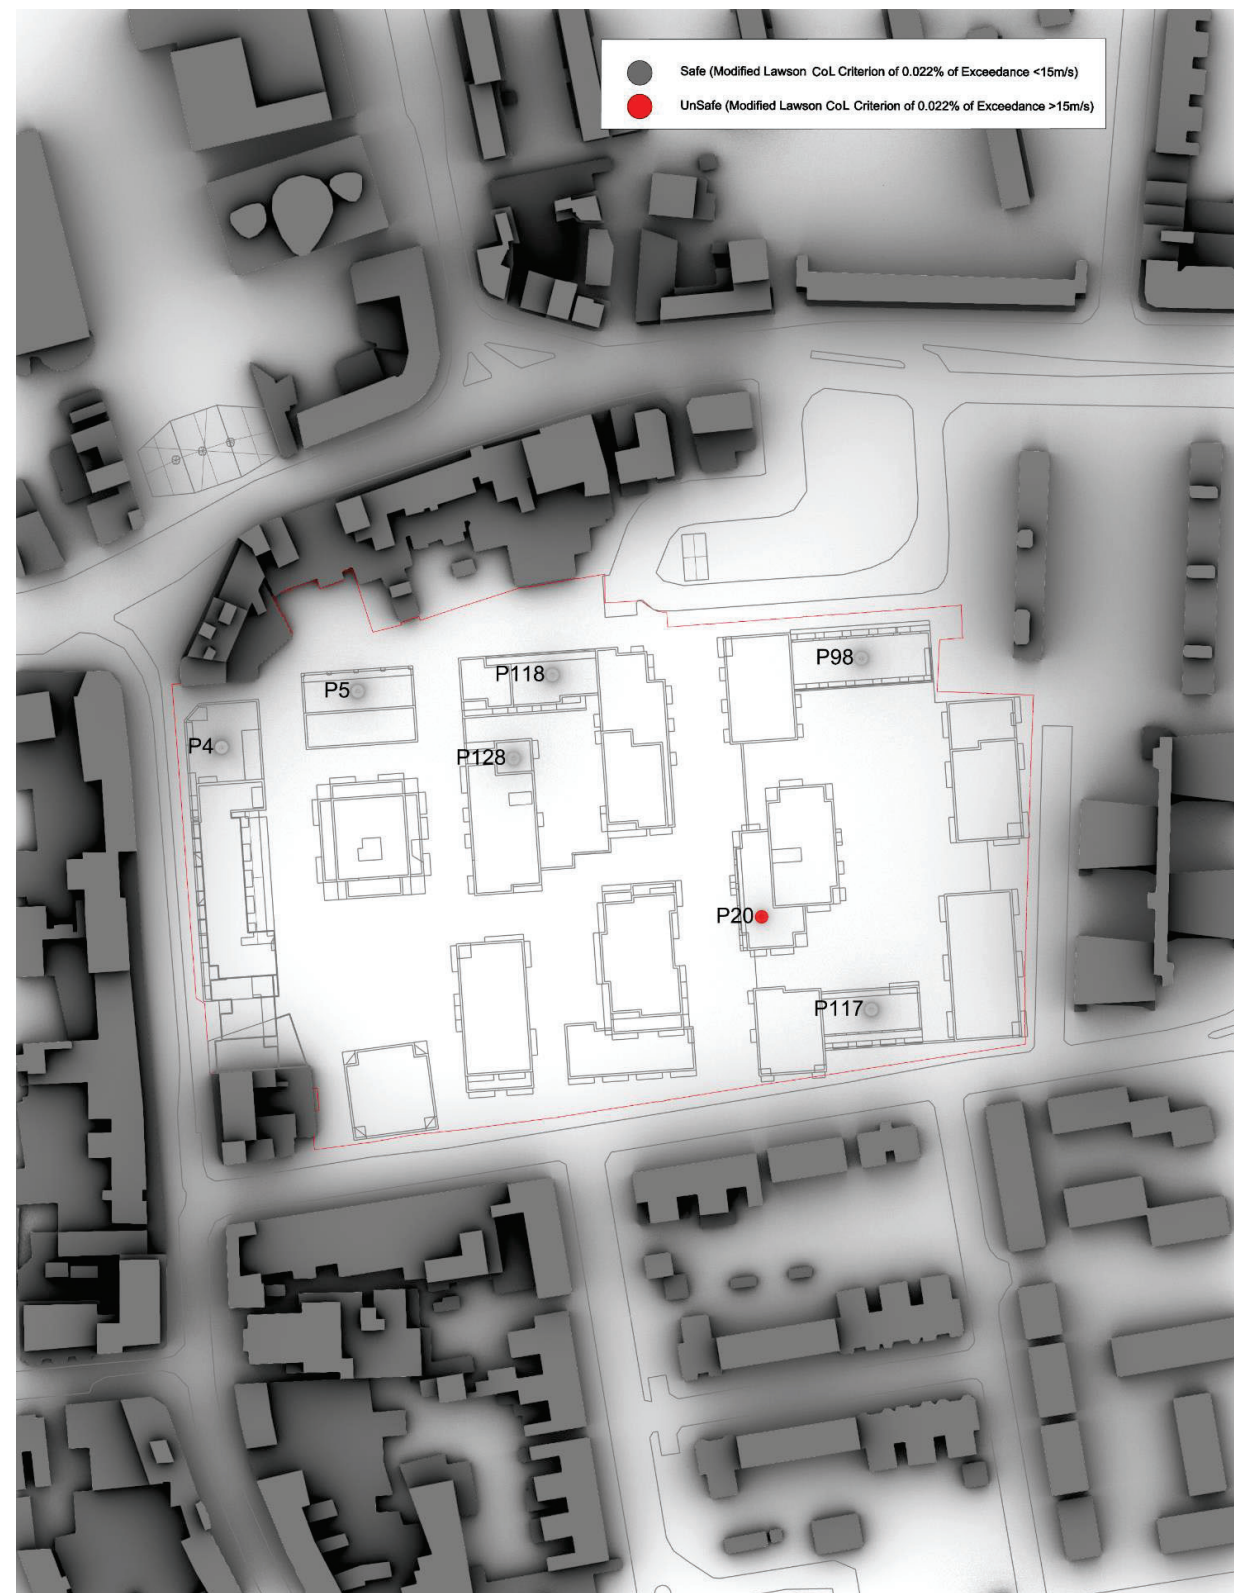
Figure 6k: Wind Tunnel Results – Completed Proposed Development with Existing Surrounds, Safety Results, Annual, Elevated Terraces Top

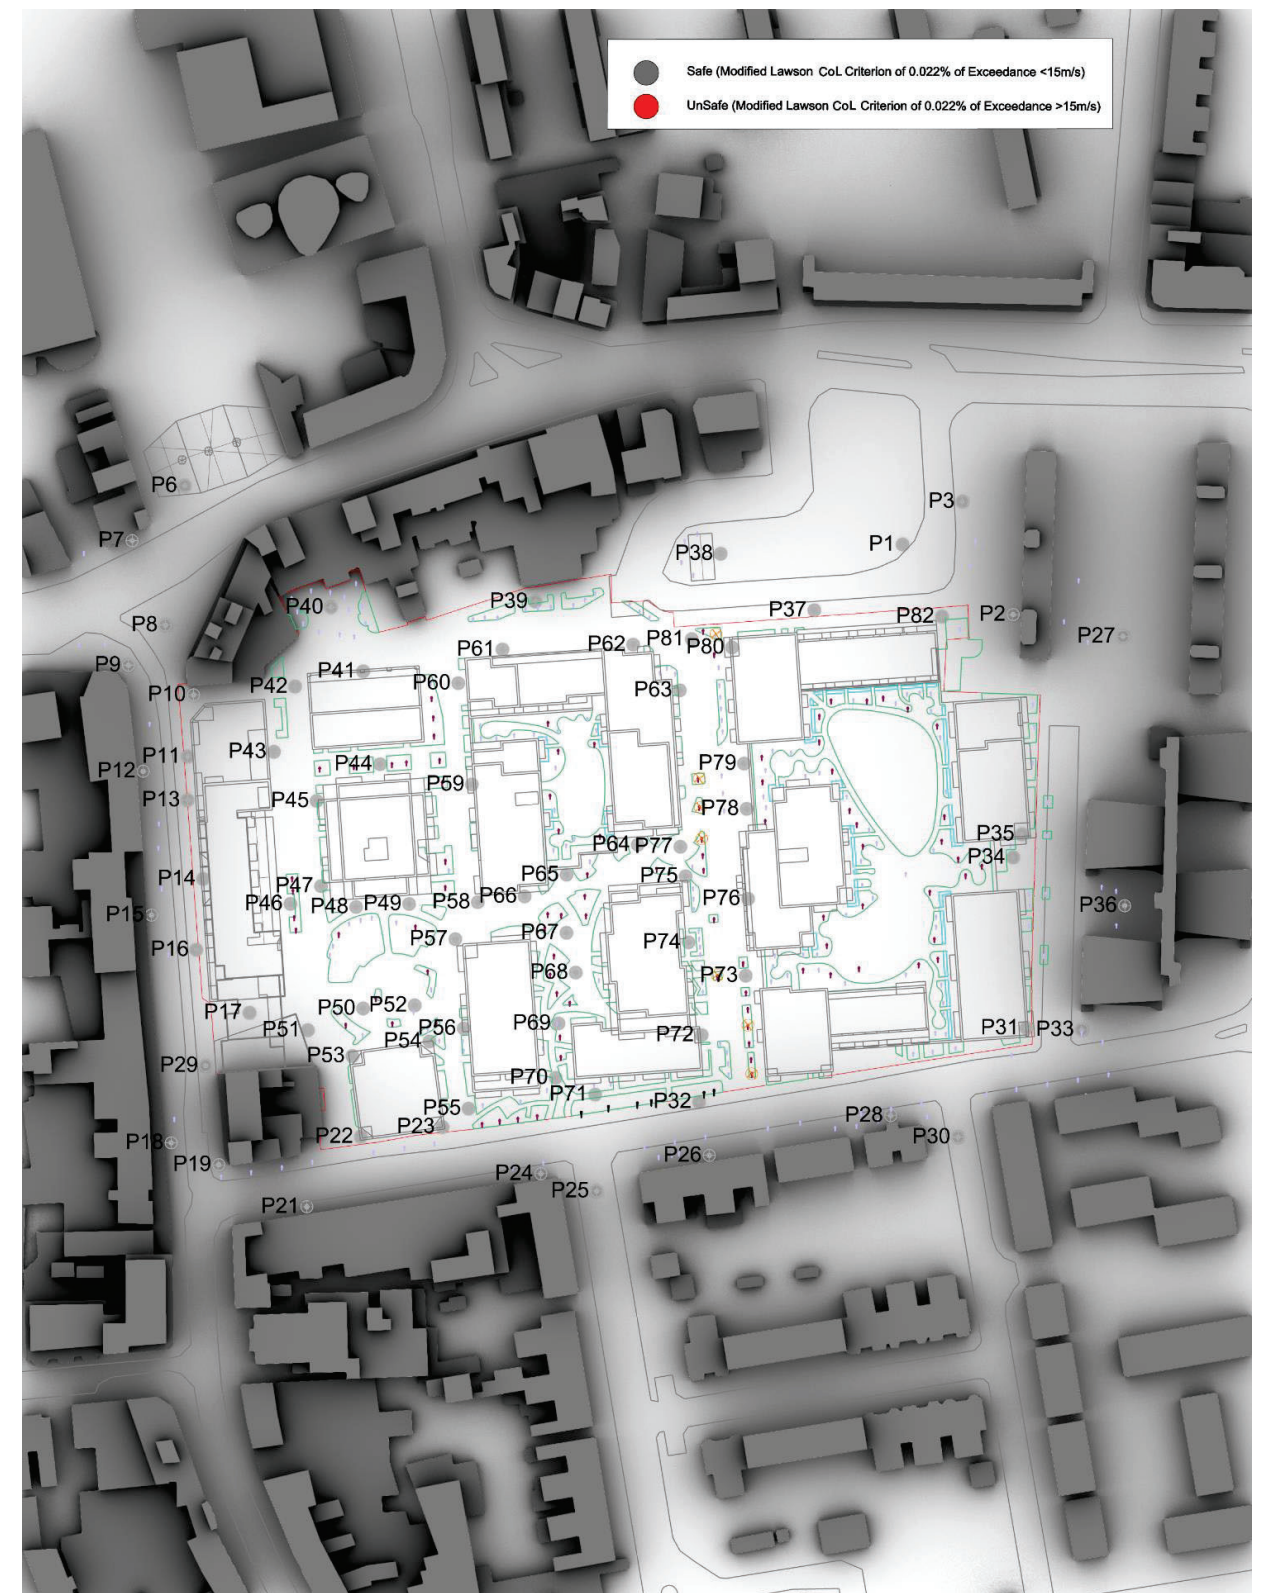
Figure 6l: Wind Tunnel Results – Completed Proposed Development with Existing Surrounds and Proposed Landscaping, Safety Results, Annual, Ground

The results for the completed proposed development with the existing surrounds and Proposed Landscaping indicate that the wind conditions at Two elevated levels do exceed the safety criterion (**Points P102 and 143**). The wind conditions in all other areas on and off-site are rated as safe for pedestrians and cyclist use throughout the year.

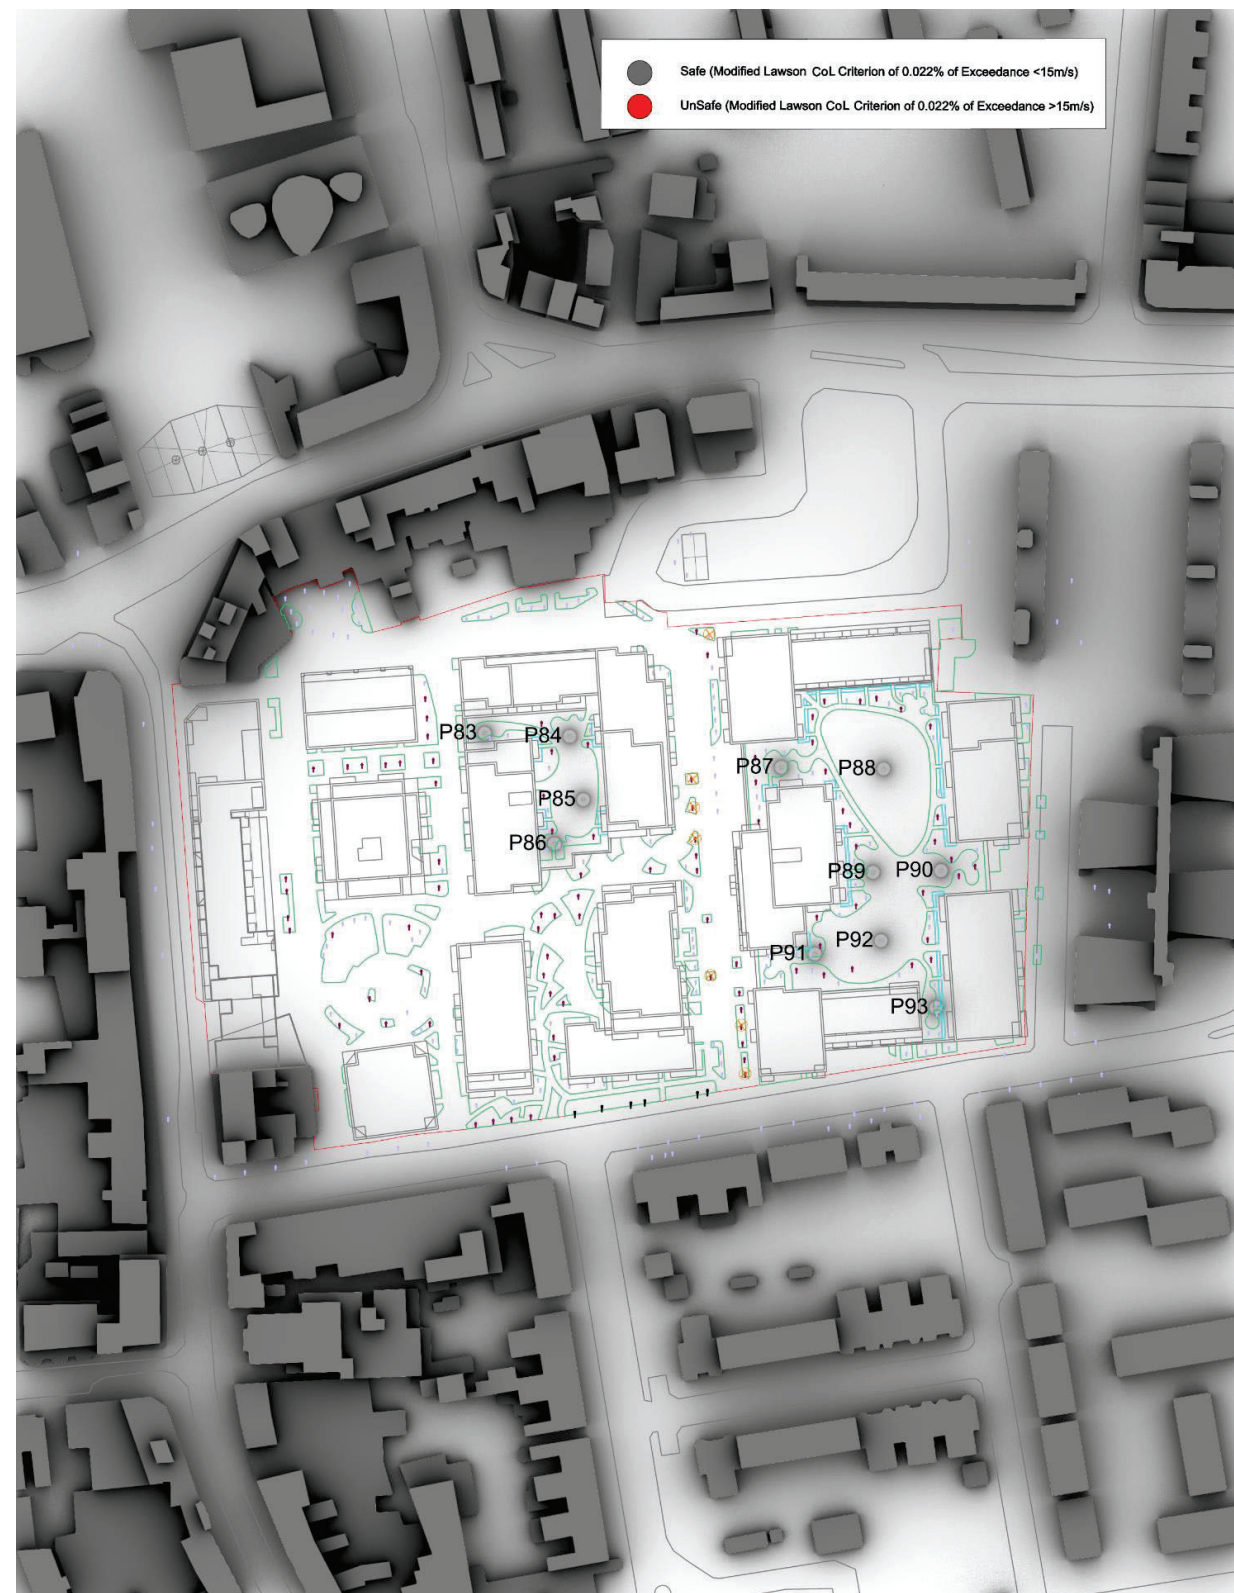
Figure 6m: Wind Tunnel Results – Completed Proposed Development with Existing Surrounds and Proposed Landscaping, Safety Results, Annual, Elevated Amenity

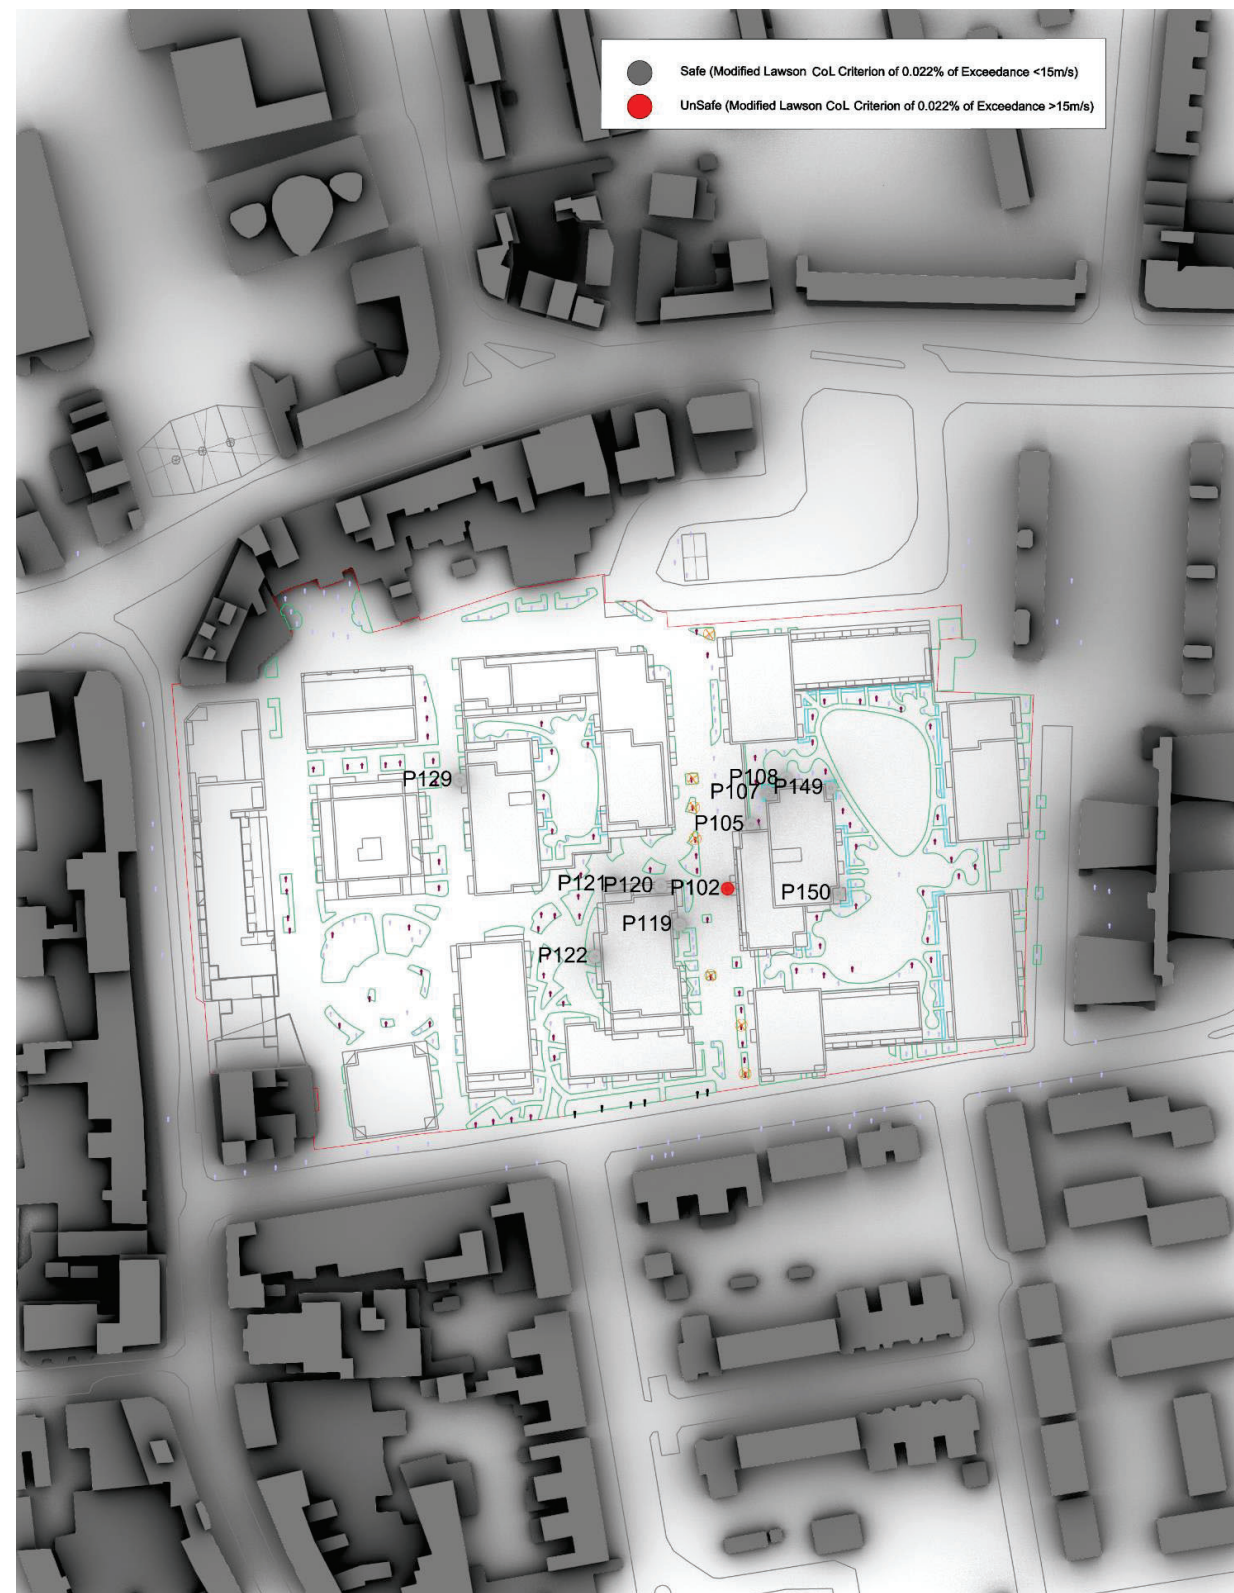
Figure 6o: Wind Tunnel Results – Completed Proposed Development with Existing Surrounds and Proposed Landscaping, Safety Results, Annual, Elevated Balcony Top

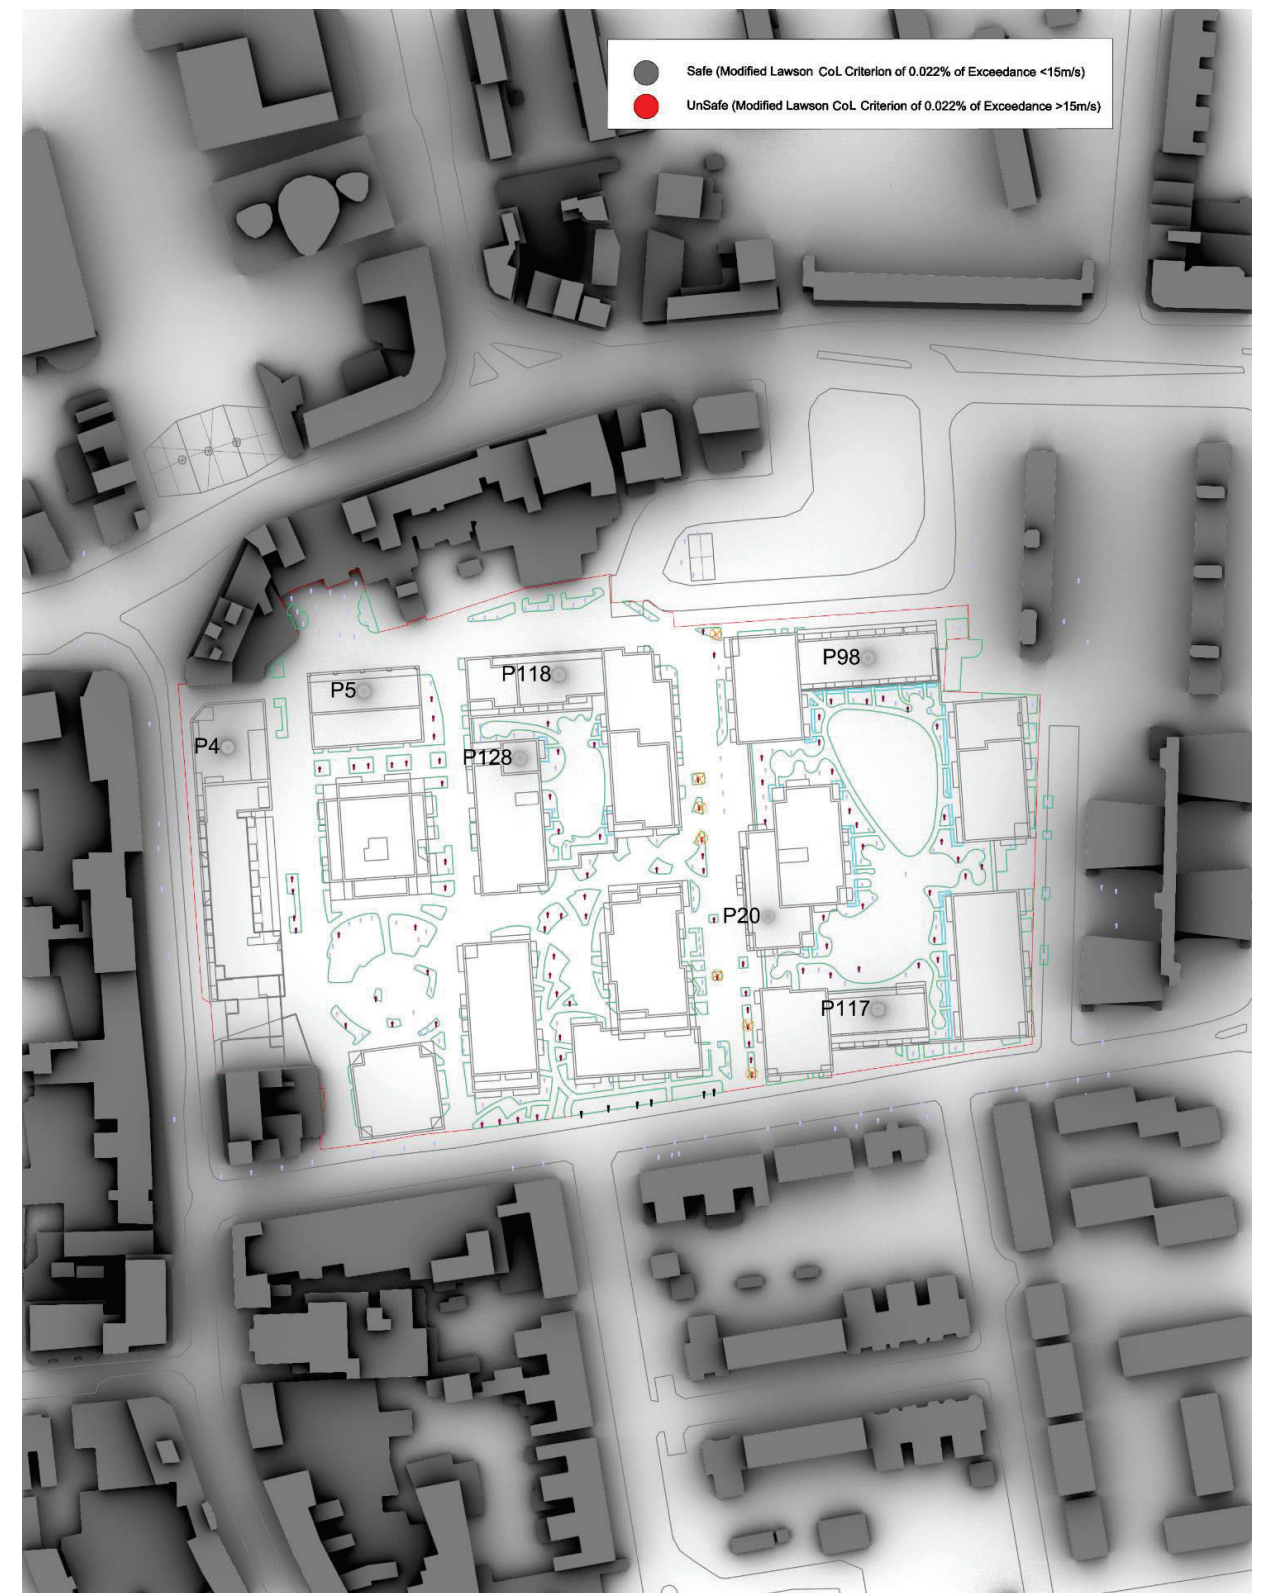
Figure 6p: Wind Tunnel Results – Completed Proposed Development with Existing Surrounds and Proposed Landscaping, Safety Results, Annual, Elevated Terraces Top
