**THE NETWORK RAIL (TACKLEY LEVEL CROSSING) ORDER**

**PROOF OF IAN ASTON**

**TACKLEY LEVEL CROSSING**

**21 May 2024**

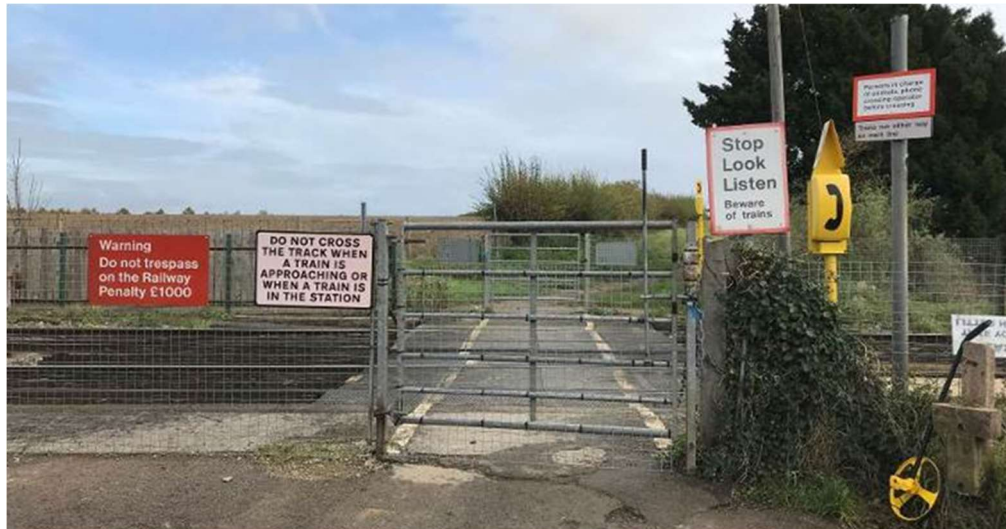
Figure 3: Western approach to Tackley Level Crossing (taken in November 2019)

4.6 The western approach from the village, on the “Down” side of the railway, is metalled as shown in Figure 3 below and the bridleway leading to the eastern “Up” side gate is a rural path as shown in Figure 4.

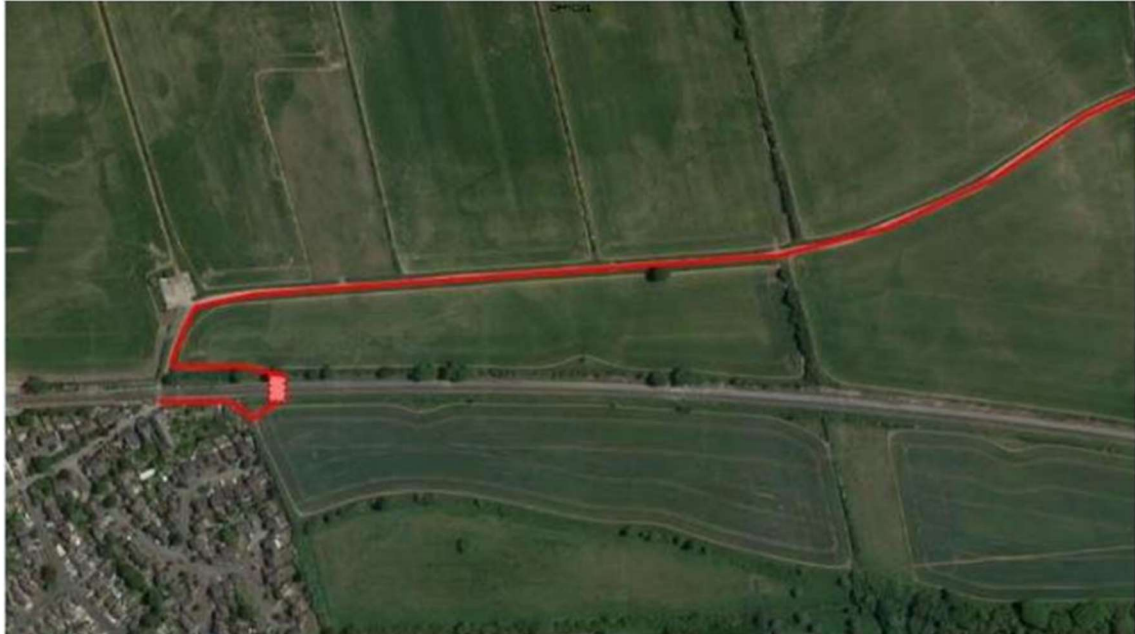
i. **Equestrian Subway**

This would have seen the Crossing closed by the construction of a subway near the site of the Crossing, capable of taking mounted equestrians and cyclists, and pedestrians. This option was deemed unviable due to the significant financial and engineering challenges, which would have seen major disruption to the railway and local area.

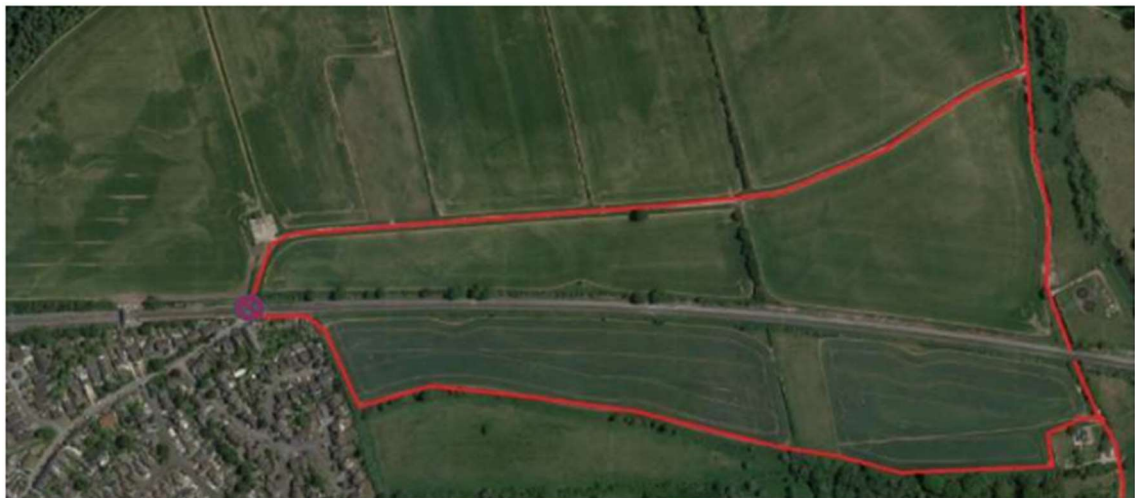
ii. **In-Field Route**

This option saw a bridleway diversion implemented through the field to the south-west of the crossing, which would have cut the field in two and dramatically affected the potential uses for this land. In order to accept this route, the landowner concerned, who also owns the land to the south-east of the Crossing (where the existing bridleway leads) required the existing bridleway be stopped up at its southern point to allow them to make full use of the field. The clear consensus was that there would be significant opposition to the existing bridleway being stopped up, so this option was discounted.

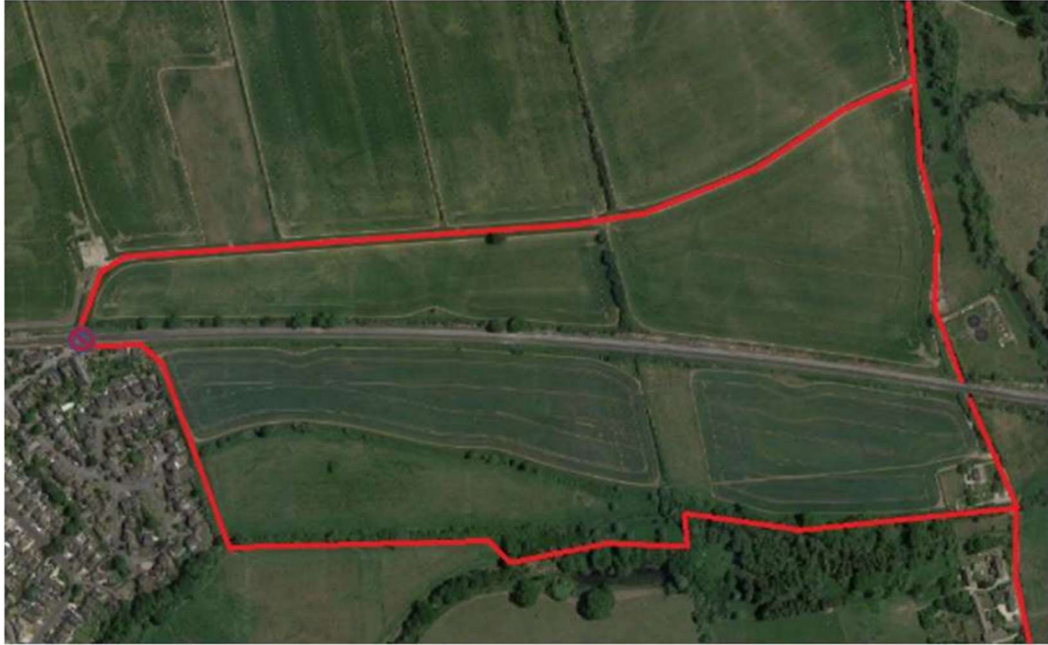
iii. **Western In-Field Route**

This option saw the bridleway diverted to the far west of the field to the south-west of the Crossing, no longer splitting the field in two. However, it was found that there were significant engineering difficulties, flood risks, and ongoing maintenance concerns with this route, plus the cost of making the new bridleway good was deemed excessive.

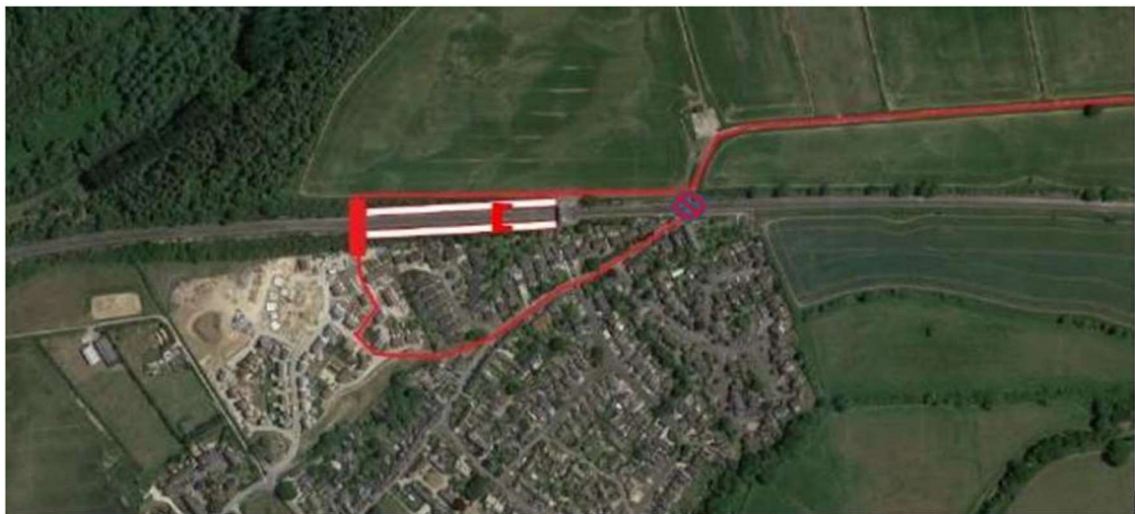
iv. **Barwood Bridge.**

Also known as the developer bridge, this would have seen a new bridle bridge constructed 300m north of Tackley station, diverting the existing bridleway north and past the station to meet it. This option was discounted as unviable as the proximity of it to the station meant that the ramps required would not be suitable for disabled access, while at the same time it was too far away from the station to act as a convenient method of transferring between the platforms, being approximately a 1km walk. This meant that for the Barwood Bridge to be considered, a secondary bridge at the station would need to be constructed as well, meaning the cost to the taxpayer was too great to further consider this option.

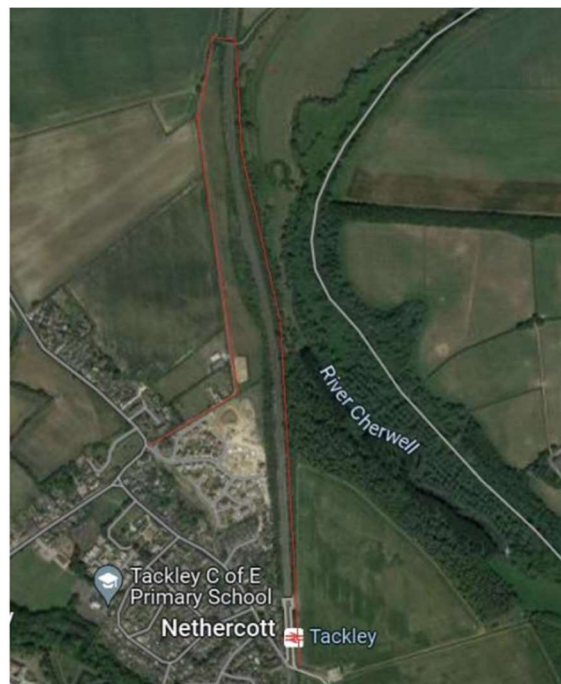
v. **Northern Route**

This option would have seen the bridleway diverted on the Crossing's east side circa 1.2km north to an existing bridge, then use the existing bridleway and public road network to create a circular route to the Crossing's west gate. The total route was calculated at approximately 3.2km, which Network Rail did not deem a suitable or convenient length of diversion. Further to this, there were significant challenges in clearing the route, flood risk, and a second landowner would have had to have been involved, who did not respond to Network Rail's attempts to open discussions in 2022. Therefore, additional compulsory purchase powers would have been required, and it was felt the case for this was not strong enough to proceed with. As such, this option was discounted.
