# CAMBRIDGE SOUTH EAST TRANSPORT PHASE 2

Document title: Cambridge South East Transport Phase 2 Scheme – Otter and Water Vole Survey Report

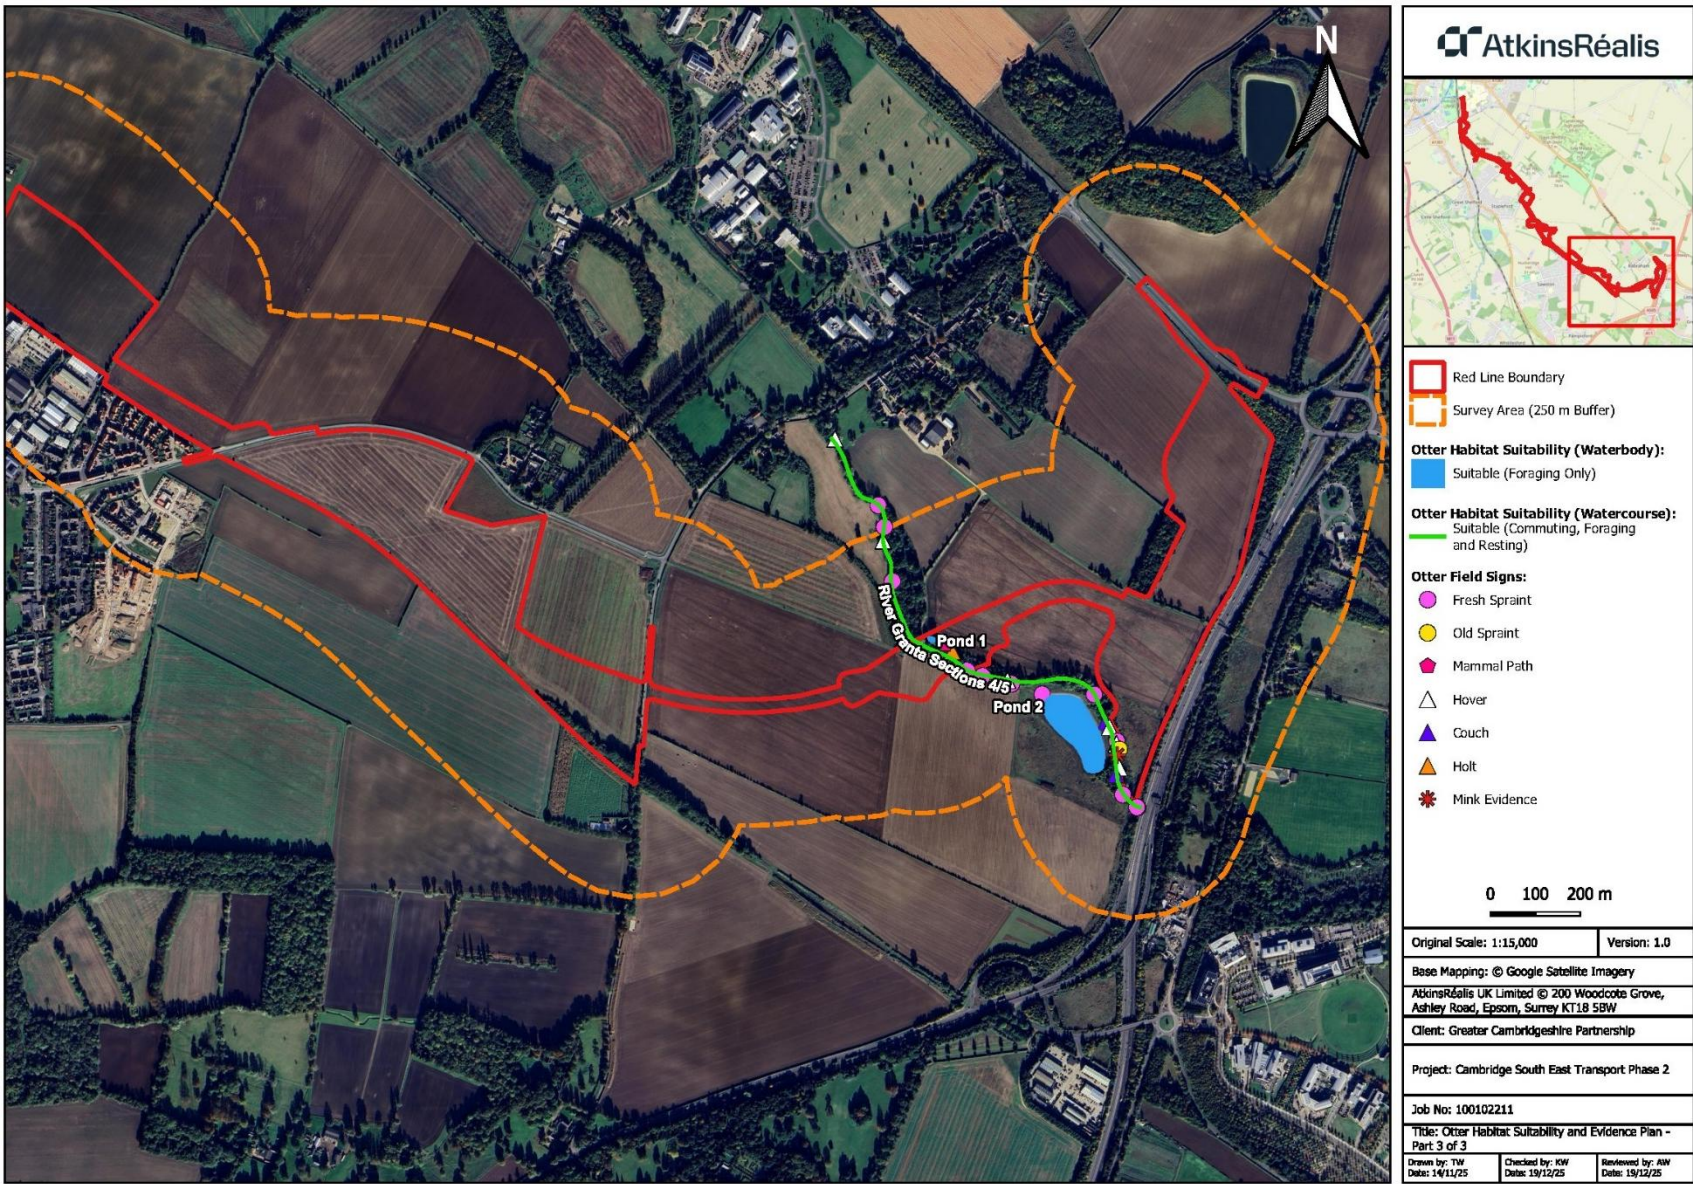
C.3 Figure C-3: Otter Habitat Suitability and Evidence Plan – Part 3 of 3

The River Granta was found to be suitable for commuting and foraging otter. Numerous potential resting sites were identified on all sections of the river including holts, couches and hovers. Various field signs of otters were recorded along all sections of the River Granta, including spraints of varying age classes, feeding remains (primarily of signal crayfish) and footprints, highlighting the regular use of this watercourse by otter.

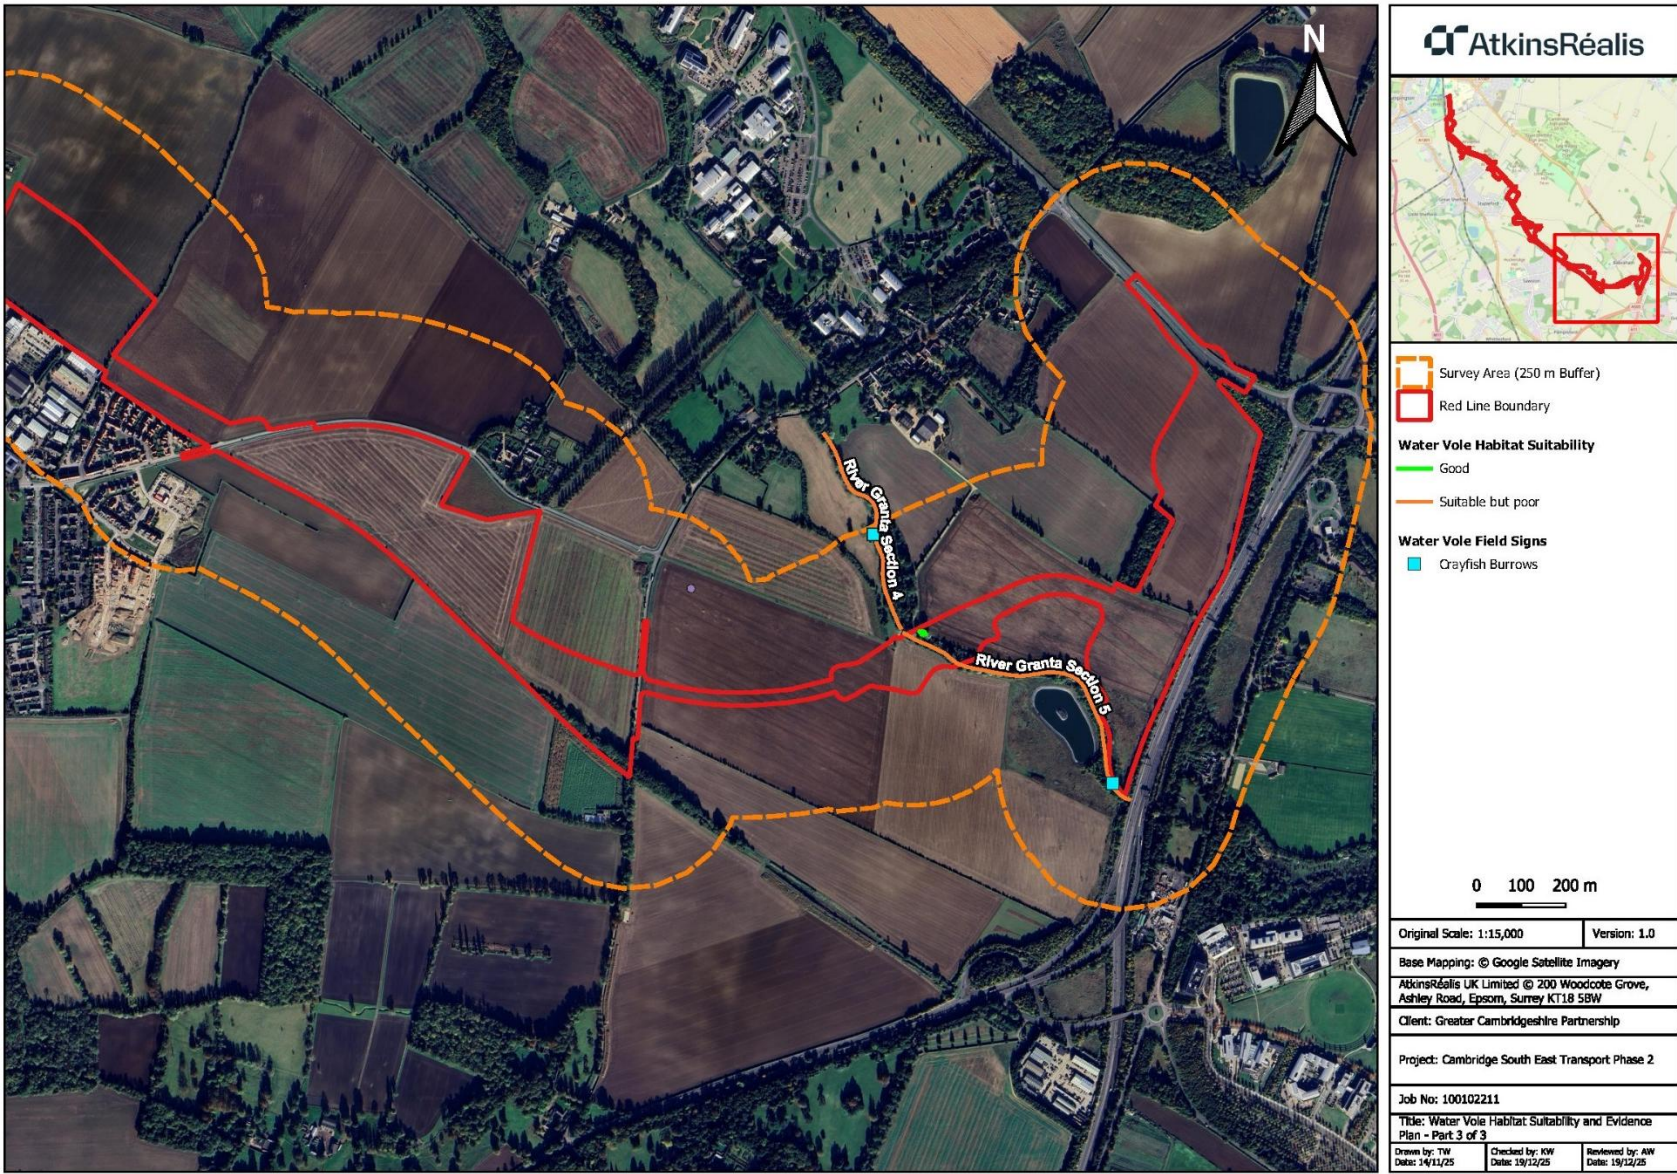
C.6 Figure C-6: Water Vole Habitat Suitability and Evidence Plans – Part 3 of 3

| River Reference | Results |
|---|---|
| River Granta at Stapleford | No signs of water vole activity were recorded on the River Granta at Stapleford during survey one.<br>During survey two several feeding stations were noted in stands of reed-canary grass and six burrows were recorded. A small number of latrines was also recorded. |

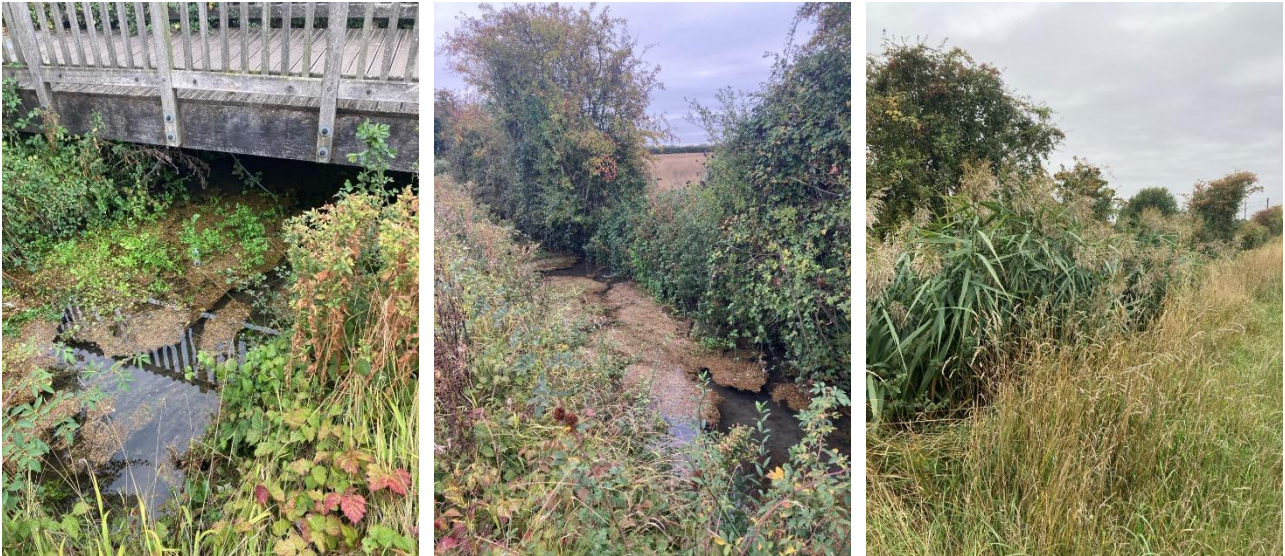
| Feature ID | Description of Habitat | Photo(s) |
|---|---|---|
| Hobson's Conduit | <p>Watercourse with clear, slow flowing water approximately 2 m wide and 0.5 m deep.</p> <p>Manmade trapezoidal watercourse, conveying chalk spring water from Nine Wells Local Nature Reserve to Hobson's Brook.</p> <p>Adjoining land is arable fields, with patches of longer grassland and is adjacent to a PROW.</p> | |

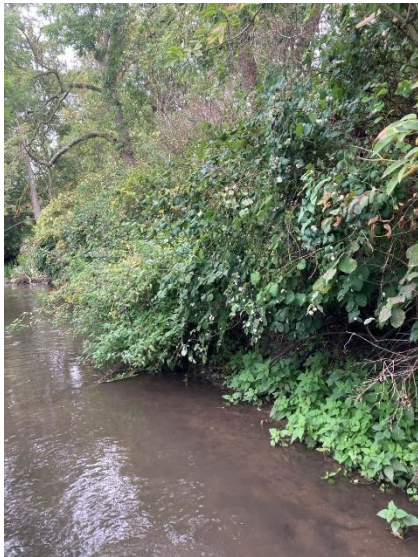
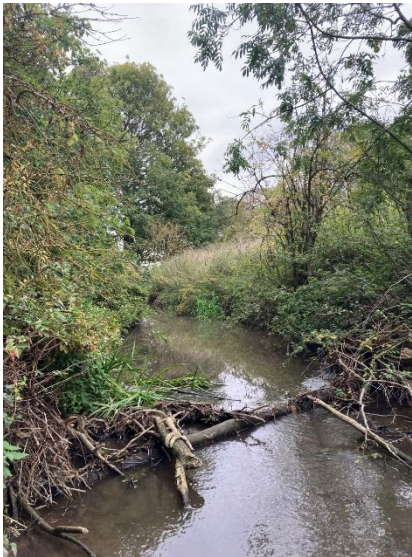
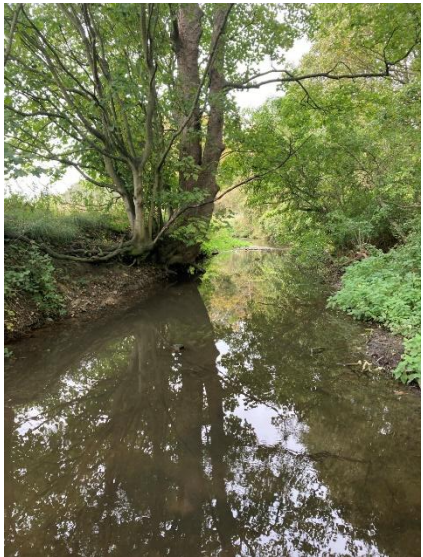
| Feature ID | Description of Habitat | Photo(s) | | |
|---|---|---|---|---|
| River Granta<br>Section 4 | <p>Section of the River Granta, with slow flow and approximately 3 m wide and 0.5 m deep at time of survey. Earth banks, very steep approaching vertical.</p> <p>Bankside vegetation cover was 20% with this mostly dominated by scrub and woodland areas.</p> | | | |

Sections 4 and 5 of the River Granta was considered suitable but poor habitat for water vole. No evidence of water vole was found along this section suggesting their absence from this stretch of the River Granta.

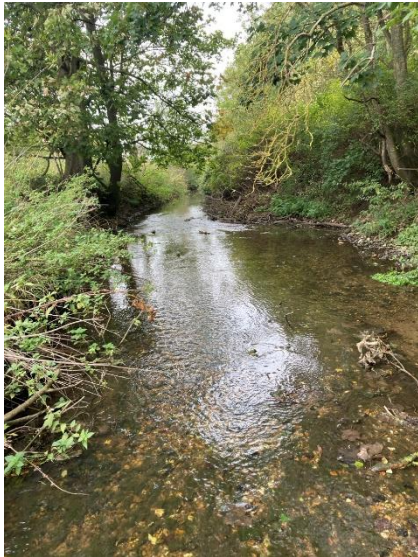
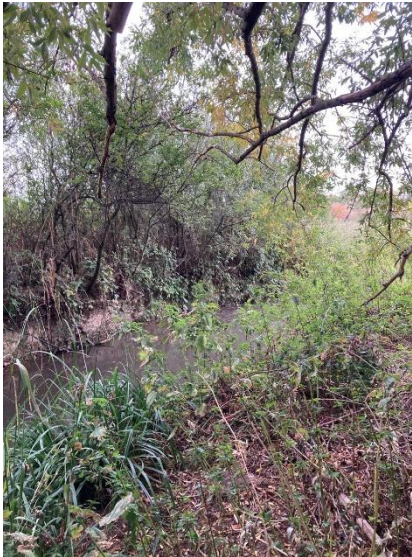
| Feature ID | Description of Habitat | Photo(s) | | |
|---|---|---|---|---|
| River Granta<br>Section 5 | <p>Section of the River Granta, with slow flow and approximately 3 m wide and 1 m deep at time of survey. Cobbled bed and quite stony banks, with the banks steep.</p> <p>Similar to Section 4.</p> | | | |

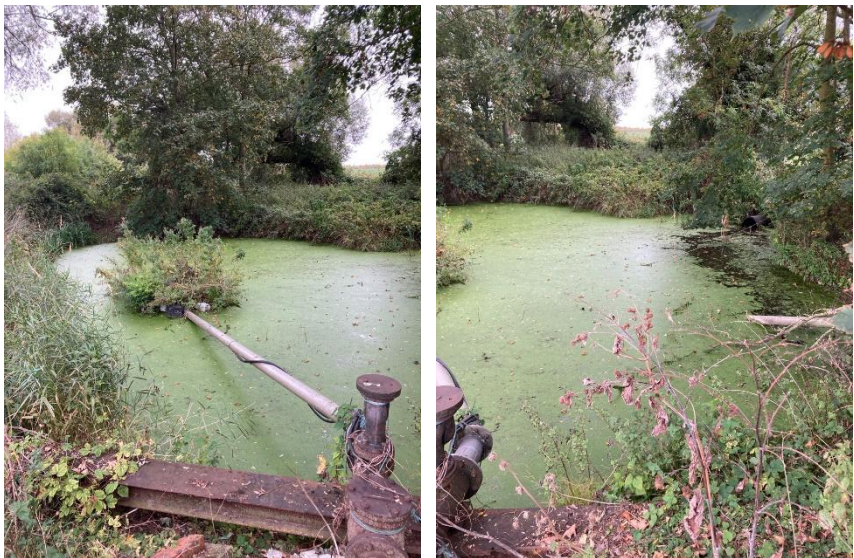
| Feature ID | Description of Habitat | Photo(s) |
|---|---|---|
| Pond 1 | <p>Small, shallow pond adjacent to the River Granta, with it likely an overflow from the river. The pond may temporarily dry during summer</p> <p>There is abundant bankside vegetation dominated by reed canary grass, brambles and nettle.</p> | |

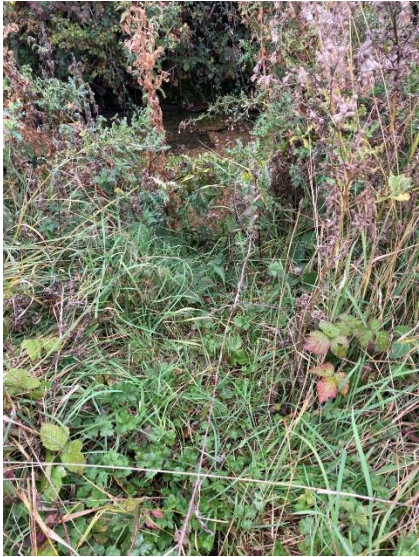
| Feature ID | Type of Evidence or Resting Site | Description | Photo(s) |
|---|---|---|---|
| Hobson's Conduit | Mammal Path | Path leading into the water; however, this is near a PROW and likely from dogs with no evidence of otter nearby. | |

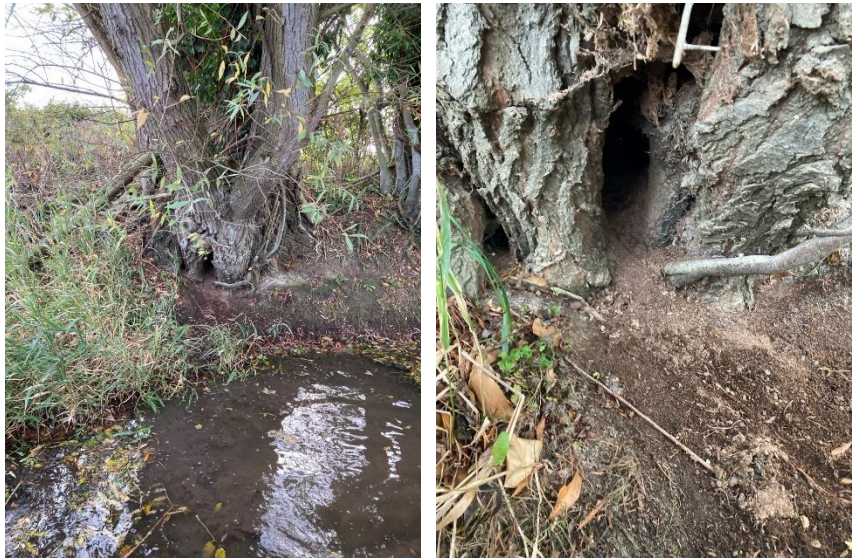
| Feature ID | Type of Evidence or Resting Site | Description | Photo(s) |
|---|---|---|---|
| River Granta Sections 1, 2 and 3 | Potential Holt | <p>Hole in base of willow adjacent to river. Root plate area outside of the hole flattened, with fresh spraint outside.</p> <p>Hole was assessed to be narrow, so possibly not ideal for larger otters. However, the hole seemed to be well-used.</p> <p>The feature was not assessed to be a high-status resting site due to no abundance of spraint within and a lack of odour. The feature may also be inaccessible during high flow. Deemed to be a moderate-status resting site.</p> | |

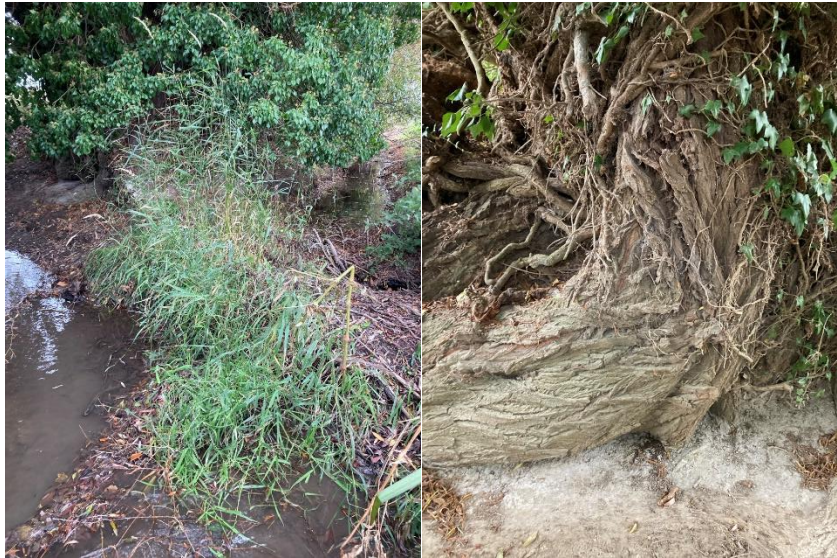
| Feature ID | Type of Evidence or Resting Site | Description | Photo(s) |
|---|---|---|---|
| River Granta Sections 1, 2 and 3 | Potential Hover | <p>A large area containing a low tree and flattened grassy patch. A range of spraint age classes were present throughout but cover was generally limited.</p> <p>Deemed to be a moderate-status resting site.</p> | |

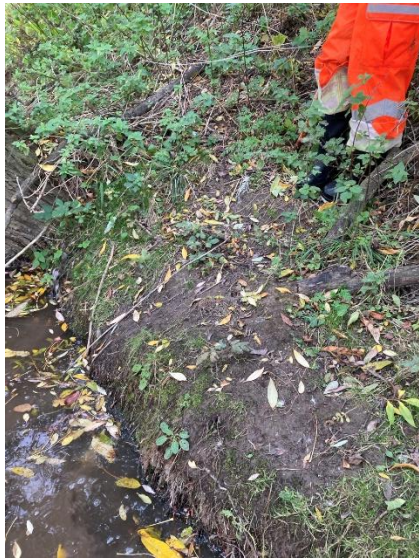
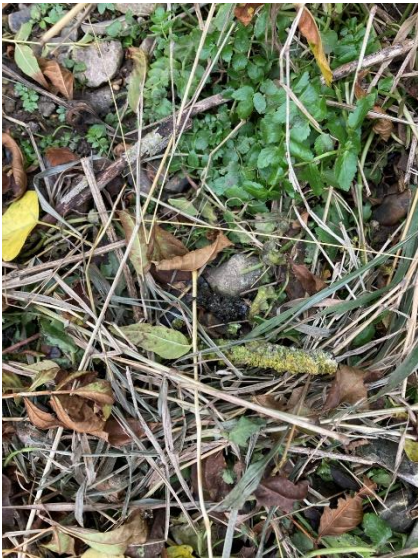
| Feature ID | Type of Evidence or Resting Site | Description | Photo(s) |
|---|---|---|---|
| River Granta Sections 1, 2 and 3 | Potential Couch | Multiple spraints from fresh to old, with castling, flattened vegetation and compacted earth surrounding the site.<br><br>Low-status resting site, due to lack of refuge opportunities. | |

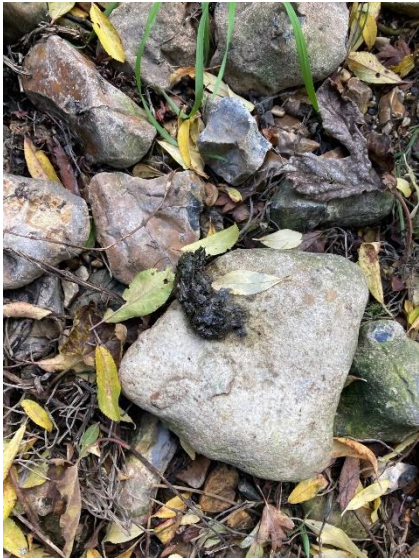
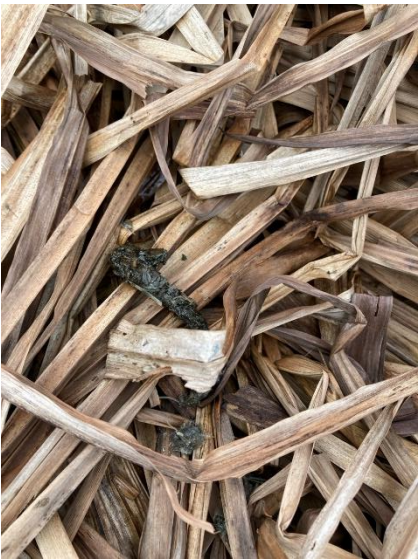
| Feature ID | Type of Evidence or Resting Site | Description | Photo(s) |
|---|---|---|---|
| River Granta Sections 1, 2 and 3 | Fresh Spraint | Numerous fresh spraint was recorded along these sections of the River Granta. | |

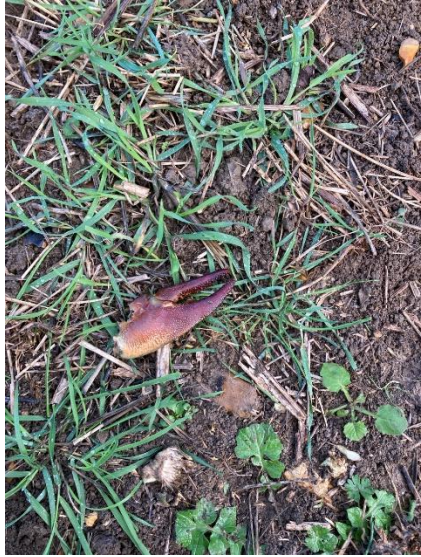
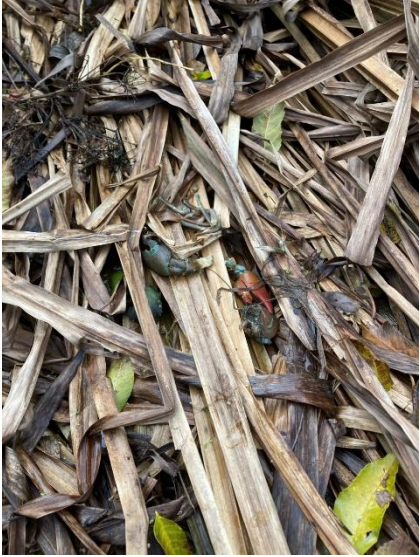
| Feature ID | Type of Evidence or Resting Site | Description | Photo(s) |
|---|---|---|---|
| River Granta Sections 1, 2 and 3 | Feeding Remains | Three separate piles of feeding remains, all comprised of signal crayfish, were recorded throughout these sections of the River Granta. | |

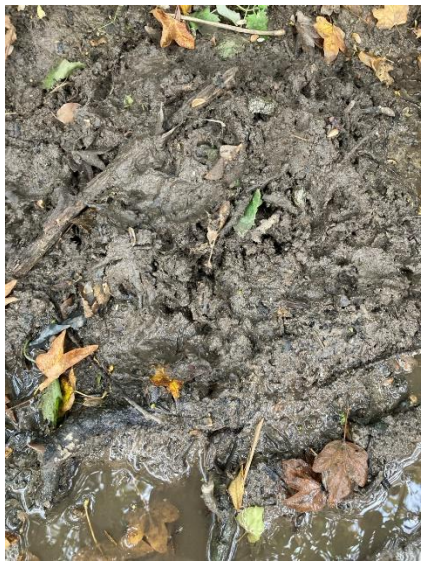
| Feature ID | Type of Evidence or Resting Site | Description | Photo(s) |
|---|---|---|---|
| River Granta Sections 1, 2 and 3 | Footprint | Otter footprint present within mud along riverbank. | |

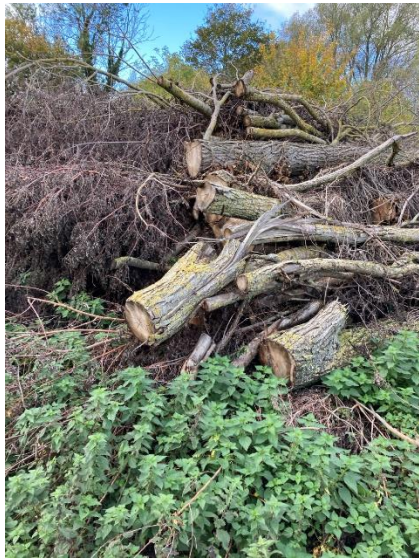
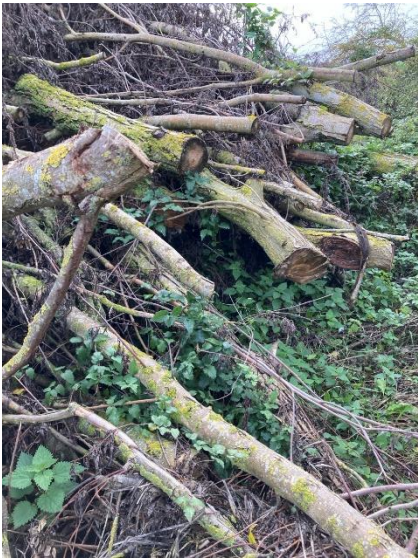
| Feature ID | Type of Evidence or Resting Site | Description | Photo(s) |
|---|---|---|---|
| River Granta Sections 4 and 5 | Potential Holt | Large log pile located near to this section of the River Granta. No evidence to suggest any use by otter but has resting site potential as a holt in voids beneath the log pile. | |

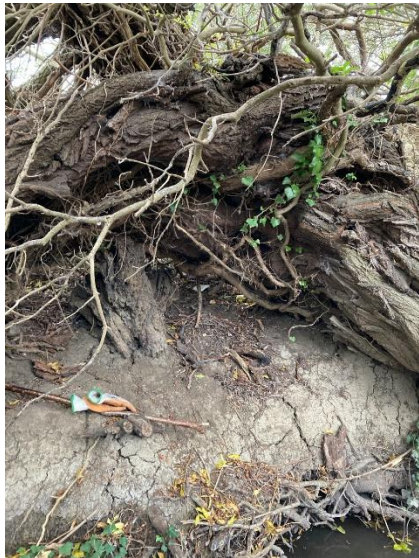
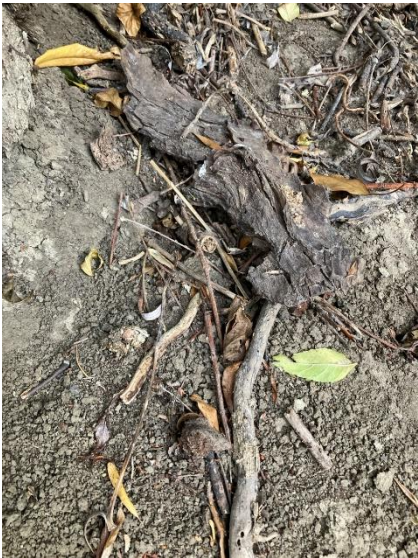
| Feature ID | Type of Evidence or Resting Site | Description | Photo(s) |
|---|---|---|---|
| River Granta Sections 4 and 5 | Potential Hover | Half covered area with old, dry fragmented spraint within. However, no evidence to suggest frequent or recent use so deemed low-status resting site. | |

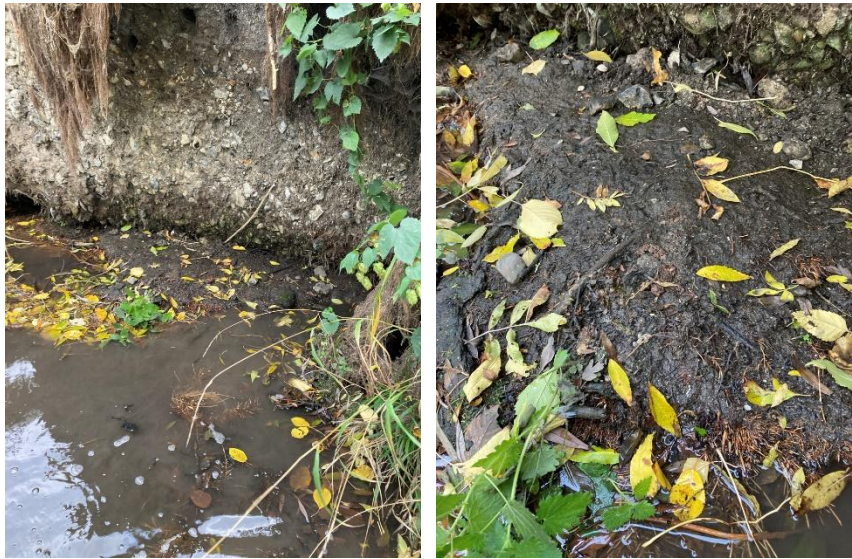
| Feature ID | Type of Evidence or Resting Site | Description | Photo(s) |
|---|---|---|---|
| River Granta Sections 4 and 5 | Potential Couch | <p>Spraints (fresh to old), otter prints and otter impressions on muddy bank. Suggests frequent use by otter as a lying up spot. Deemed to be a moderate-status resting site</p> <p>Feature extends underneath root plate but is open on both sides; therefore, no possibility of a hole or higher status resting site.</p> | |

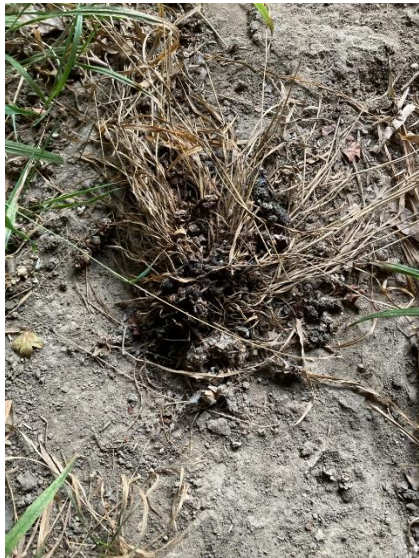
| Feature ID | Type of Evidence or Resting Site | Description | Photo(s) |
|---|---|---|---|
| River Granta Sections 4 and 5 | Fresh Spraint | <p>Multiple fresh spraints along these sections of the River Granta, including multiple spraints underneath the A11 road bridge ranging in age between fresh and old. Indicates this is likely a temporary 'stop off' feature for territory marking.</p> | |

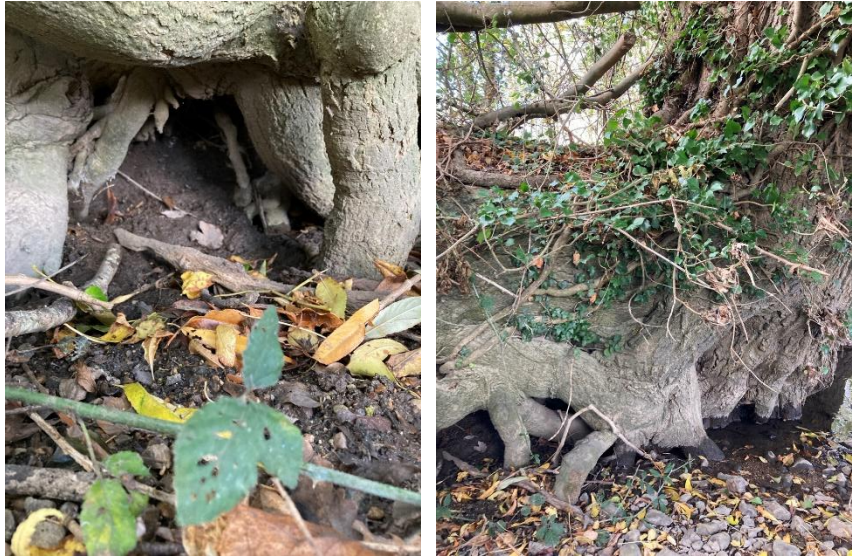
| Feature ID | Species and Type of Evidence | Description | Photo(s) |
|---|---|---|---|
| River Granta Sections 4 and 5 | American mink hole and scat | Small hole in base of tree roots with fresh mink scat present inside. | |

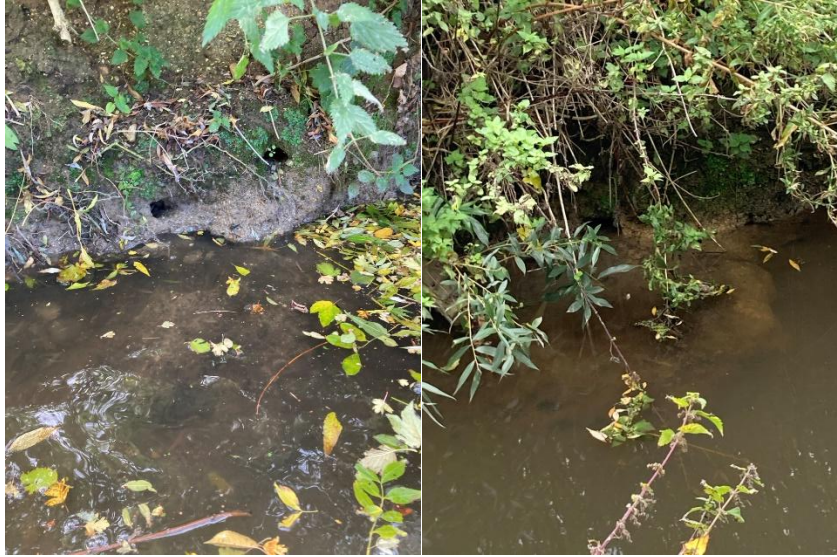
| Feature ID | Species and Type of Evidence | Description | Photo(s) |
|---|---|---|---|
| River Granta Sections 1, 2, 3, 4 and 5 | Signal crayfish burrows | Several observations of signal crayfish burrows along the River Granta, with their presence confirmed by several recordings of otter feeding remains comprised of signal crayfish. | |

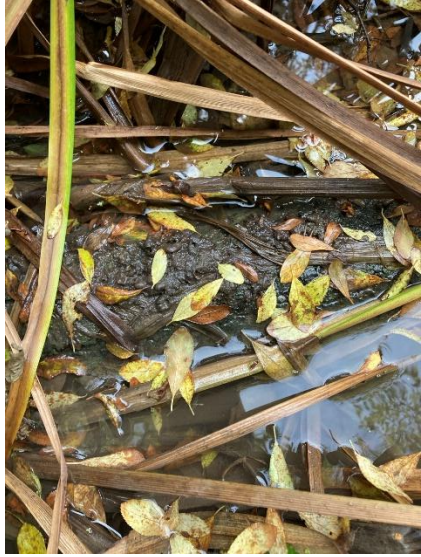
| Feature ID | Species and Type of Evidence | Description | Photo(s) |
|---|---|---|---|
| River Granta Section 3 | Brown rat droppings | Identified as rat droppings due to smell and colour. | |
