# The Cambourne to Cambridge Order

## Technical Report 14: Arb Report

| Document<br>Reference | CtoC-11-TR14 |
| Author | Greater Cambridge Partnership |

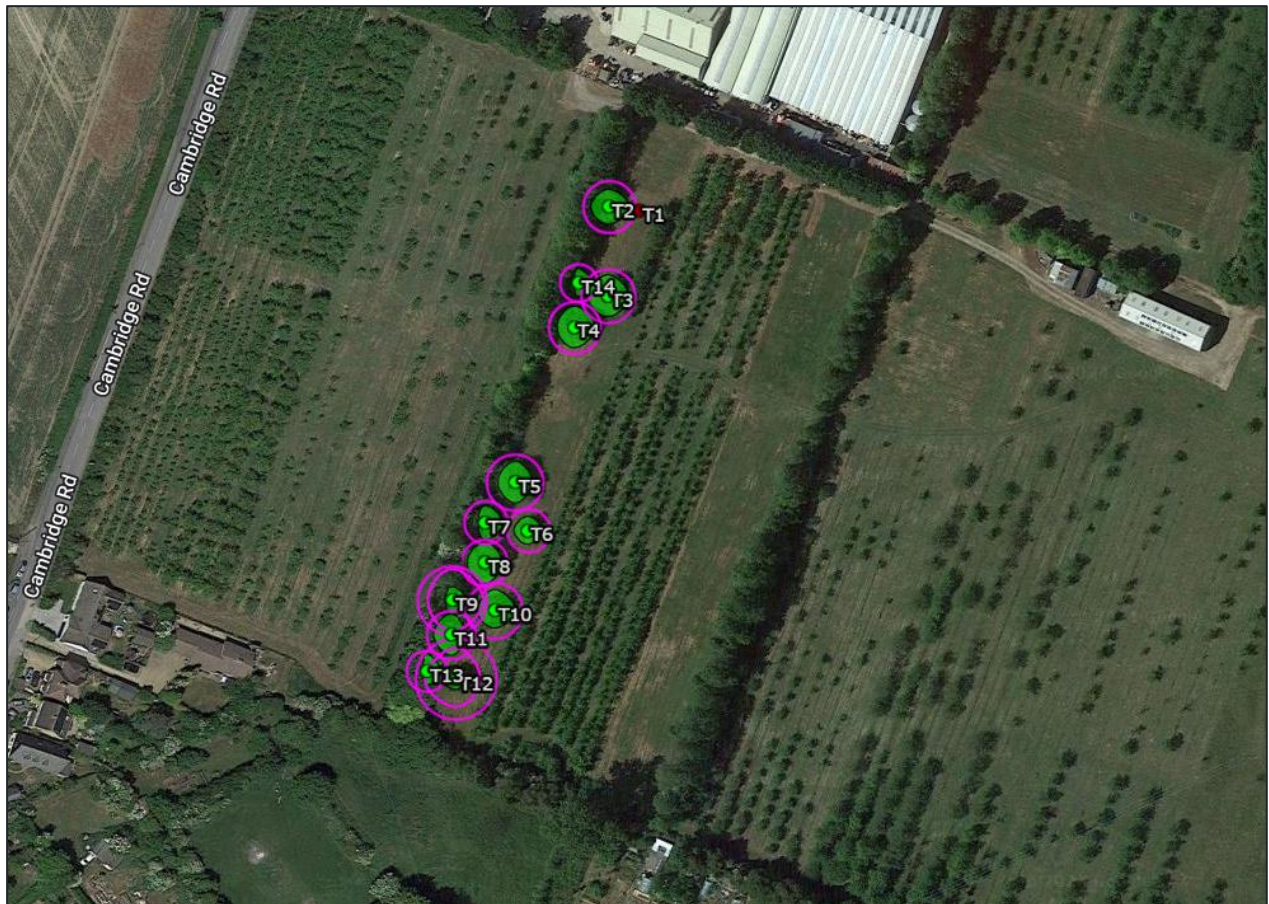
**Plate TR14-4-1 - Coton Orchard, apple trees**

- 4.1.3. One area of the orchard contains old trees, believed to date from the foundation of the orchard (or soon after) in 1922 (see **Plate TR14-4-1**).

- 4.1.4. There are 13 live specimens of these oldest apple tree. An elder is growing from the stump of what was once a fourteenth tree (referenced as T1 but not qualifying as a tree to be classified under BS5837). Detailed analysis of these trees in terms of their potential veteran status is provided in **Appendix TR14.1**. In summary, the approach uses different assessment tools to determine veteran status, with the RAVEN2 method (Forbes-Laird, 2023) providing structure to the assessment, with other approaches employed to inform the overall assessment as necessary. RAVEN2 follows a five-step process:

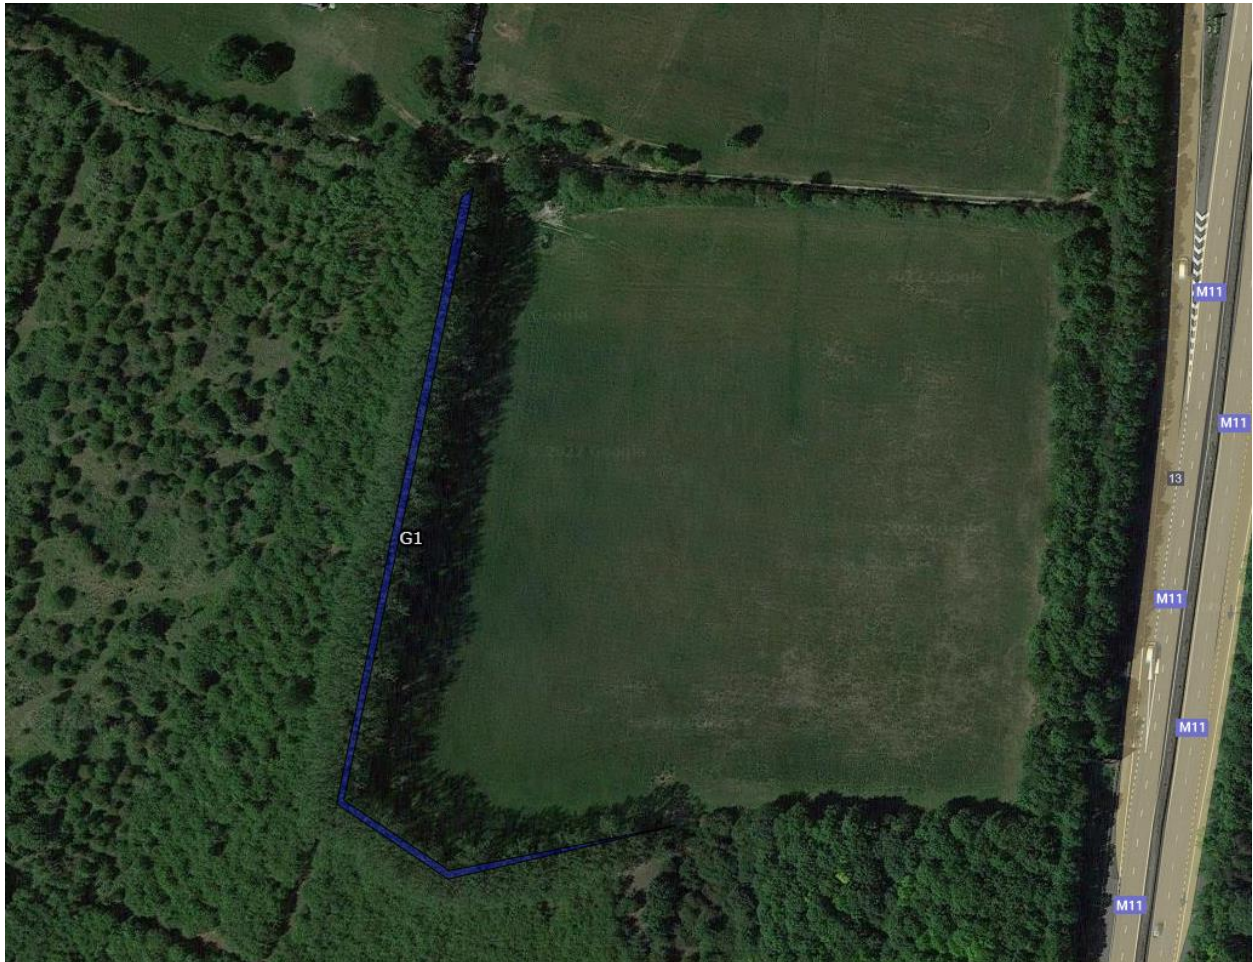
Plate TR14-5-1 - Polar trees at Coton Orchard

- 5.1.1. The fruit trees of Coton Orchard give way to low quality scrub woodland in the eastern parcel of the site (see **Plate TR14-5-1**). On the eastern boundary of the land parcel is a line of poplar trees at very close spacing. The stems are typically between 1m and 3m separation and grow along the top of a ditch. The group has an understorey of hawthorn.

- 5.1.2. A small number of the poplar trees have been blown over. The closely spaced trees and the ditch have significantly restricted rooting and incipient tree instability is anticipated. The trees are tall to 26m and have stem diameters of up to 900mm (with most stems in the range 600-700mm). Collectively the trees form a moderate quality/B category group but individually the trees are of low quality/C category.
