# The Cambourne to Cambridge Order

## Environmental Statement Addendum

# Cambourne to Cambridge

## Environmental Statement (Addendum)

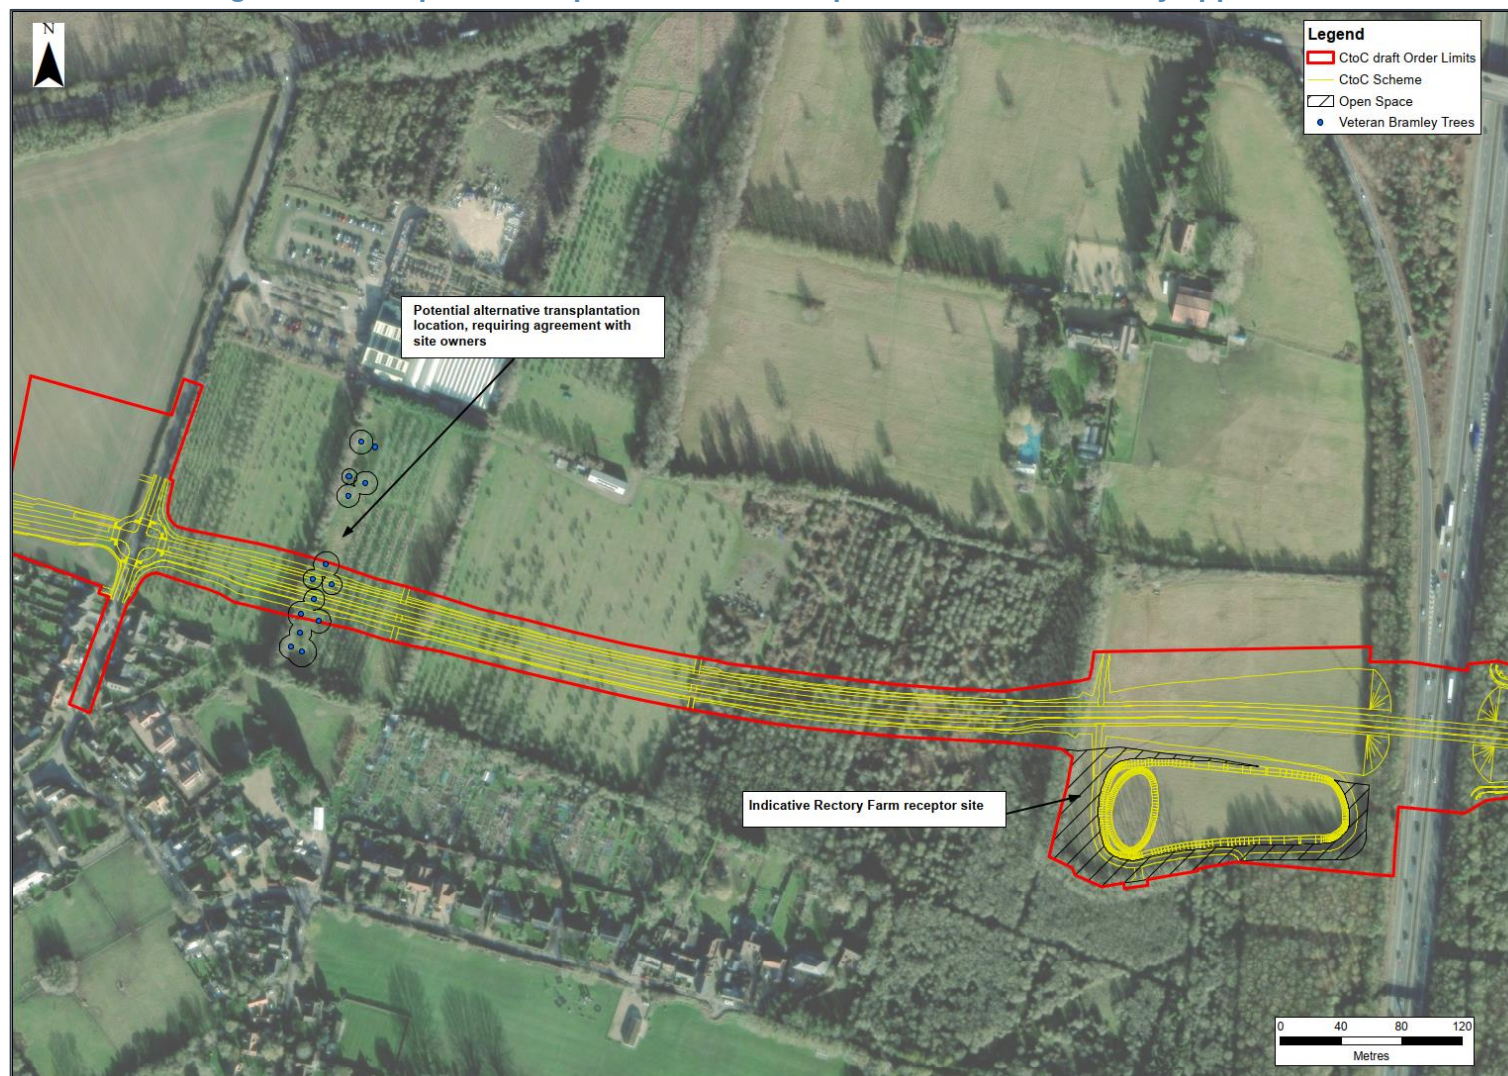
Figure 2-2 - Proposed receptor sites for transplanted veteran Bramley apple trees

- 2.3.26. A photographic record will be maintained over each tree from the first site visit until the end of aftercare. In addition annual extension growth will be recorded. BRIX levels will be recorded in spring and summer. Each visit, including aftercare, will generate a brief report (of works, comments on trees and images).
- 2.3.27. The proposed site for transplanting within the draft Order Limits, together with the potential alternative within the orchard, are shown in **Figure 2-2**.
