# The Cambridge South East Transport Order

### Appendix 9.4 – Contaminated Land Risk Assessment

# Cambridge South East Transport Scheme

## Contaminated Land Risk Assessment - Historical Landfills

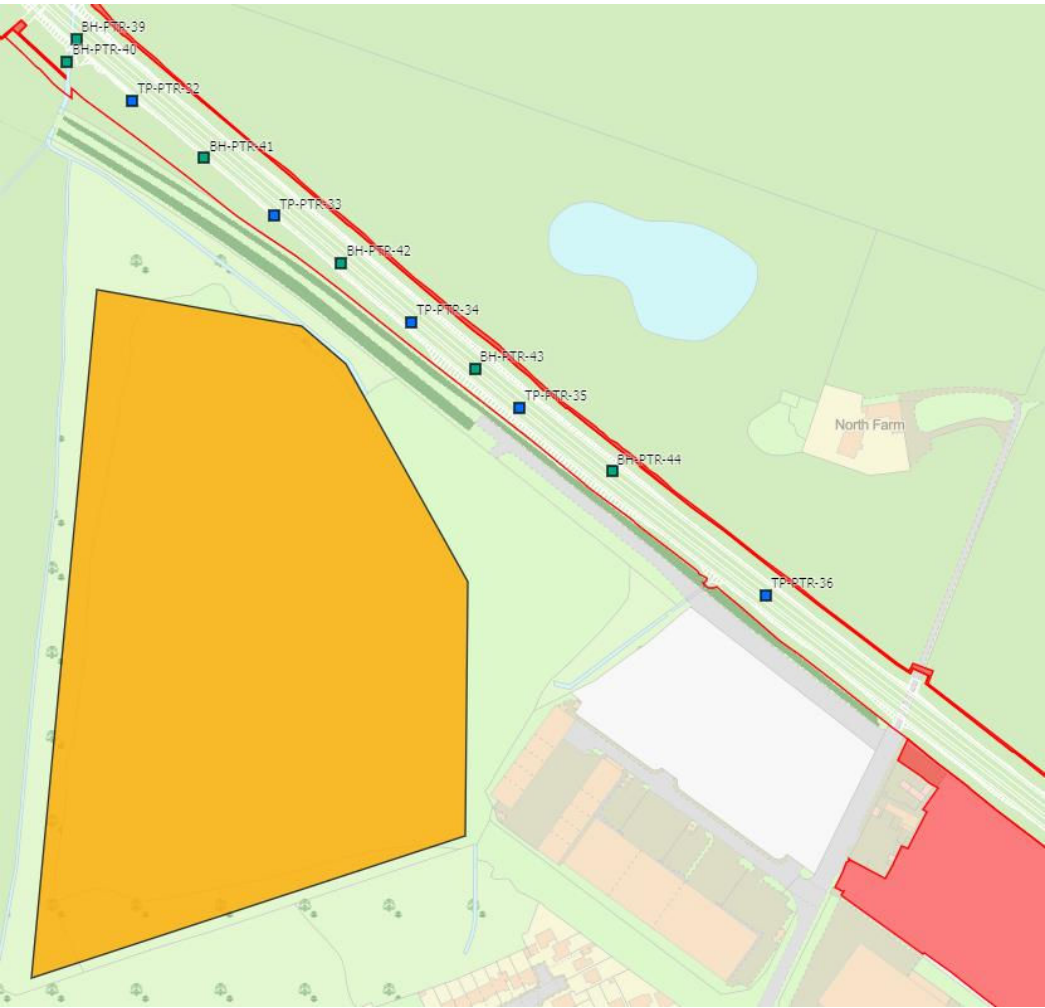
Figure 2.1: Sindalls Landfill

Note: orange polygon indicates historic landfill site. Red line indicates red line boundary of scheme. Red polygons indicate temporary land take areas.

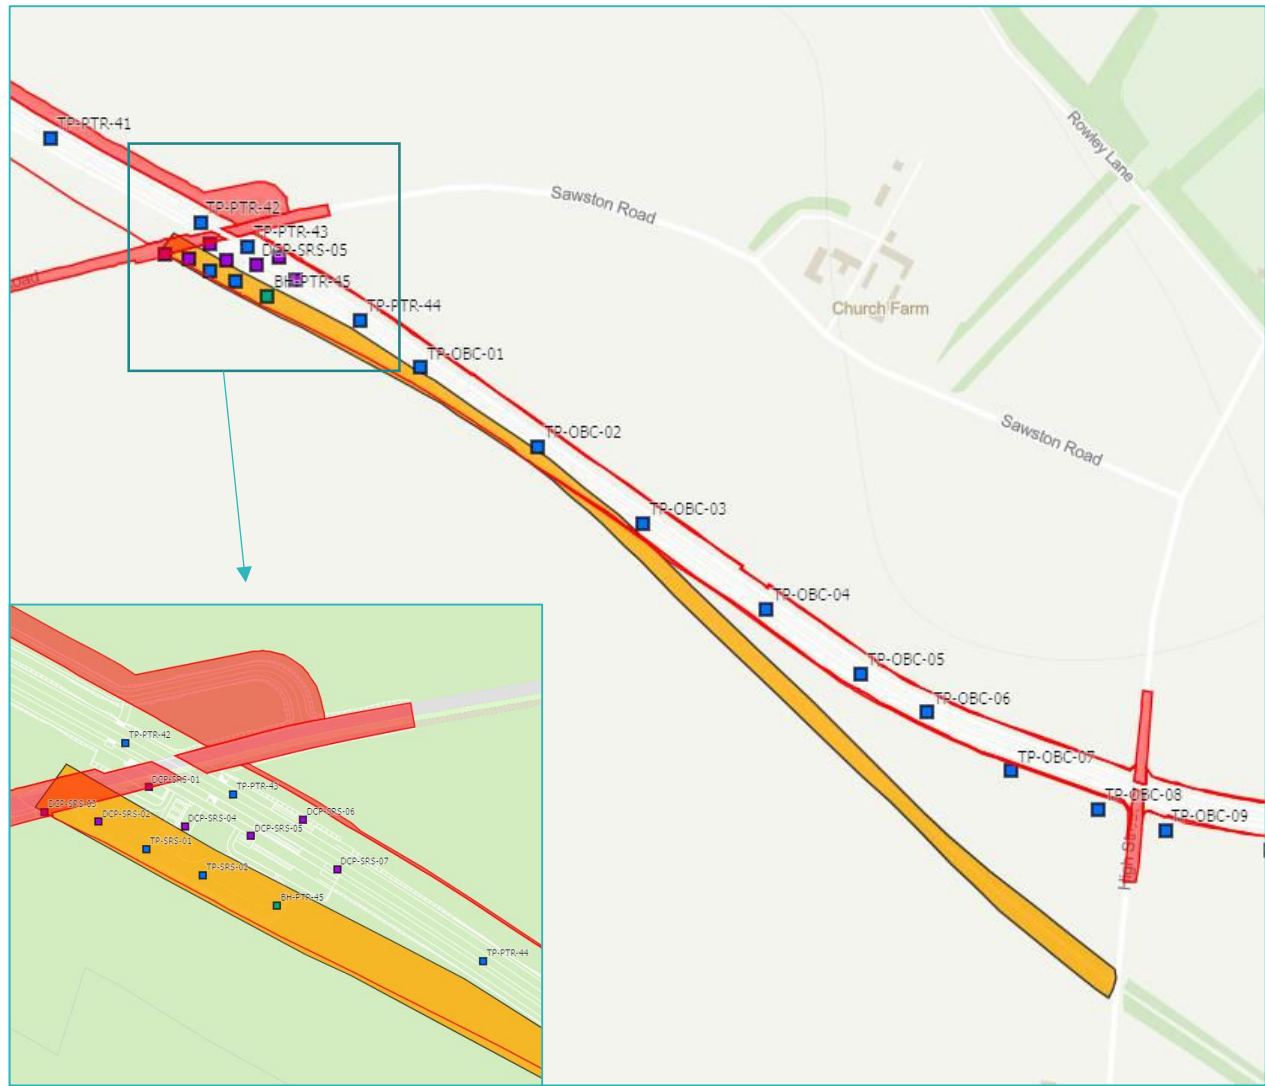
Figure 2.2: Home Farm Landfill – 1

Note: orange polygon indicates historic landfill site. Red line indicates red line boundary of scheme. Red polygons indicate temporary land take areas.

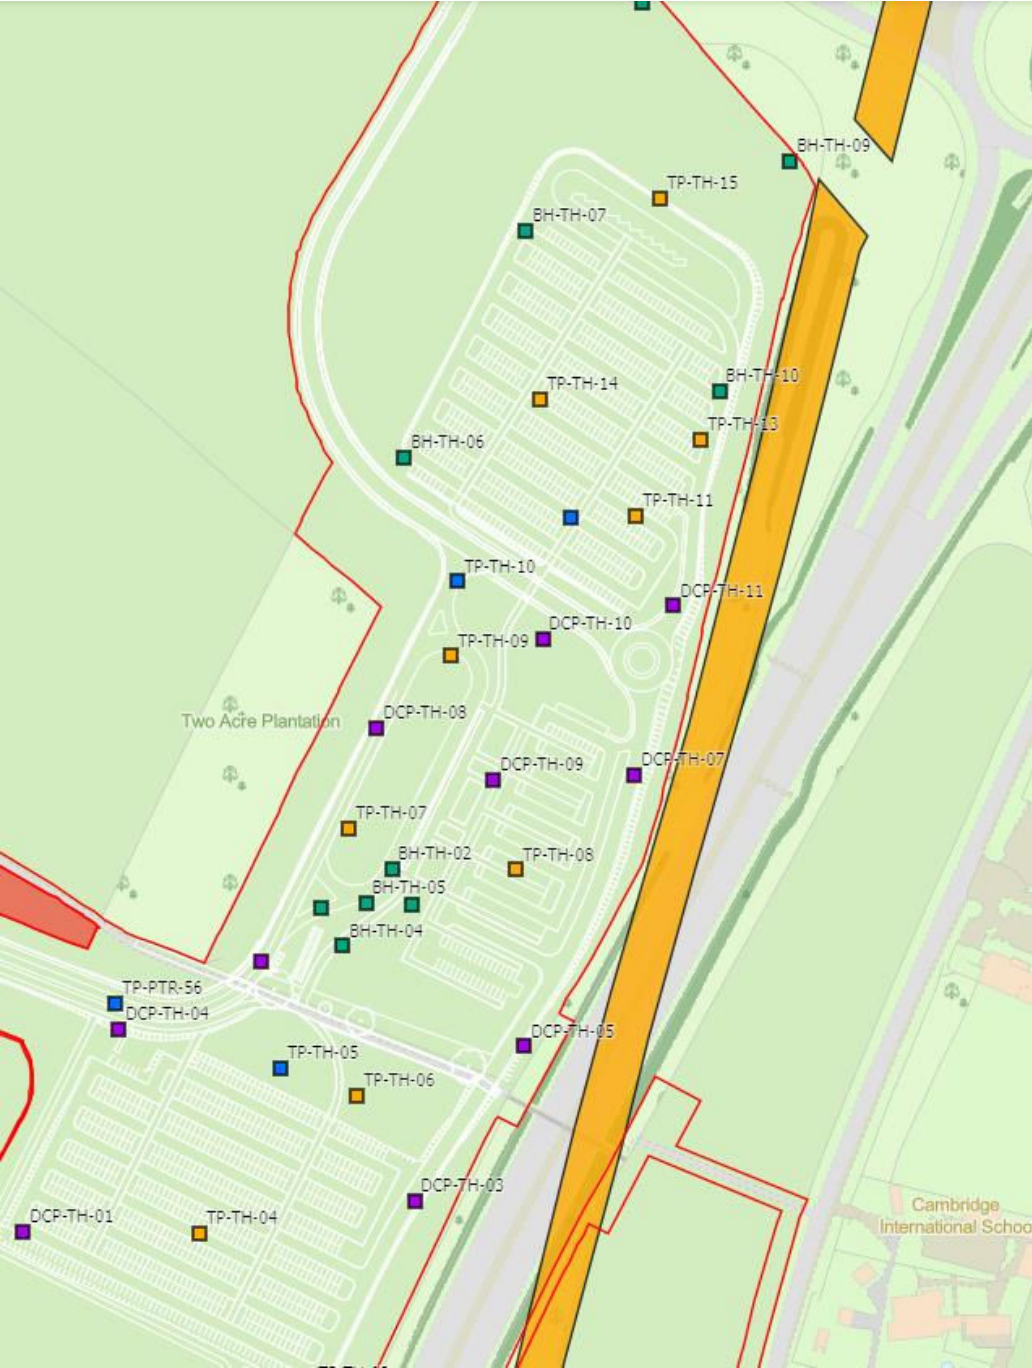
Figure 2.3: Home Farm Landfill - 2

Note: orange polygon indicates historic landfill site. Red line indicates red line boundary of scheme. Red polygons indicate temporary land take areas.

The linear Home Farm 2 historical landfill appears to cross the River Granta and other drains located east of the A11 (see Figure 2.3). However, the river is not affected by the landfill (ie. not covered by the landfill) as it is on an embankment in this area.
