# **Cambourne to Cambridge**

Otter and Water Vole Report

**Project no. 70086660**

**Our Ref. No. 70086660-OTTWV-01**

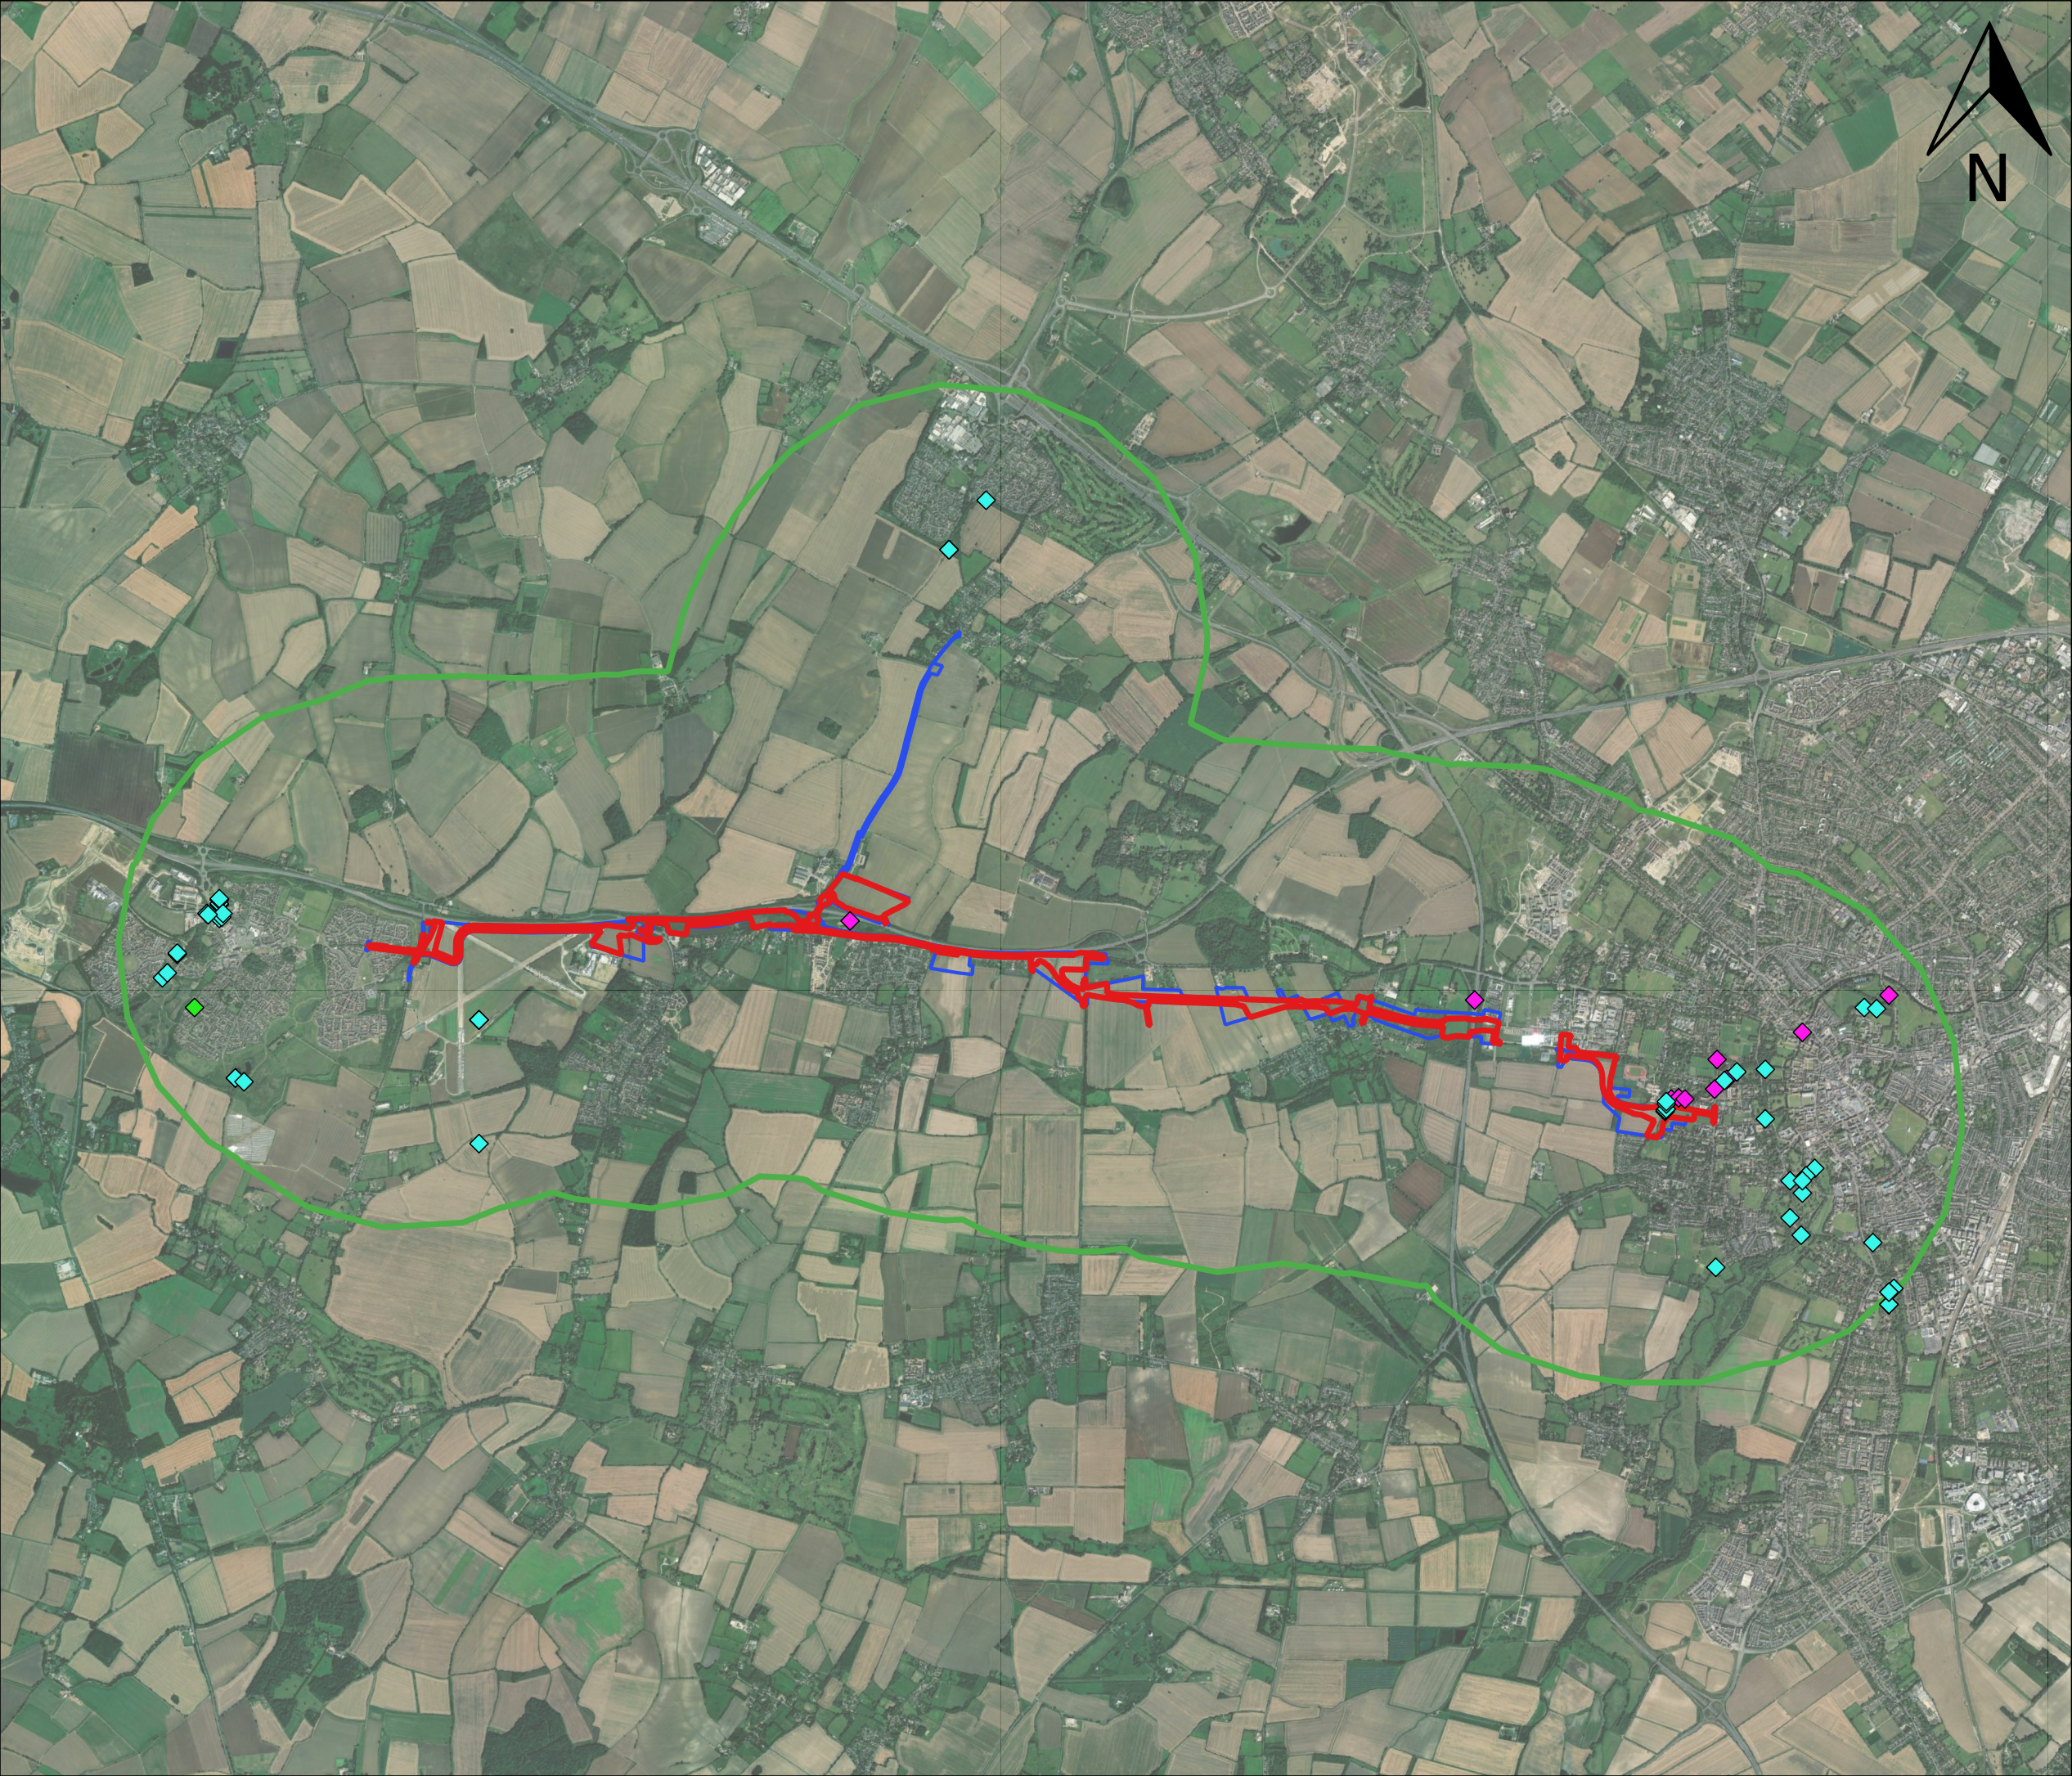
## 2022 Desk Study Results

- 3.1.1. An updated ecological desk study was completed in 2022. As part of this study, records of any notable or legally protected species, including Otter and Water Vole, from within the Study Area were requested from CPERC. Records of American Mink were also requested due to their known predation on Water Vole. Records from the last 10 years were included in this report. The Study Area for the desk study was defined as a 2km radius of the Scheme, as shown in **Annex A**.

- 4.2.1. The Desk Study returned 16 records of Otter within the 2km Study Area (see **Annex A**). The majority of Otter records are located in Cambridge, either in or around the River Cam and its tributaries, or the Bin Brook. A single Otter record was returned as roadkill on the M11 west of Cambridge, and further to the west, there was an Otter record by P2.

- 4.2.2. The Desk Study also returned 53 records of Water Vole within the 2km Study Area (see **Annex A**). Similar to the Otter records, the majority of Water Vole records are clustered in or around the River Cam and Bin Brook. A second cluster of Water Vole records also exist in Cambourne centre approximately 890m to the east of the Scheme Alignment. Numerous other records for Water Vole were recorded across the Study Area, with one record on Bourn Airfield ~730m south of the Scheme Alignment, and one record approximately 440m to the south of the airfield. Two further Water Vole records were returned in Bar Hill, approximately 415m north of the Scheme Alignment.

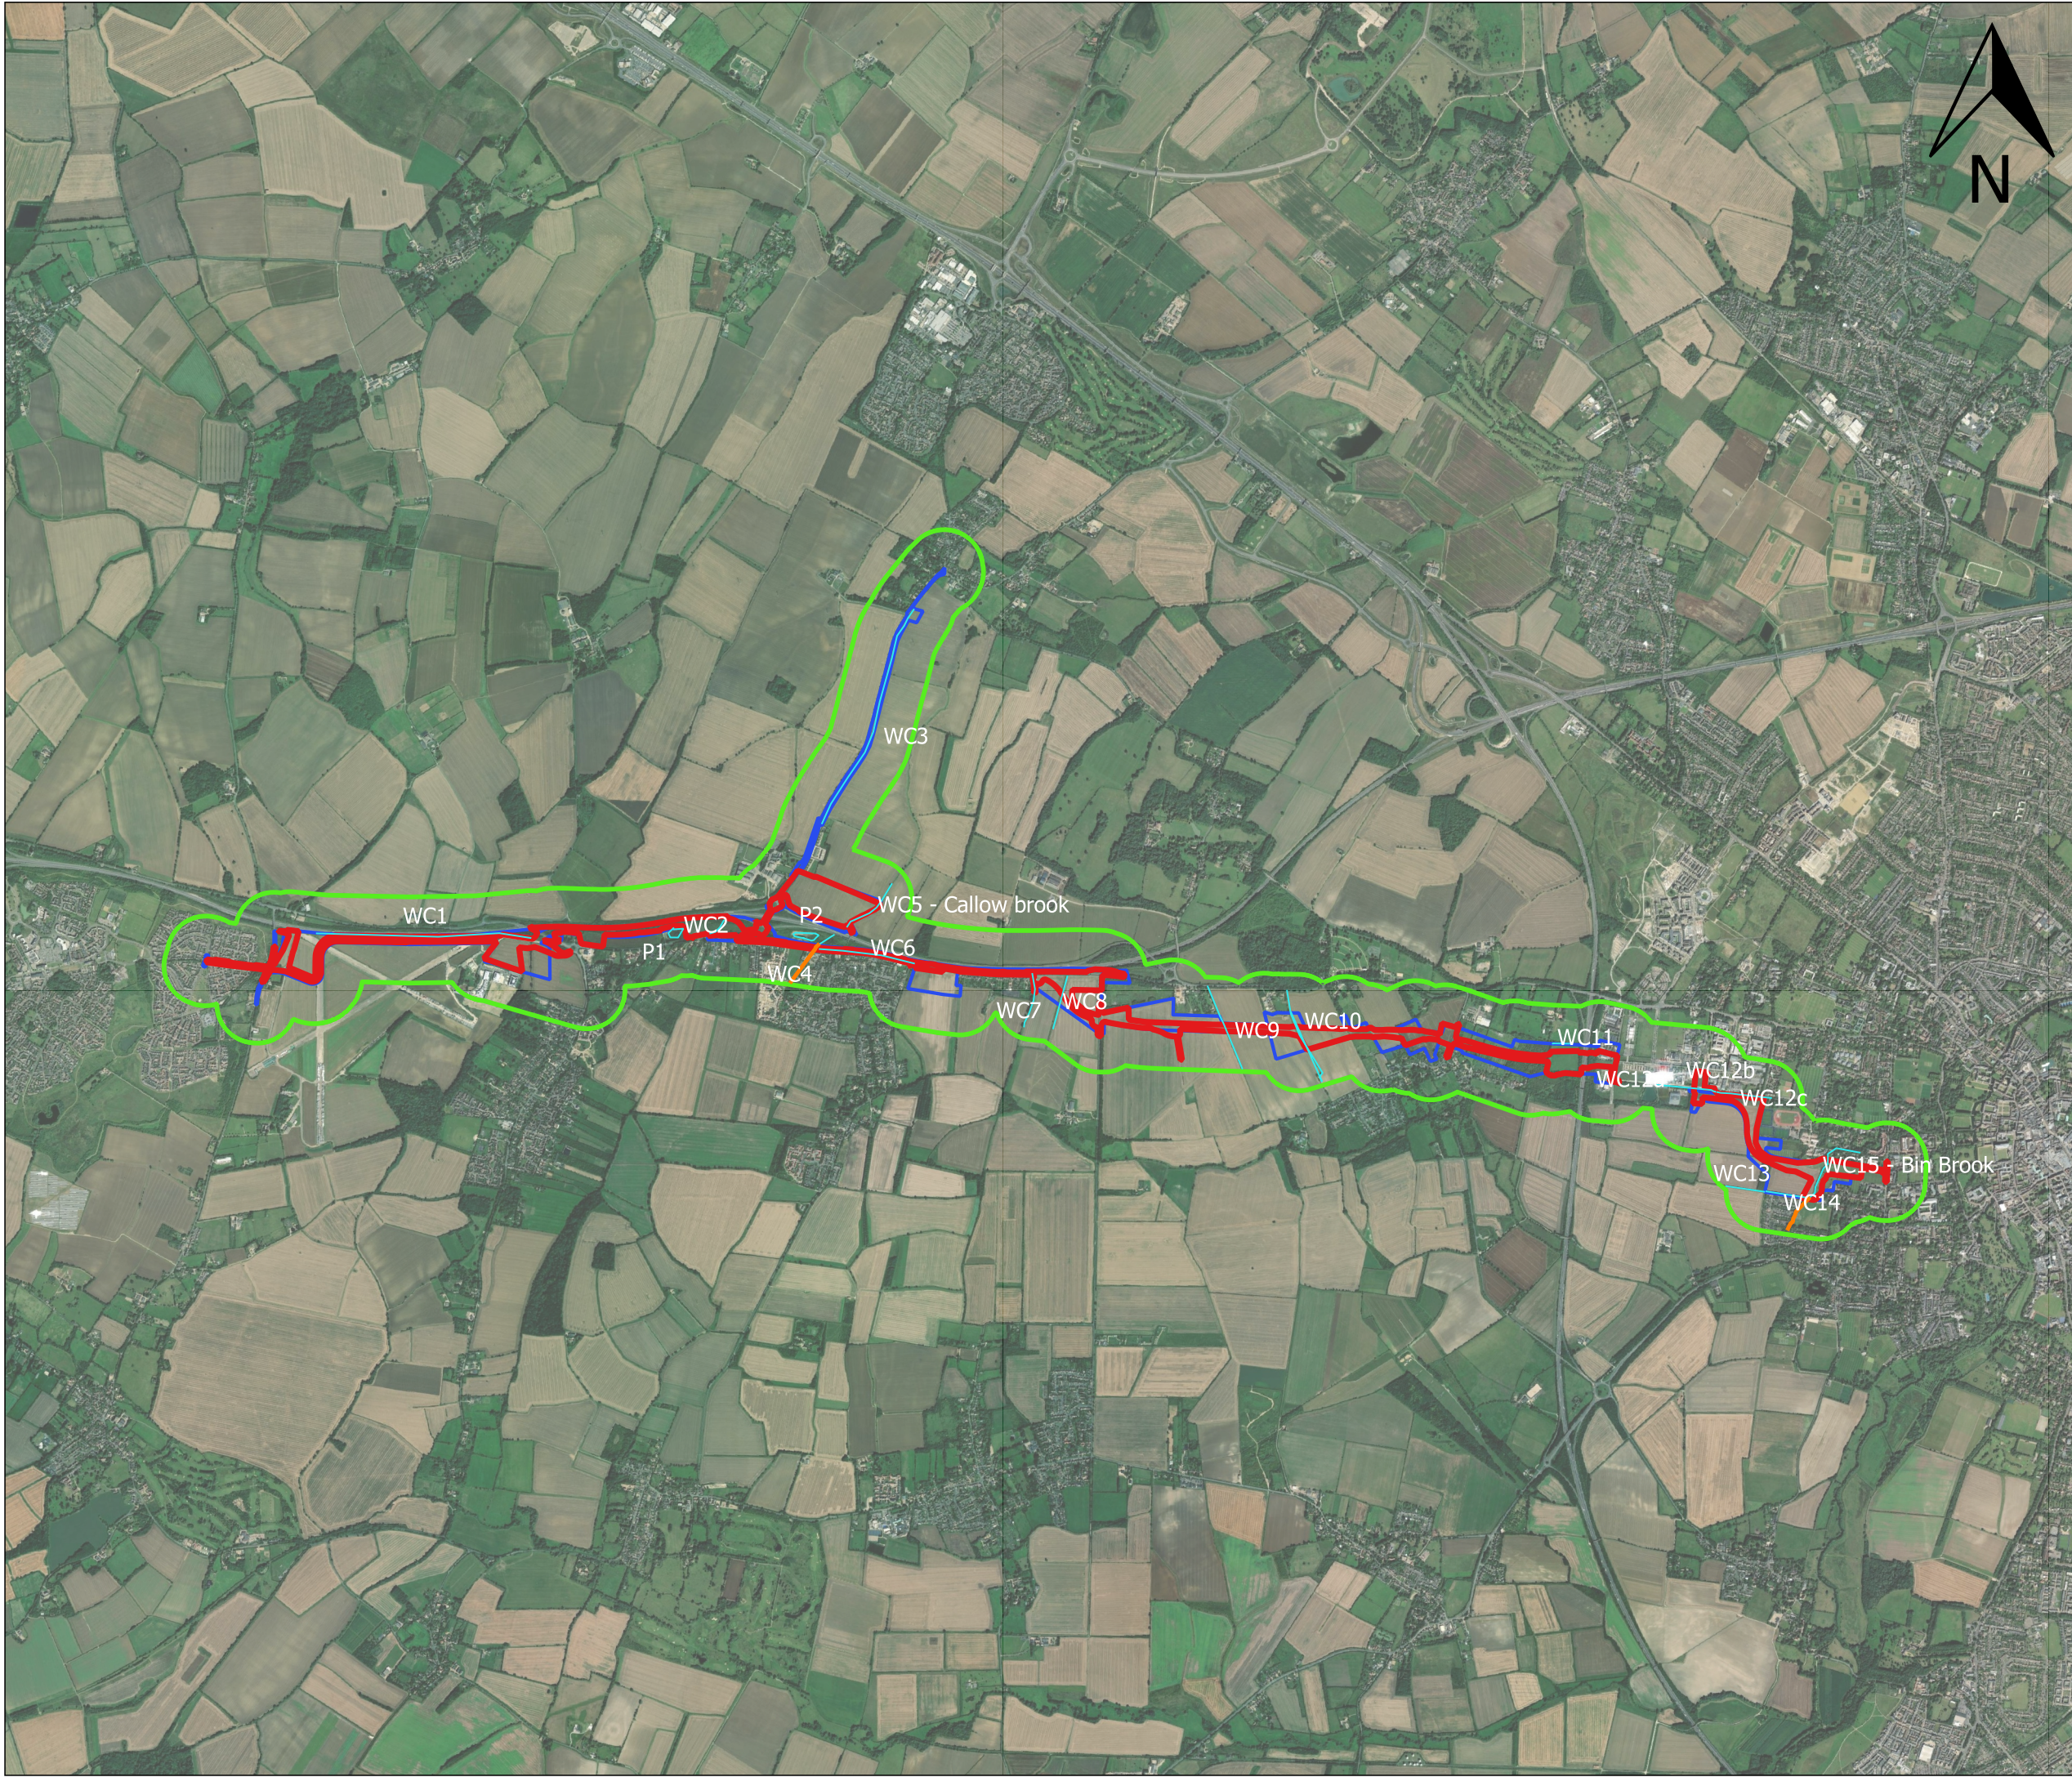
## Otter and Water Vole Survey Area

- 3.2.1. All watercourses identified as suitable habitat in the Survey Area were subject to detailed Otter and Water Vole survey. The watercourses are labelled WC1-WC15, with the exception of two ponds, labelled as P1 and P2. WC4 and WC5 are known locally as 'Callow Brook' and WC15 is known locally as 'Bin Brook'. These terms will be used hereafter to describe these watercourses, where Callow Brook is split into Callow Brook South (WC4) and Callow Brook North (WC5). All watercourses are located throughout the Scheme. The locations of the watercourses are shown in **Annex B**.

- 3.2.5. The Survey Area was informed by guidance in The Water Vole Mitigation Handbook (Dean, Strachan, Gow, & Andrews, 2016) which recommends a field survey area of between 200m and 500m upstream and downstream for a scheme with the potential for permanent impacts affecting more than 50m of watercourse. The Survey Area comprised 250m sections up and downstream from the Scheme Alignment. This also included all directly connected water features and associated riparian habitat. The Survey Area extents are shown in **Annex B**.

- 4.3.1. The waterbodies surveyed comprised 15 watercourses set within a combination of fallow arable and intensive arable/crops. The waterbodies also include two balancing ponds between St Neots' Road and the A428. The locations of the watercourses and ponds are shown in **Annex B**.

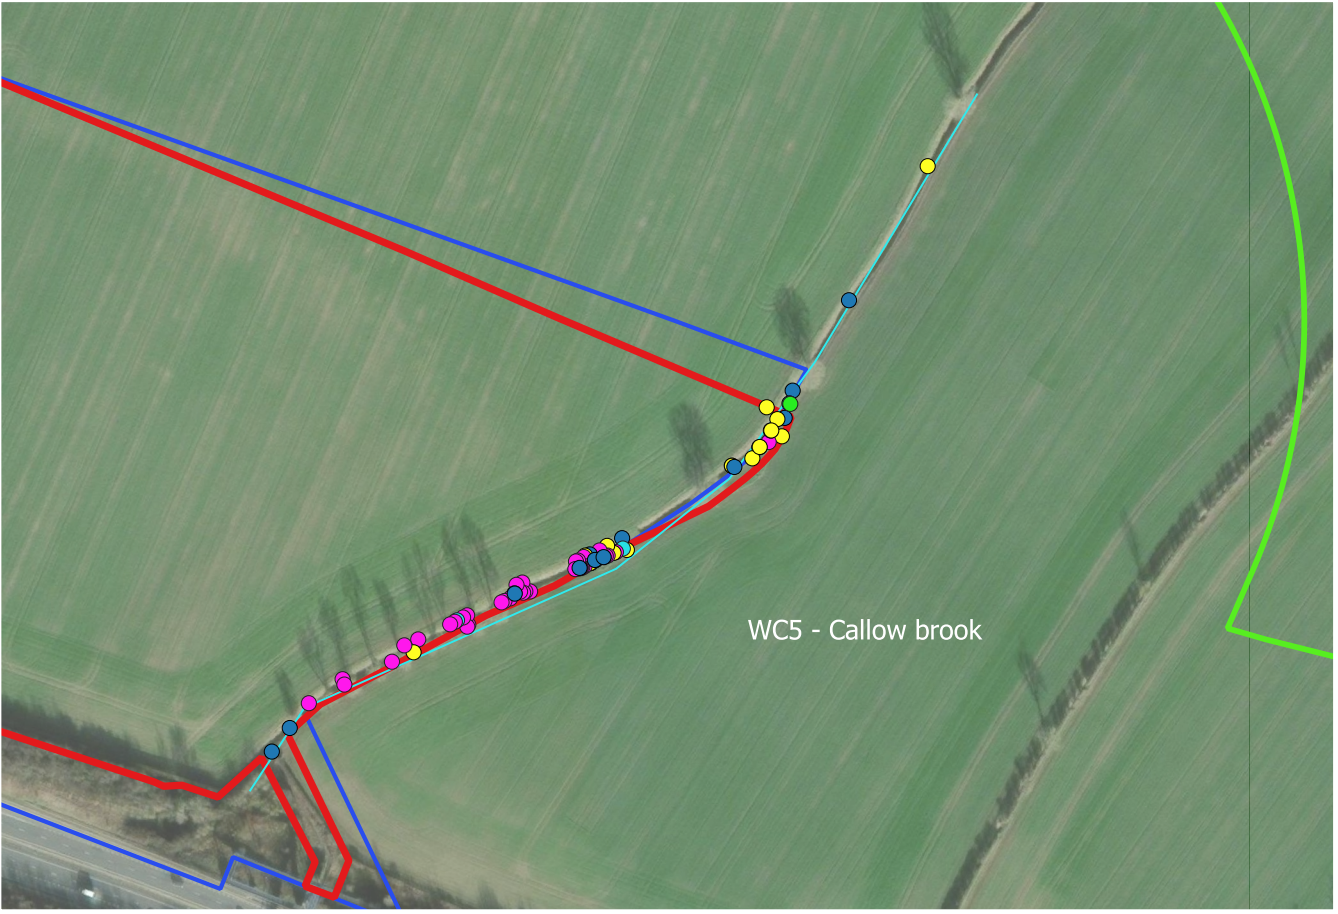
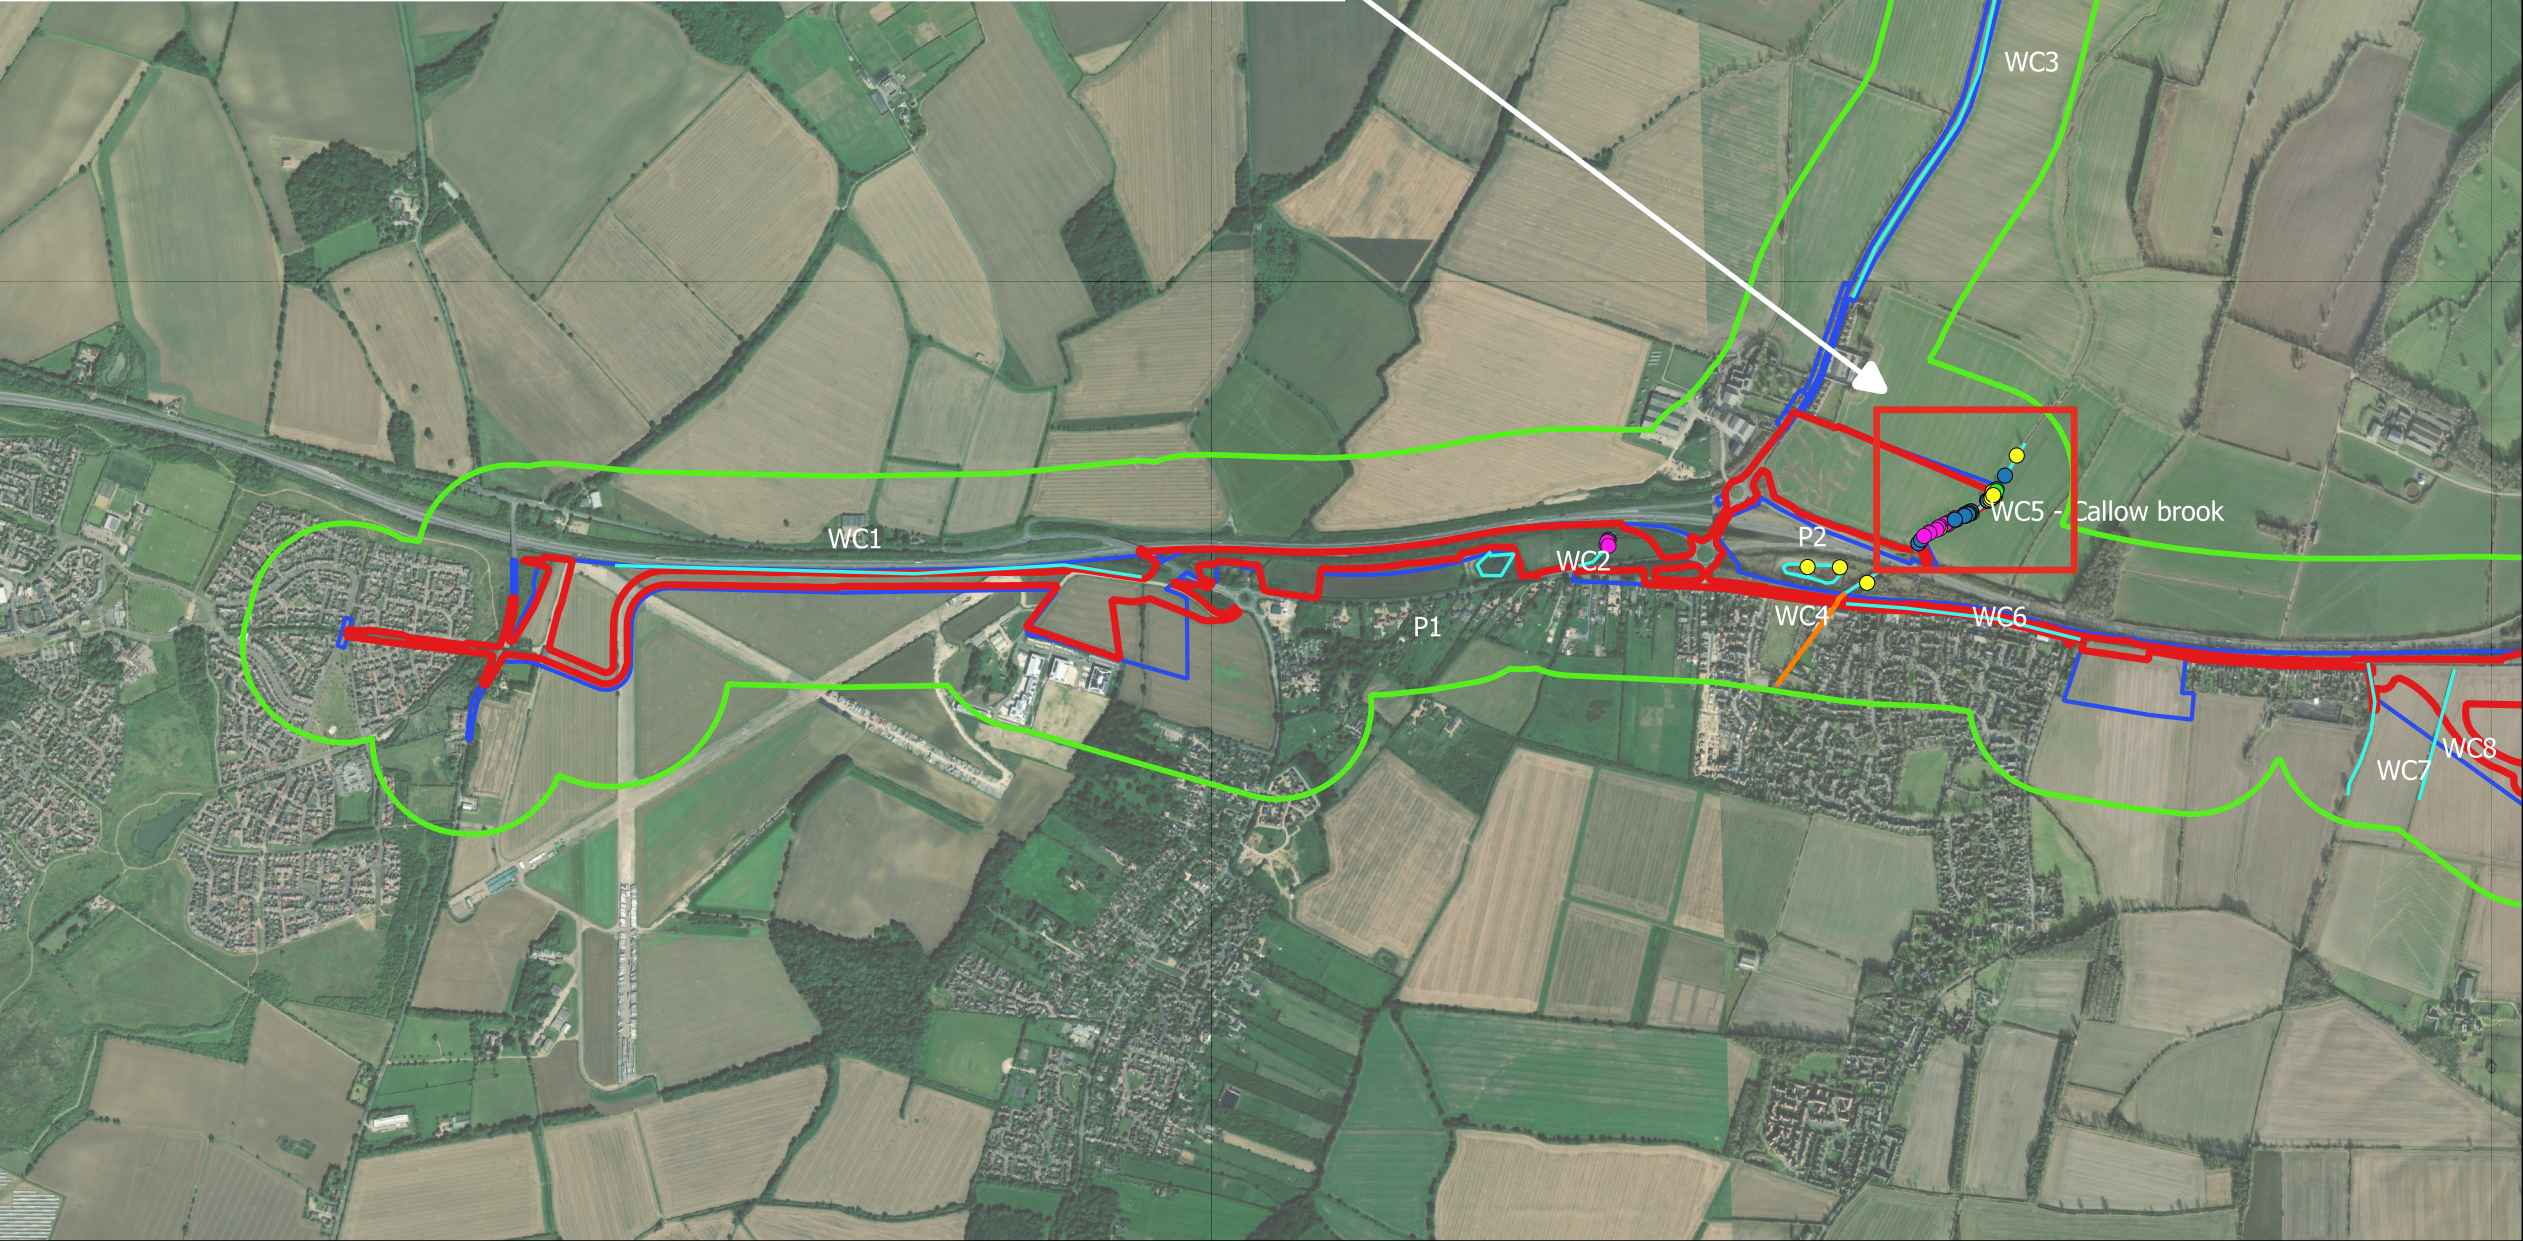
## **Water Vole Survey Results – West (Ponds and Callow Brook North & South)**

- 4.5.1. The 2022 surveys recorded field signs indicative of Water Vole in P2, WC2, Callow Brook South, Callow Brook North, and Bin Brook. A summary of evidence of Water Vole is given in **Table TR5-12-4-3**. Full survey data is included in **Annex C**, **Annex D** and **Annex F**.
- 4.5.2. The survey did not record any signs of Water Vole within southern sections of Callow Brook South and Bin Brook (as shown in **Annex B**). However, as these watercourses were subject to limitations, as outlined in **Section 3.3**, and Water Vole are confirmed to be present in the surveyed northern portions of these watercourses, this information has been used to infer presence in those southern areas. It should be noted that Water Vole presence can only be confirmed through sightings or latrines/droppings.

| <b>Watercourse</b> | <b>Survey number</b> | <b>Date</b> | <b>Water Vole field signs identified</b> | <b>Description of evidence present</b> |
|---|---|---|---|---|
| Callow Brook North (WC5) | Survey 1 | 14/06/2022 | Yes | Three Water Vole latrines were recorded with x3 and x2 droppings, respectively. |
| Callow Brook North (WC5) | Survey 2 | 08/09/2022 | Yes | 45 Water Vole burrows were recorded along the entire length of Callow Brook. Three records of blunt holes were recorded, and 17 records of Water Vole feeding remains. 17 Water Vole latrines were also recorded. |

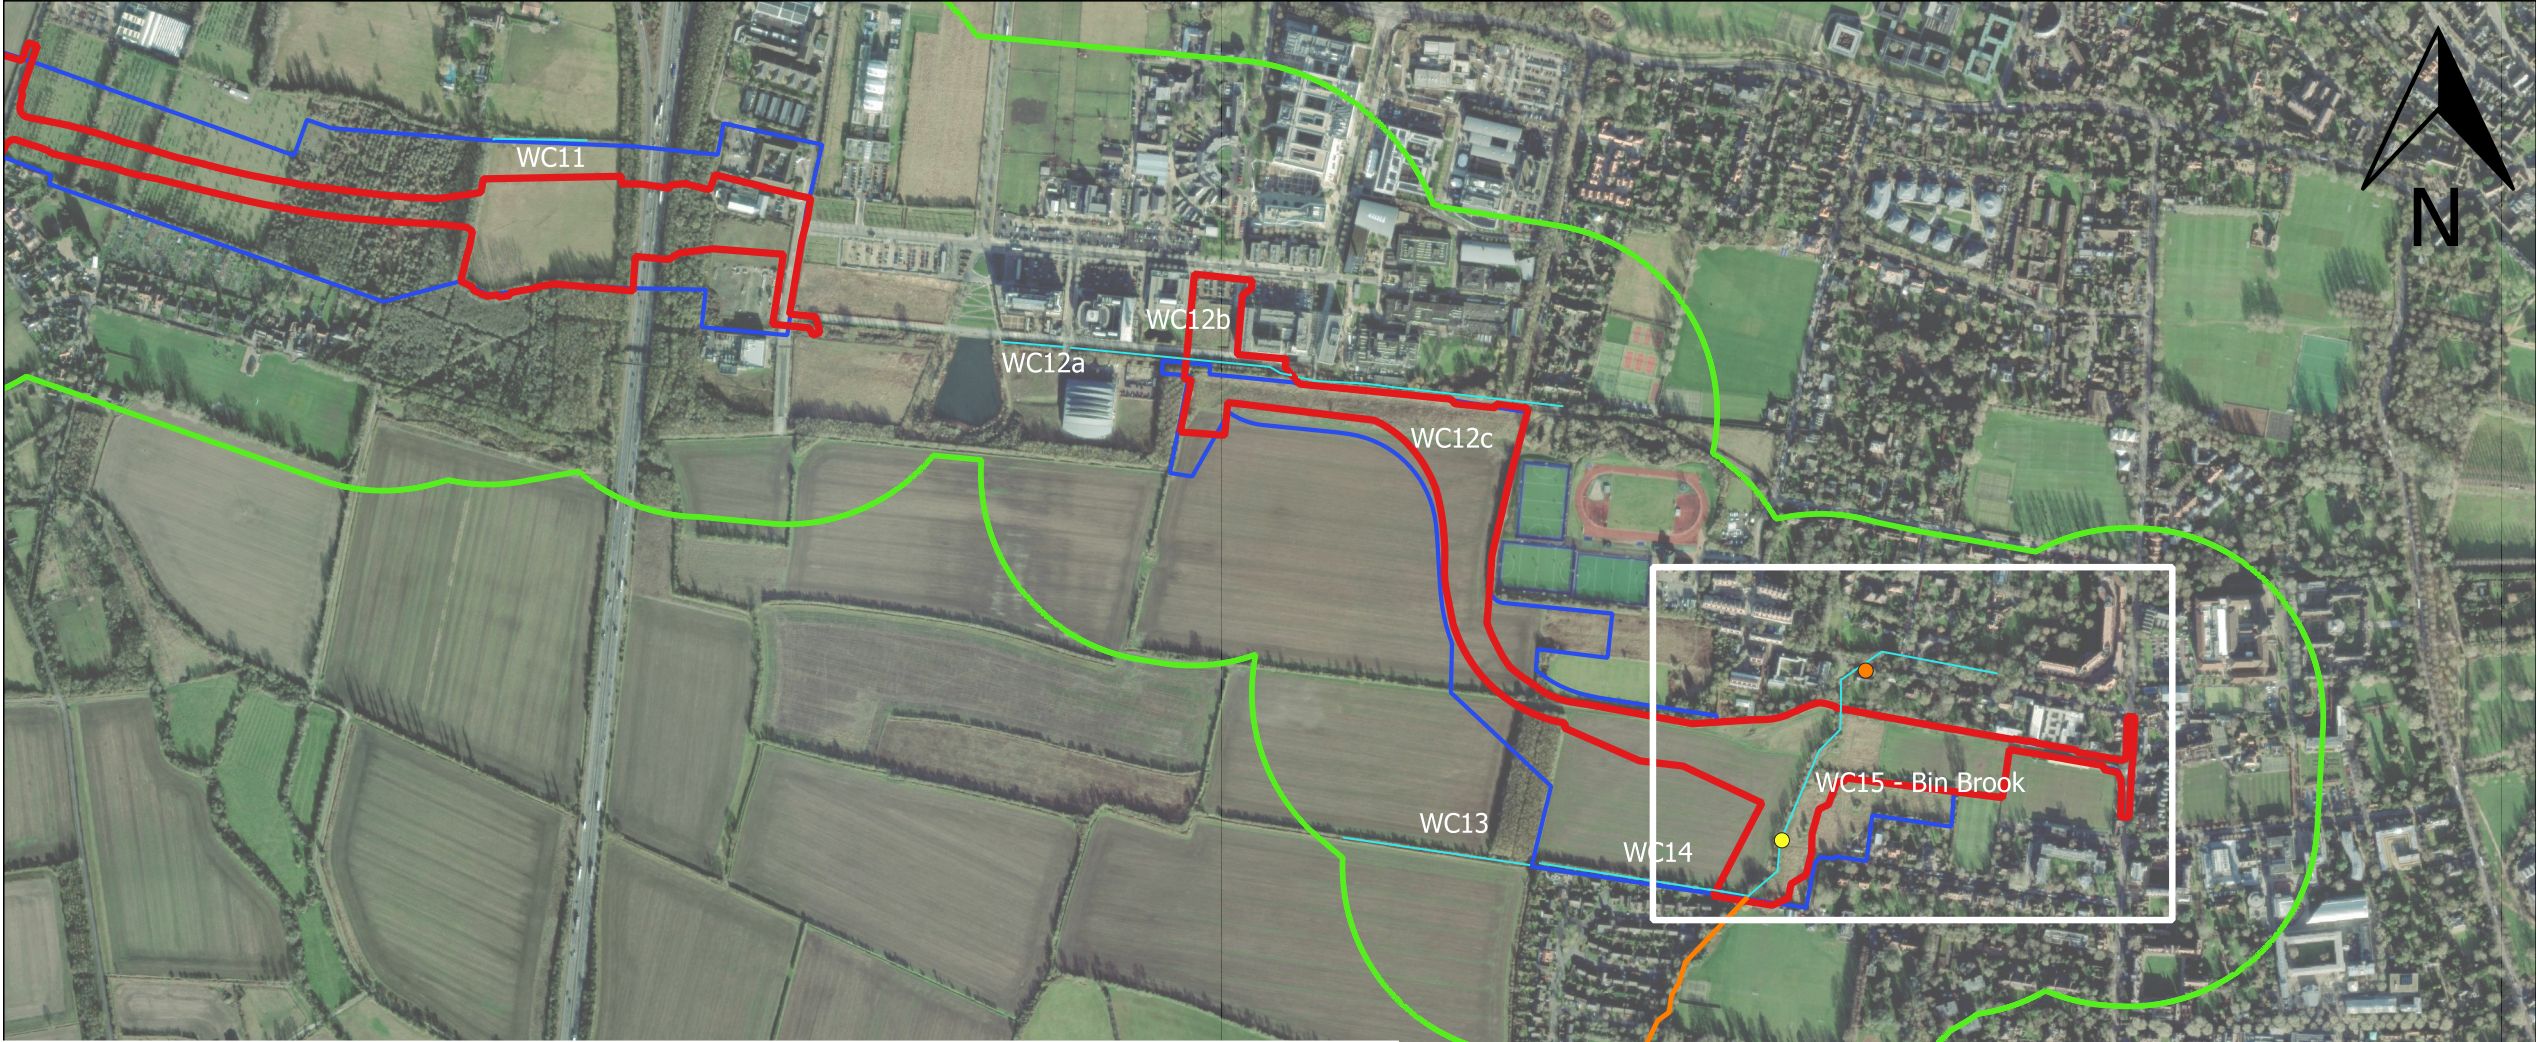
## **Otter Survey Results – East (Bin Brook)**

- 4.4.1. The 2022 surveys recorded partial field signs of Otter within the Bin Brook only. These included partial prints and feeding remains (Freshwater Pearl Mussel shells). Whilst these field signs are not definitive evidence of Otter, as they could have been from other species, the presence of Otter in the Bin Brook cannot be discounted.
- 4.4.2. A summary of evidence of Otter is given in **Table TR5-12-4-2**. Full survey data is included in **Annex E** and **Annex F**.

| <b>Watercourse</b> | <b>Survey number</b> | <b>Date</b> | <b>Otter field signs identified</b> | <b>Description of evidence present</b> |
|---|---|---|---|---|
| Bin Brook (WC15) | Survey 2 | 15/09/2022 | Partial field signs identified – presence cannot be confirmed. | One set of feeding remains (Freshwater Pearl Mussel shells) was recorded, and one set of partial prints were found. Such field signs cannot confirm Otter presence as these are not definitive field signs for the species. However, it cannot be ruled out. |
