APPENDIX N: UXO RISK MANAGEMENT

PRELIMINARY UXO RISK ASSESSMENT PEER REVIEW

| <p><b>STAGE 1 PRELIMINARY UXO RISK ASSESSMENT</b></p> <p>REPORT REF: PRA-21-1392 Revision: 0</p> | <p>The Joiner’s Shop, The Historic Dockyard<br/>Chatham, Kent, ME4 4TZ<br/>0207 117 2492<br/>www.brimstoneuxo.com</p> |
| <p><b>Client:</b> Tetra Tech</p> <p><b>Project:</b> A1307 Cambridge South East, Cambridgeshire</p> <p><b>Date:</b> 15/02/2021</p> | |

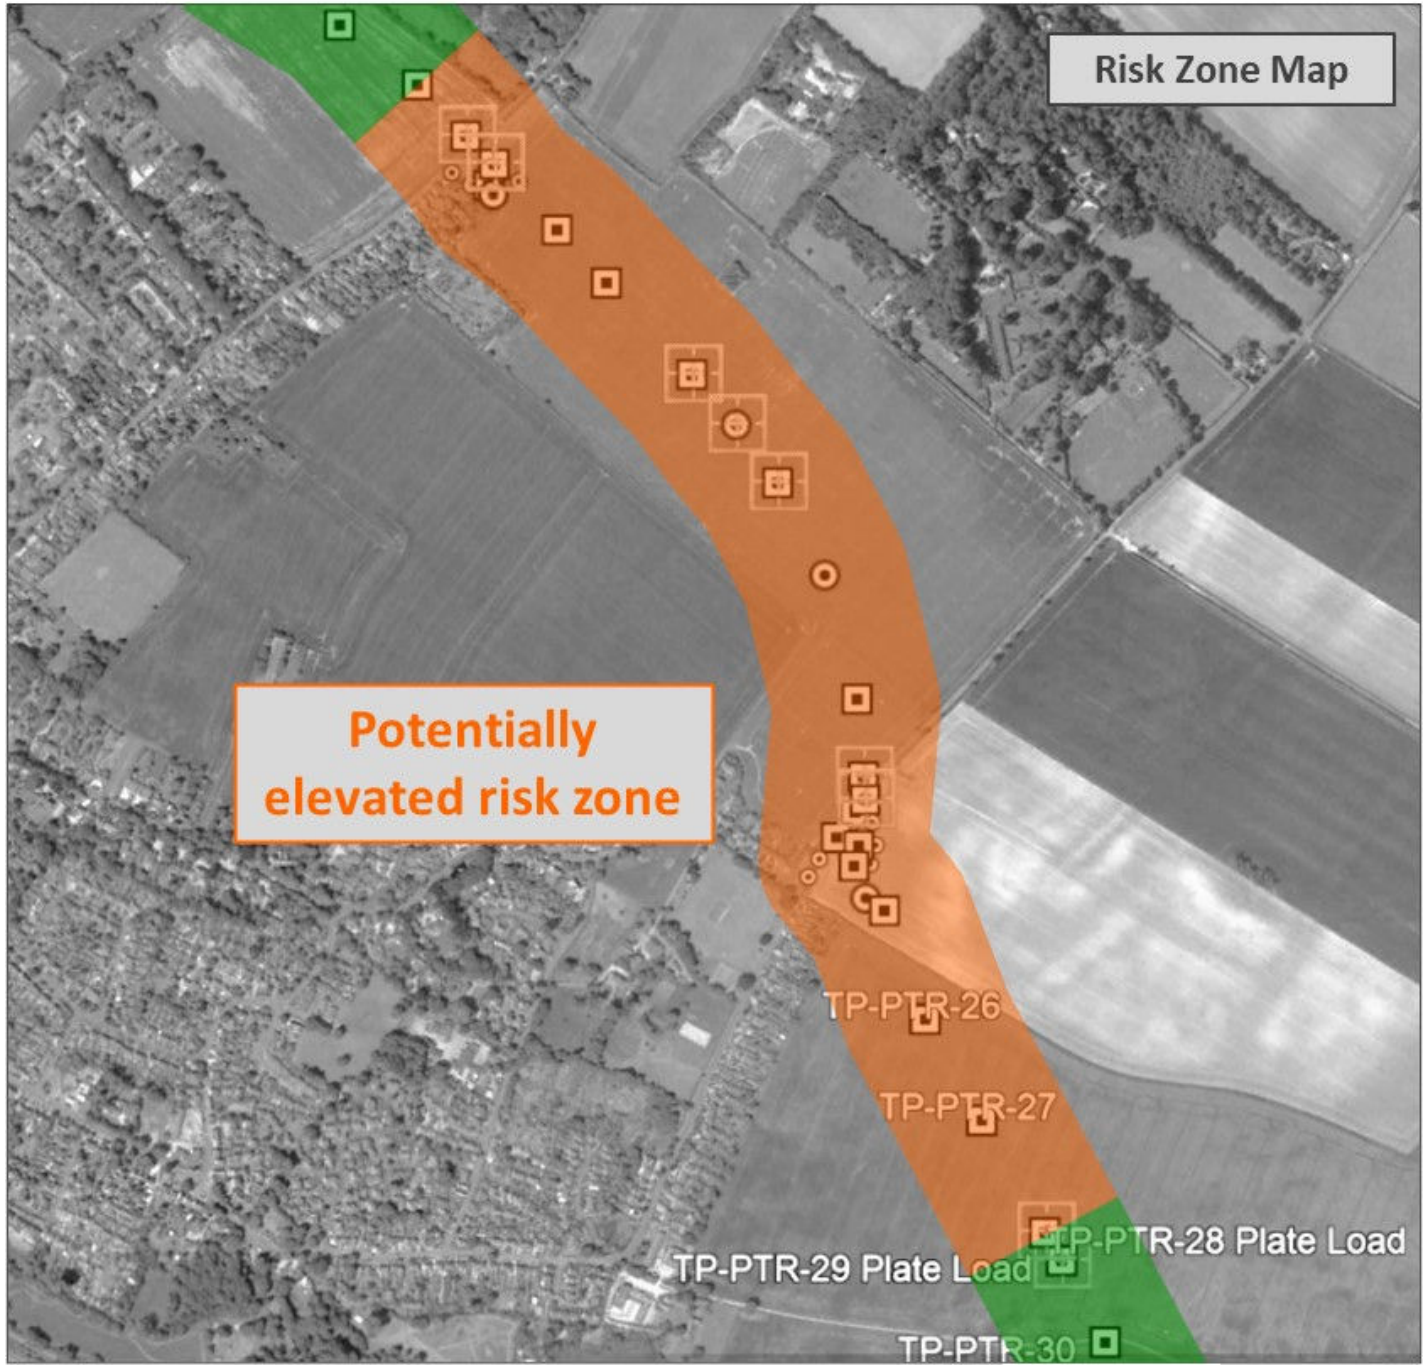
| RECOMMENDATION(S) | |
|---|---|
| SI Works | A <b>Stage 2 Detailed Risk Assessment</b> is recommended to elucidate the potentially elevated UXO risk between SI positions <i>TP-PTR-15</i> and <i>TP-PTR-28</i> (approx. TL 47250 53136 and TL 48106 51667), see risk zone map below.<br>Alternative option: <b>EOD Engineer - Watching Brief</b> . |

| | | Local Bombing Decoy Sites | The Babraham Decoy ('SF' Series Decoy No. SF54) was located ~2km north of the south-eastern Site extent. |
|---|---|---|---|
| Existing or historic military defensive fortifications | ✓ | The WWII GHQ defensive stop line passed through the centre of the Site. Although its exact alignment is not currently known, it is known to have comprised an anti-tank ditch, roadblock and pillbox within 300m of the Site. The anti-tank ditch appears to have passed very close a central section of the Site between SI positions <i>TP-PTR-16</i> and <i>TP-PTR-27</i> . | |
