# **CAMBOURNE TO CAMBRIDGE**

Aquatic Ecology Report 2022

**Project no. 70086660**

**OUR REF. NO. 70086660-443**

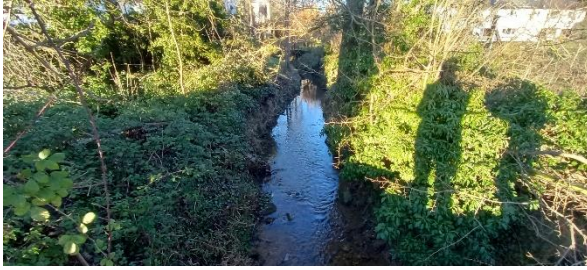
**Figure TR5.1.A-1 – General Character 1**

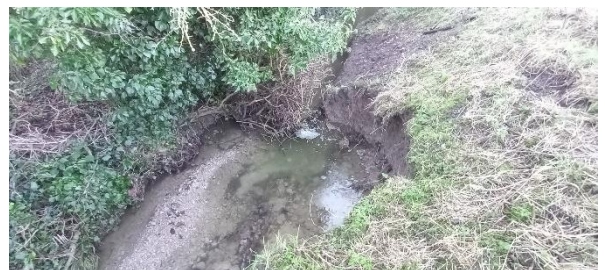
- 4.2.5. The substrate was variable, with some areas of coarse sediment (boulder, pebble and gravel), but the majority consisted of fine sediment. Channel morphology was varied, containing gravel beds and deeper pools. Bank erosion and poaching was observed, a possible consequence of walkers, dogs and cyclists crossing the brook on the existing footbridge, and wildlife crossing the brook.

**Figure TR5.1.A-6 – Bank Erosion**

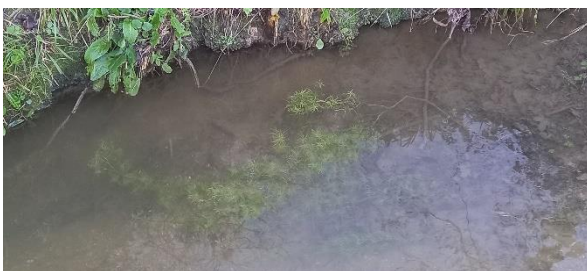
- 4.2.8. Submerged macrophyte species were observed in the brook, such as the water starwort *Callitriche spp.*
- 4.2.9. A small, modified tributary or drainage ditch (approximately 0.5m wide channel) joins Bin Brook just downstream of a small footbridge and housing estate. The ditch was fed by a concrete channel (Bin Brook Diversion Channel) which had very little flow at the time of the survey. Beyond the channel culvert (located at NGR TL 43202 58099) to the West, the channel is fed by a ditch from which it was not possible to ascertain flow type or if the ditch was dry, due to dense bramble and scrub cover.

**Figure TR5.1.A-7 – Submerged Macrophytes**

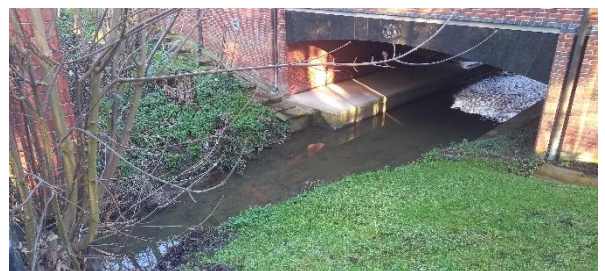
- 4.2.10. Up to 30m downstream of the crossing point, Bin Brook displayed similar channel characteristics to that of the upstream section. Beyond this, the brook flowed through a more urban environment, with heavily modified banks and a wider, more uniform channel. Concrete banks and various outfalls were observed as the brook flowed through this urban area.

**Figure TR5.1.A-8 – Modified Channel**

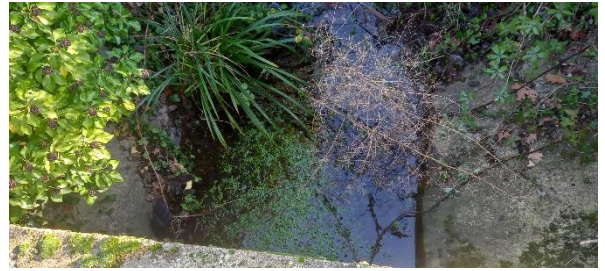
| Waterbody Name | Section Number | Site Location | Habitat Description | Further Surveys |
|---|---|---|---|---|
| Coton Stream | 3a | Upstream extent:<br>TL 43366 58691<br><br>Downstream extent:<br>TL 42911 58740 | Narrow, straightened channel. Heavily modified with multiple outfalls. Connected to both Payne's Pond and West Cambridge Canal. Variety of macrophytes present. | No – Unfavourable habitat and unsafe access. |

**Figure TR5.1.A-22 – Coton Stream  
Macrophytes**

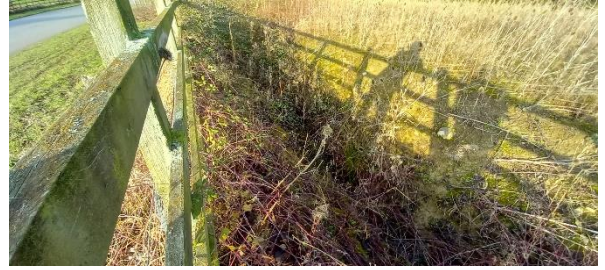
**Figure TR5.1.A-62 – Dry Ditch**

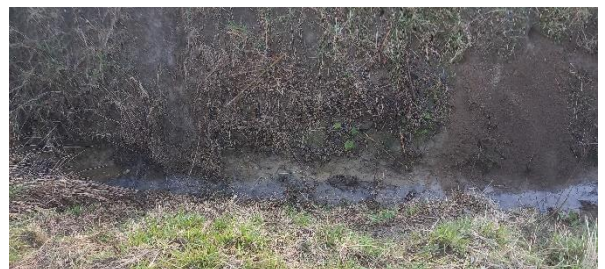
**Figure TR5.1.A-72 – Evidence of rats using banks**

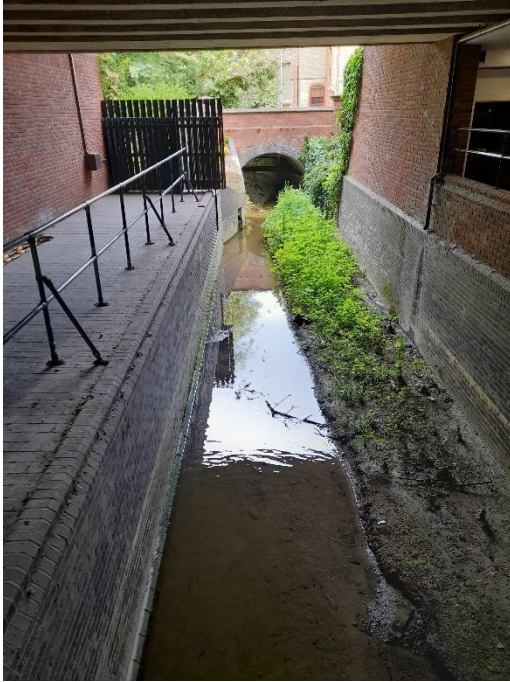
- 4.4.1. Bin Brook mostly comprised artificial, man-made structures, that provided limited suitable habitats for white-clawed crayfish. Within the grounds of Robinson College, Bin Brook was spilt by a weir system at NGR TL 43963 58445 potentially limiting the movement of aquatic fauna, including crayfish. It was concluded that this downstream section had limited potential to support a viable population of white-clawed crayfish. An eel pass was observed on this section, see **Annex B, Figure TR5.1.B-3**.

Figure TR5.1.B-1 – Man-made banks

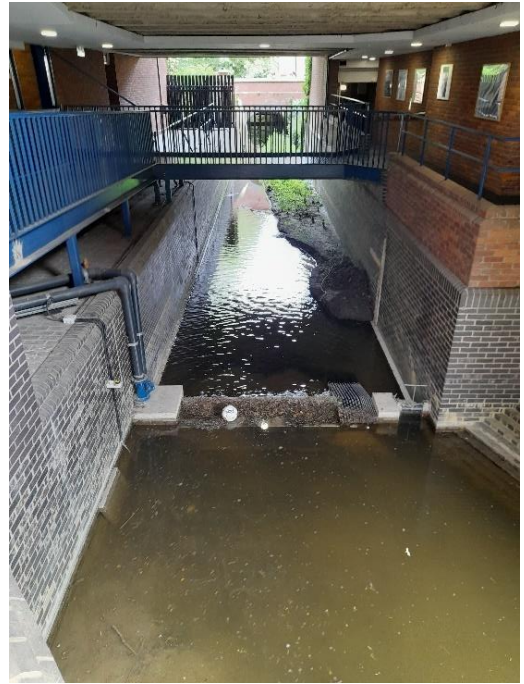
Figure TR5.1.B-5 – Weir and eel pass

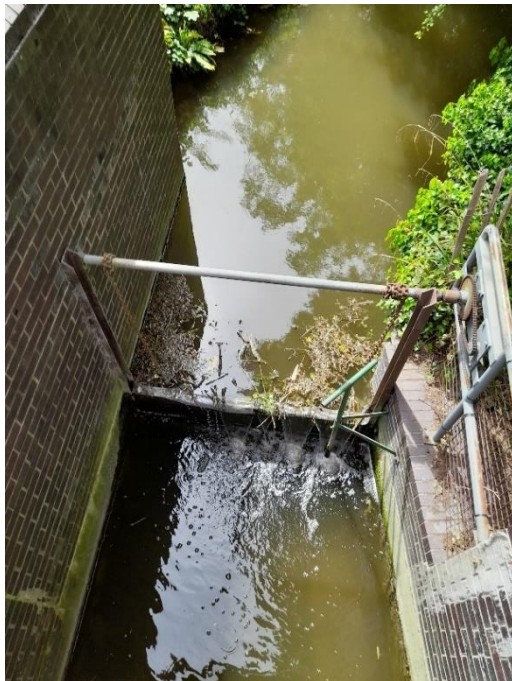
Figure TR5.1.B-6 – Potential barrier to movement

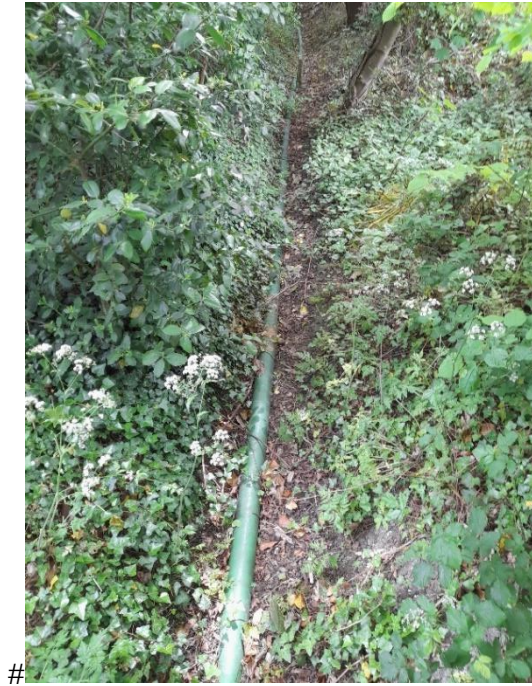
- 4.4.3. A small unnamed ditch located within the grounds of Robinson College at NGR TL 43770 58390 was found to be dry, thus is unlikely to support populations of white-clawed crayfish.

**Figure TR5.1.B-13 – Dry ditch**
