## Rother Valley Railway Level Crossing – C18 Northbridge Street, Robertsbridge Stage 1 Road Safety Audit

**Rother Valley Railway Level  
Crossing - C18 Northbridge Street,  
Robertsbridge**

Stage 1 Road Safety Audit

RSA1.1

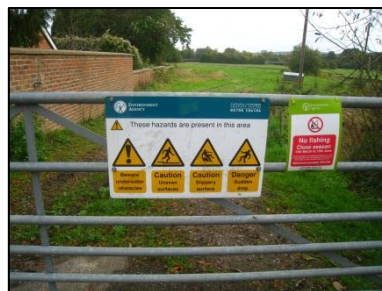
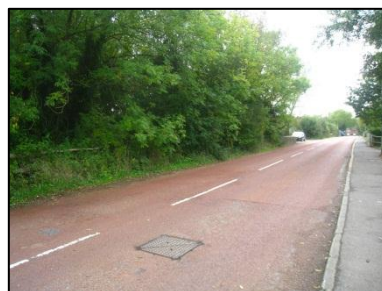
- There is an Environment Agency access situated immediately north of the proposed level crossing site on the north bank of the River Rother. The railway will truncate this access and it is not clear how suitable, safe access to the riparian environment will be maintained.
- It is not clear whether the existing verge width (especially on the eastern side of the road) is able to safely accommodate the required traffic sign infrastructure.

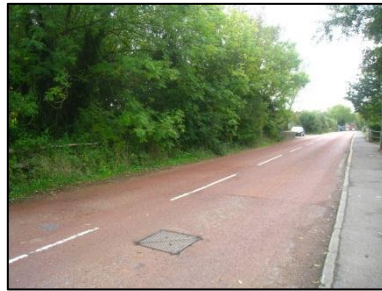
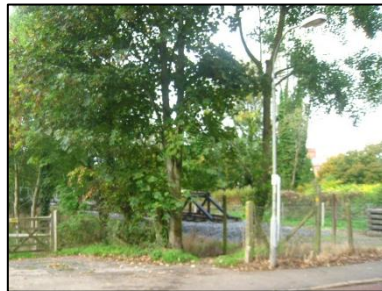
- The drawing provided does not show the extent of the vegetation clearance required in order to provide the appropriate visibility envelope for the level crossing as set out in Railway Principles and Guidance.

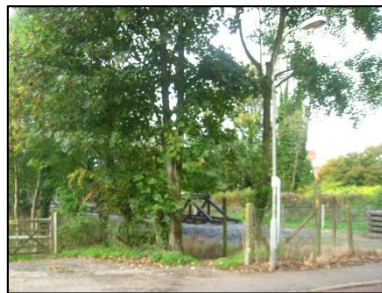
IMG\_2940.jpg

- Northbridge road is lit, and the construction of the crossing may necessitate the removal of an existing lighting column, reducing illumination levels. The provision of consistent street lighting levels will need to be addressed in the detailed design.

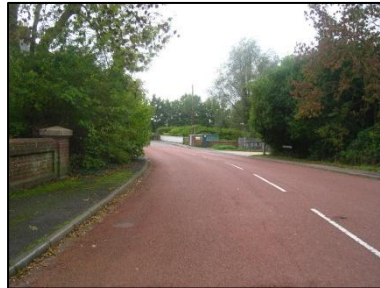
IMG\_2951.jpg

- Location:** Northbridge Street, southbound approach
- Summary:** Limited forward visibility to level crossing leading to shunt type collisions.
- Description:** The approach to the level crossing is situated on a bend in the road

There is a cottage located close to the road limiting drivers' forward visibility on the bend. In the same location there is on-street residents' parking, which requires traffic to cross the carriageway centreline. This could draw drivers' attention away from downstream hazards such as a stationary queue of vehicles at the level crossing, leading to shunt collisions.

- S1.1.1 Recommendation:** Move the northern-most warning signs to TSRGD Diagrams 770 and 773 to the northern side of the drainage culvert to provide additional advanced warning.
-

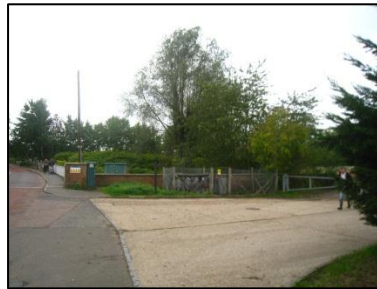
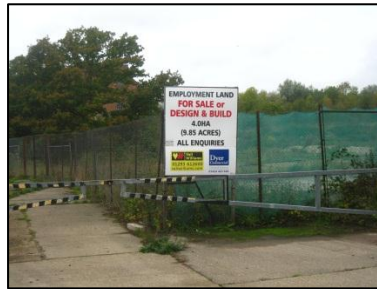
- Location:** Northbridge Street, carriageway
- Summary:** Adjacent accesses increase the risk of blocking back at the level crossing.
- Description:** There are a number of accesses close to the proposed level crossing location, not least that of a four hectare industrial development site, which could generate a significant volume of additional traffic movements.

The limited carriageway width and on-street parking could result in traffic waiting on the carriageway by the level crossing and will increase the risk of vehicles queuing over the level crossing, leading to potential vehicle / train conflict.

- S1.1.2 Recommendation:** Introduce a yellow box marking to TSRGD Diagram 1045 to deter traffic from queuing over the crossing.
-

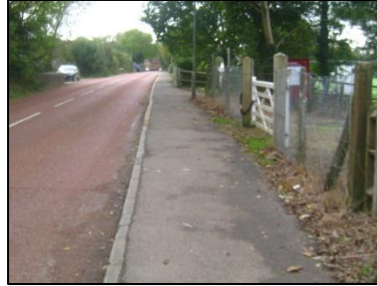
IMG\_2946.jpg

- Location:** Northbridge Street, footways
- Summary:** Insufficient warning for the visually impaired could lead to pedestrian injuries.
- Description:** Footways are provided along both sides of Northbridge Street in the vicinity of the proposed level crossing.

The visually impaired use tactile warning surfaces to identify hazards ahead. A visually impaired pedestrian could enter the level crossing zone without realising the hazardous nature of the environment, placing them at risk of being trapped by the barriers.

- SS1.1.3 Recommendation:** Introduce tactile warning surfaces, in line with national guidelines, on each footway approach to the crossing.

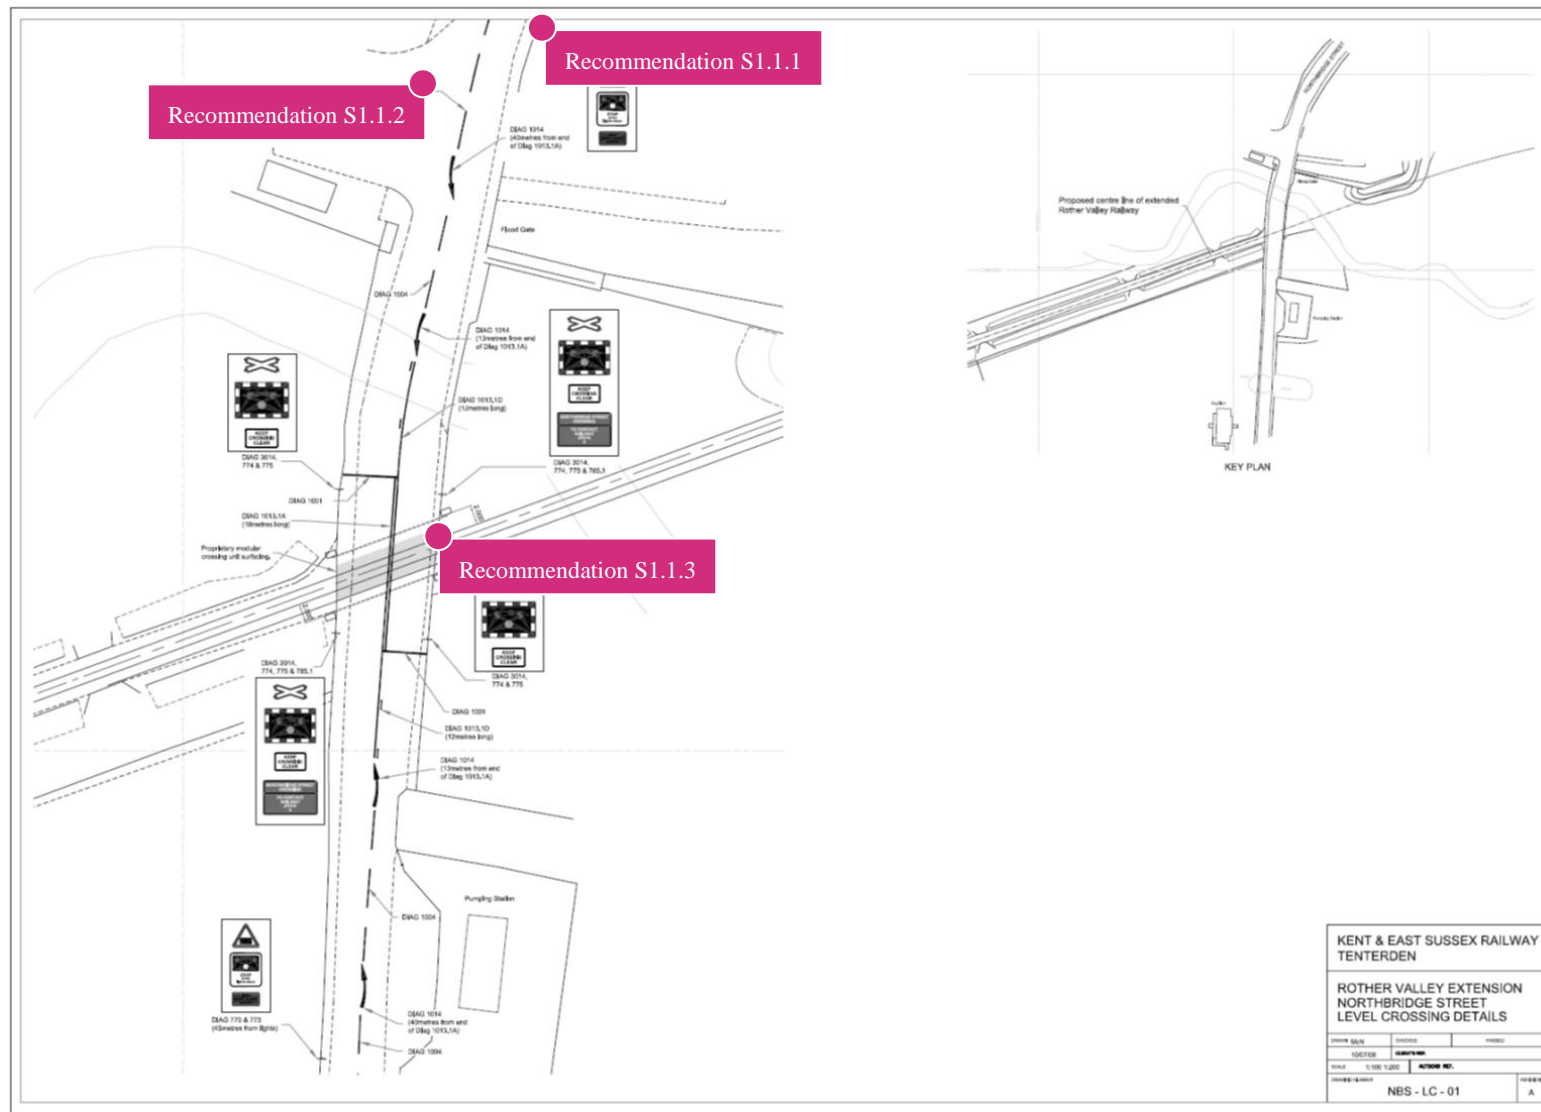
Figure 1 Location of Recommendations

All problems and recommendations identified by this audit are referenced to the design drawings and the locations have been indicated on the attached plan.
