**Rother Valley Railway Level
Crossing - A21(T) Robertsbridge
Bypass**

Stage 1 Road Safety Audit

RSA1.2

Rev B | 17 January 2014

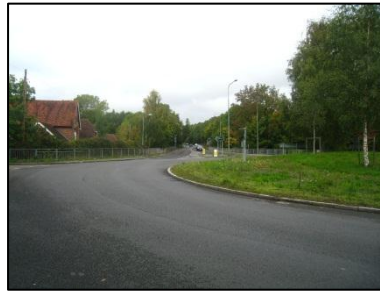
IMG_2965.jpg

- Location:** A21(T) Northbridge Street roundabout
- Summary:** Queuing at the level crossing could block the roundabout leading to injudicious manoeuvres and road user conflicts.
- Description:** The projected queue lengths at the level crossing are likely to reach the A21(T) Northbridge roundabout, blocking turning movements.

Blocking on the circulatory carriageway of a roundabout can lead to significant frustration for drivers on the side roads, not included in the main queue. This can lead to drivers trying to force their way around the junction, resulting in circulatory collisions.

- S1.2.1 Recommendation:** Introduce 'yellow box' or 'KEEP CLEAR' markings to, as far as possible, maintain the turning movements at the roundabout.
-

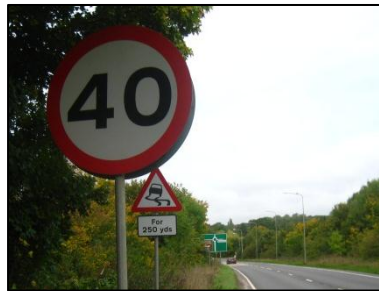
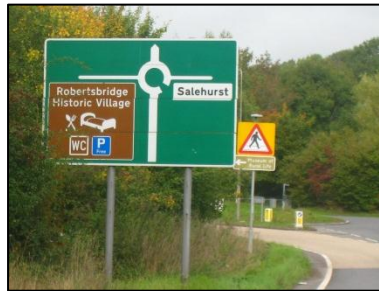
- Location:** A21(T) Robertsbridge Bypass, northbound
- Summary:** Multiple traffic signs leading to distraction, missed warnings and road user collisions.
- Description:** There are a number of existing traffic signs on the northbound approach to the A21(T) Northbridge Street roundabout, including direction signing, warning signing, and tourist signs.

The proposed level crossing layout does not consider the existing traffic signing or the effect of the proposed level crossing signing on the existing signing. This could lead to drivers missing some signs and the warnings they portray leading to a range of conflicts and/or collision types.

- S1.2.2 Recommendation:** A comprehensive review of the existing signing on the A21(T) should be incorporated into the detailed design of the level crossing including visibility splays to the various signs to demonstrate there will be no masking.
-

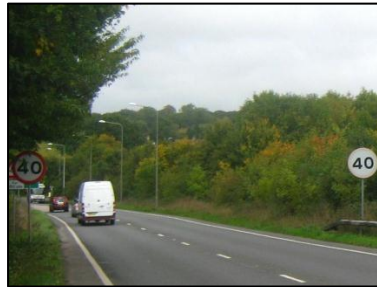
IMG_2984.jpg

- Location:** A21(T) Robertsbridge Bypass, north of proposed crossing
- Summary:** Unlit hazard in lighting transition leading to shunt or crossing collisions.
- Description:** The level crossing is proposed some 40m from the end of the existing street lighting system on the approach to the A21(T) Northbridge Street roundabout. It is not proposed to light the level crossing.

Some drivers' eyes can take several seconds to adjust from lit to unlit conditions, and vice versa. A hazard such as a level crossing or queue located within that transition distance could result in shunt type collisions or a collision at the crossing itself.

- S1.2.3 Recommendation:** Extend the street lighting system to the south side of the level crossing in order to adequately light the hazard.

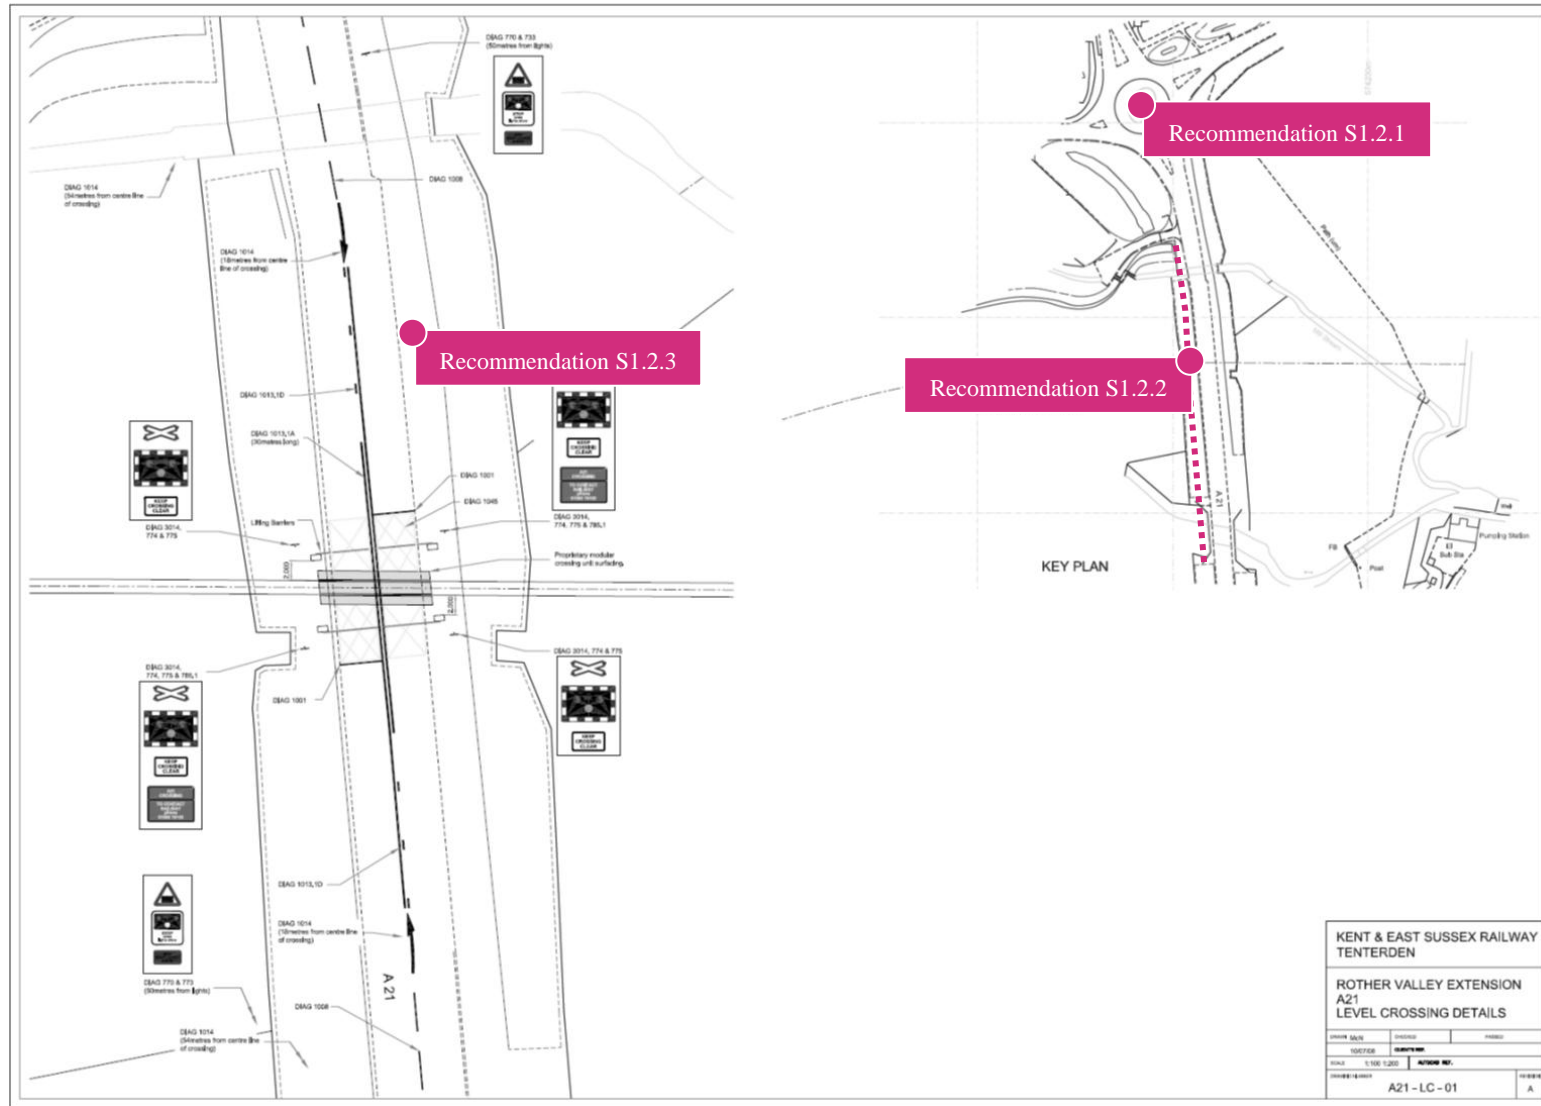
Figure 1 Location of Recommendations

All problems and recommendations identified by this audit are referenced to the design drawings and the locations have been indicated on the attached plan.
