**IN RESPECT OF THE APPEAL AGAINST THE DECISION OF HERTFORDSHIRE  
COUNTY COUNCIL FOR THE DEVELOPMENT OF  
LAND AT HATFIELD AERODROME, OFF HATFIELD ROAD, HATFIELD,  
HERTFORDSHIRE**

**PLANNING INSPECTORATE REF: APP/M1900/W/24/3346607**

**Ellenbrook Country Park Footpath Assessments**

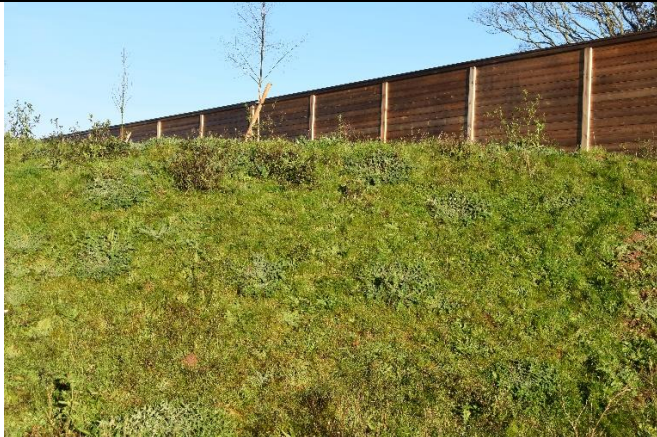
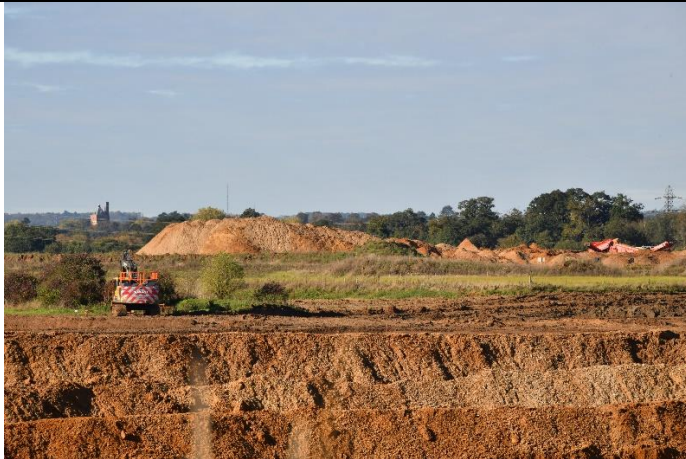
| Route 4 images | | |
|---|---|---|
| <p>Proposed bund and acoustic screen</p> | | |

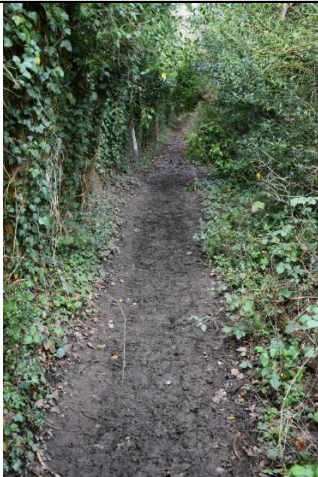
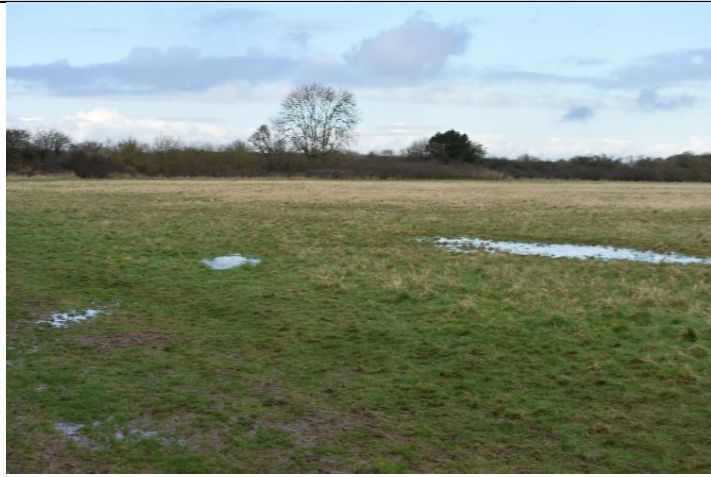
| Route 5 images | | |
|---|---|---|
| Location - | Path near Notcutts Garden Centre | View from Smallford if open route is used |

| Criteria | Requirement | Suitable | Assessment |
|---|---|---|---|
| Width restrictions | E.g. Gates etc.<br><815mm wide for <300mm length<br>or<br>915-1000mm wide<br><1600mm length<br>or<br><915mm wide<br><1600mm length | | Access at Notcutts is via kissing Gate. The gate is damaged max width 600mm.<br><br>Proposed changes unknown |

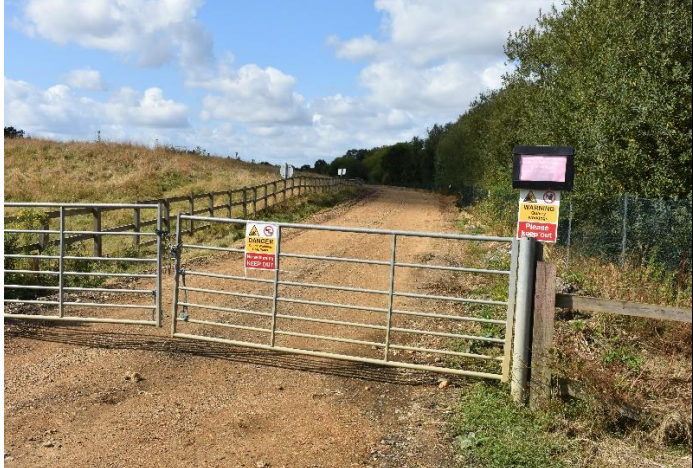
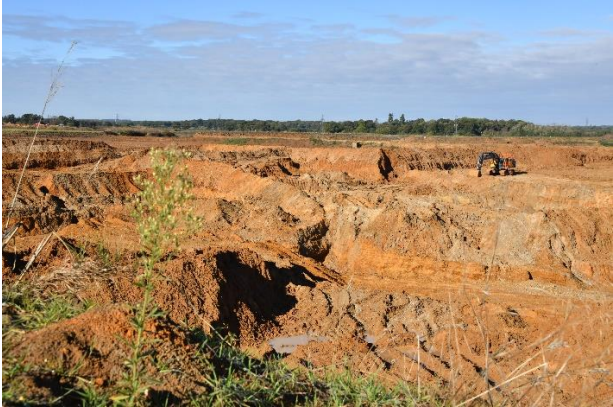
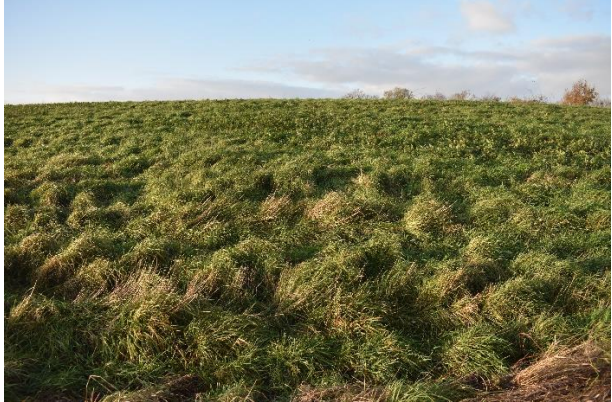
| | <p data-bbox="1041 1150 1218 1187">Open quarry</p> | <p data-bbox="1480 1150 1644 1187">Grass bund</p> |

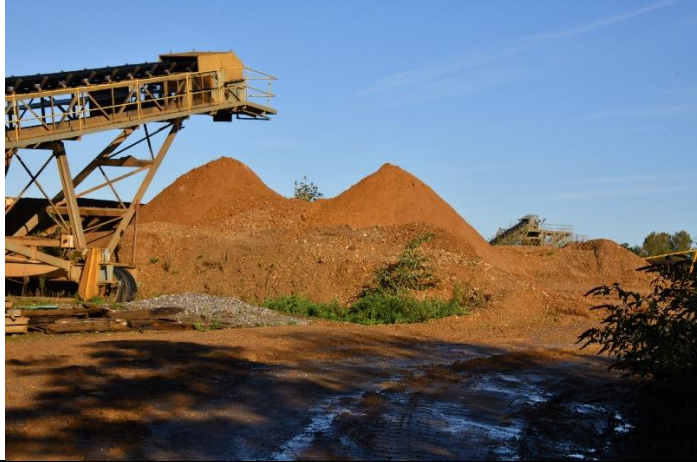
| Route 6 images | | |
|---|---|---|
| Location path between Home Wood and the taxiway | Taxiway looking northwest | Current path in the area of the proposed processing site |

| Criteria | Requirement | Suitable | Assessment |
|---|---|---|---|
| | | Brick paving<br>Mown grass | Route from start of site to taxiway unknown, it should be noted that the current path on this route is flooded in winter. See image below.<br>Taxiway - concrete |
