**Colney Heath Group (CH Group)**

**Land at former Hatfield Aerodrome Hatfield Hertfordshire AL4 0JB**

**CHG Hydrology & public access issues**

## Evidence regarding the public access strategy and the lagoons and hydrology of the park

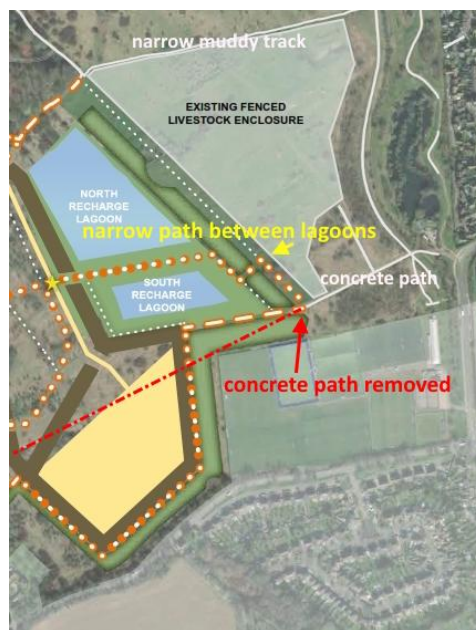
The image *drawing 1* shows the location of the lagoons from Home Covert in the North to the University playing fields in the South. It shows how the lagoons block E-W traffic.

Three routes have been proposed, one being a small path between the lagoons, the other main routes are north and south of the lagoons.

Part of the existing concrete runway path has been removed to make way for the lagoons. The concrete path is used by the majority of Park users, but the “narrow muddy track” is avoided as it goes through a cattle field

My inlaid graphic *drawing 1* from CD1702\_public\_access\_strategy\_feb26, (taken from drawing number 5)

The lagoons are just in the wrong place. There will be no way of integrating land sections or phases in the western part of the Park with the area to the East.

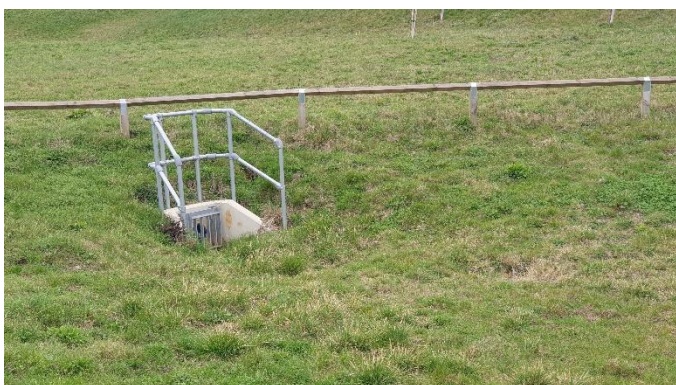
A passive swale

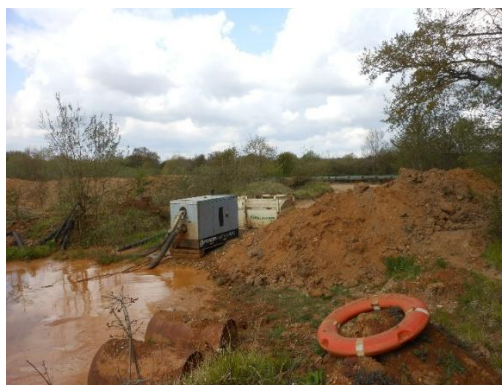
An example of active pumping

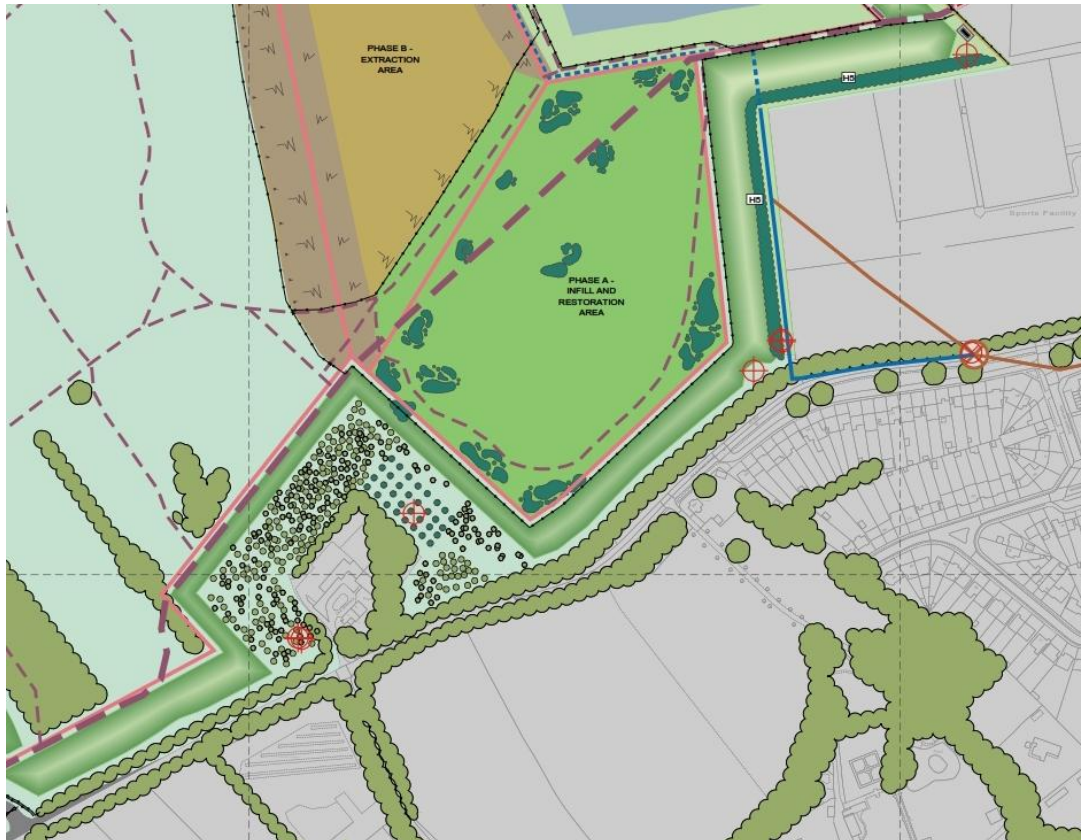
It is expected that at least 3 streams or pipes will be required to drain the parcel of land to the Northern Recharge Lagoon (NRL). I would also suggest that 24/7 pumping would be put into operation to transport this excess water.

An expanded section of drawing CD1703-04 HQ3/9 showing Phase A, *map 3*

Map 3 shows restored phase A with a multiuser path (dotted). It fails to show any water features including streams, bridges or crossing points.

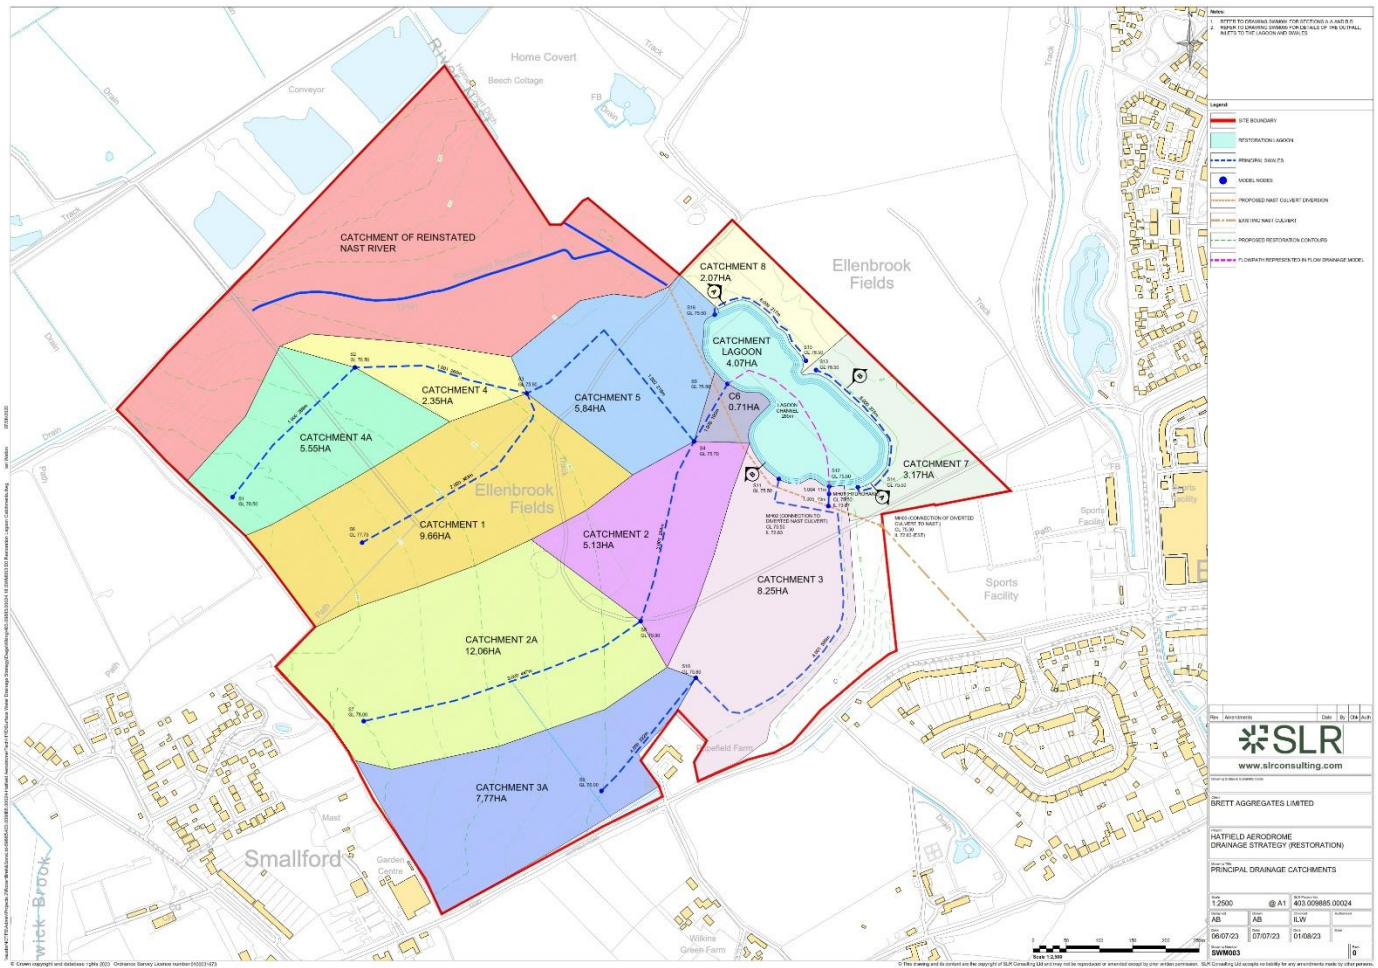
The drawing shows 5 large reedbeds (brown patches) that are part of the restoration that implies the land will be wet.

A drawing from the Technical Memorandum, Principal Drainage Catchment, SWM003, note Phase A is catchment 3
