# The Cambridge South East Transport Order

### Appendix 9. – Agricultural Land Classification Report

| Document Reference | CSET-10-28 |

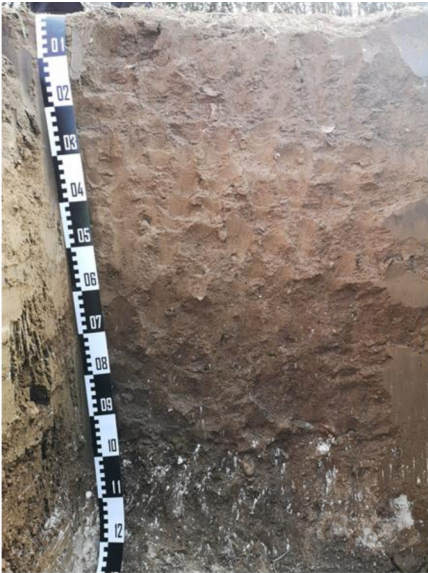
Figure 4.1.2: Inspection pit close to bore 26 within the Swaffham Prior Association. A well drained calcareous soil over chalk rubble. This example is atypically deep showing chalk drift at around 100 cms.

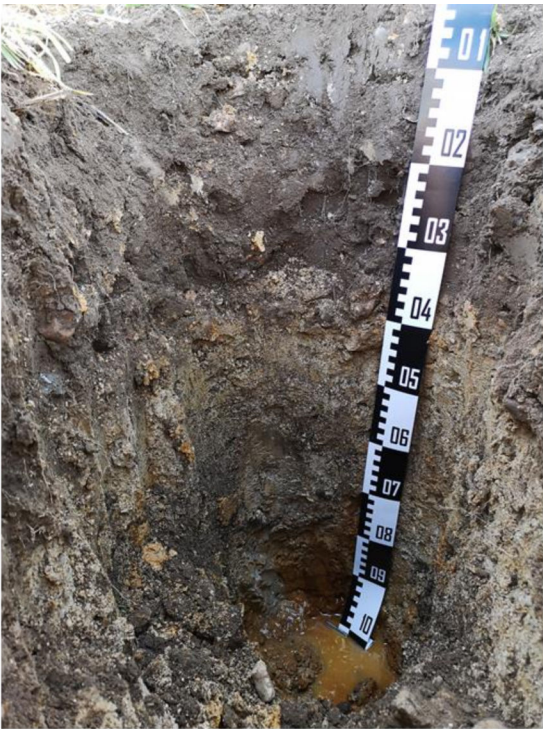
Figure 4.1.3: Inspection pit close to bore location 35. Picture shows the typical profile of the Thames Soil Series. A seasonally wet deep clayey soil affected by groundwater

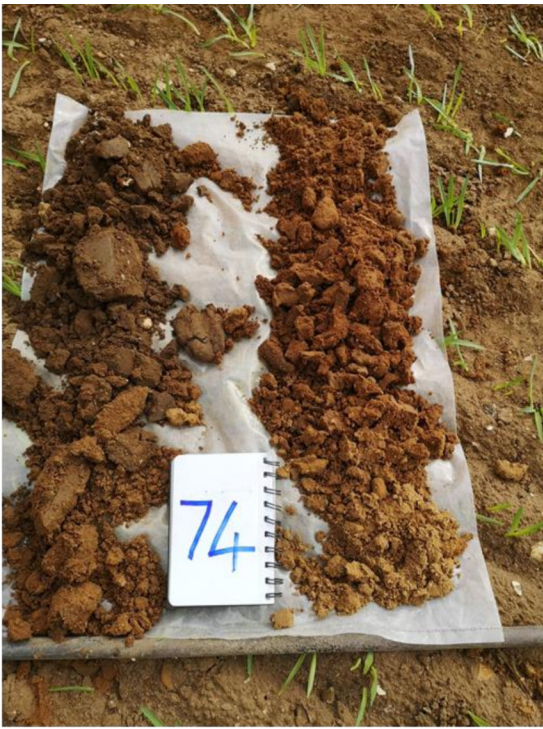
Figure 4.1.4: Example of a borehole excavation laid out for examination and logging
